Parks & Wildlife Service, Tasmania
Newdegate Cave
Rehabilitation Plan 1994

HASTINGS NEWDEGATE CAVE REHABILITATION PLAN

Parks and Wildlife Service
July 1994

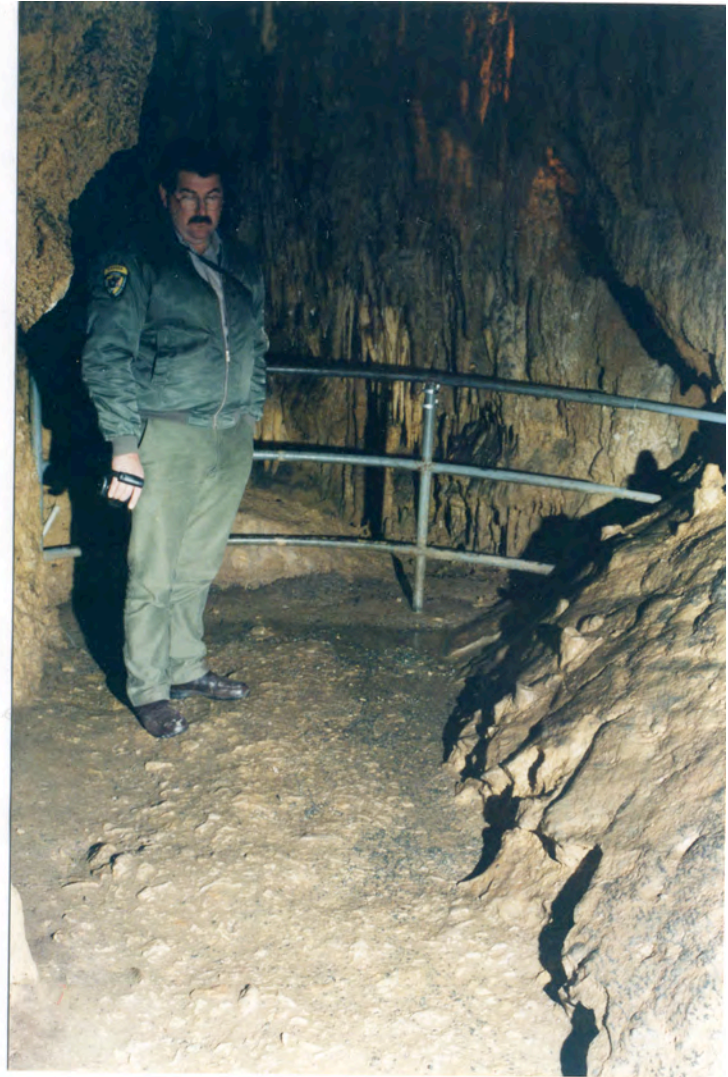
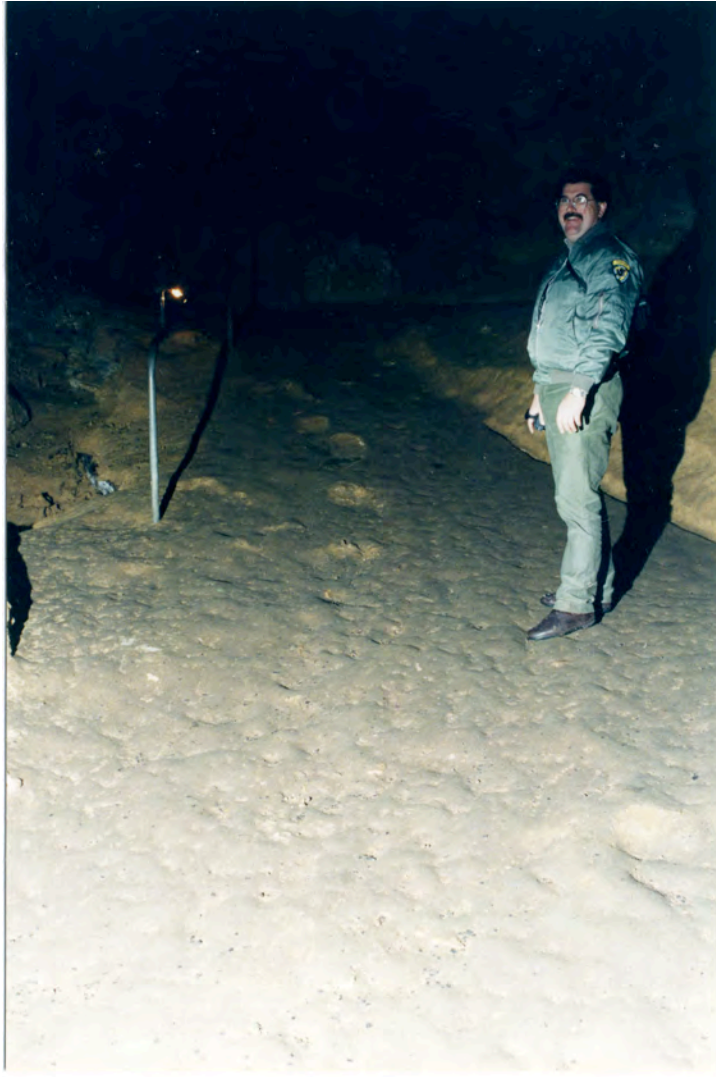
Section 2.2. Unconsolidated material from unstable areas such as these is transferred on visitors shoes throughout the cave system, particularly when surface are wet. Rough surfaces are potential safety hazards for visitors.

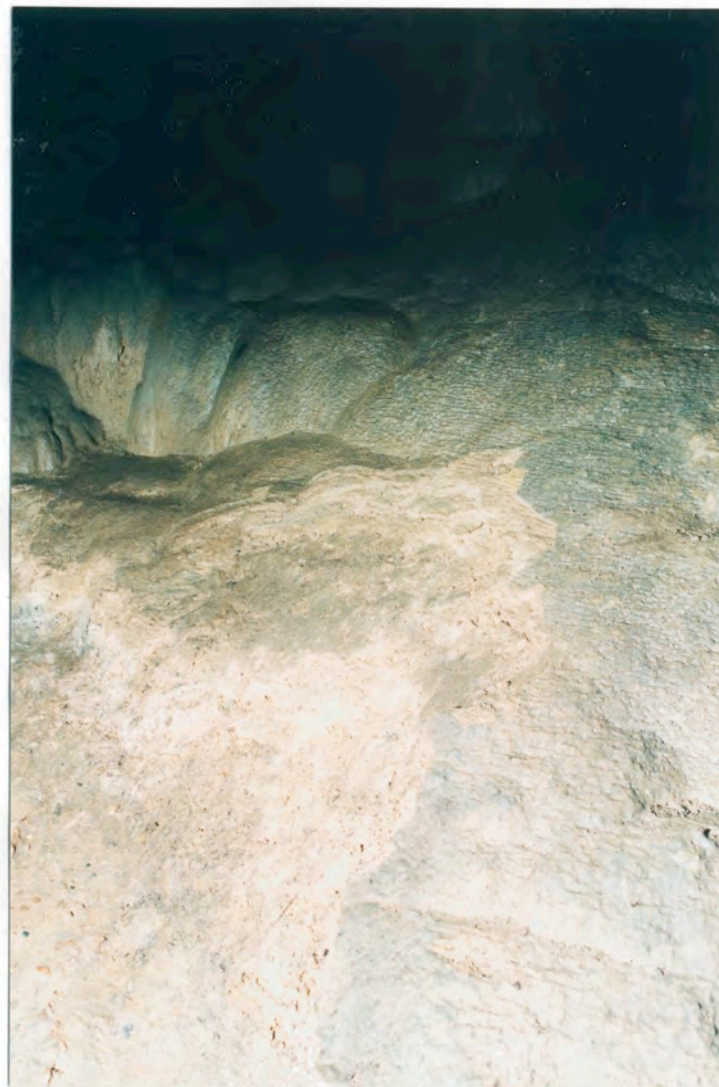
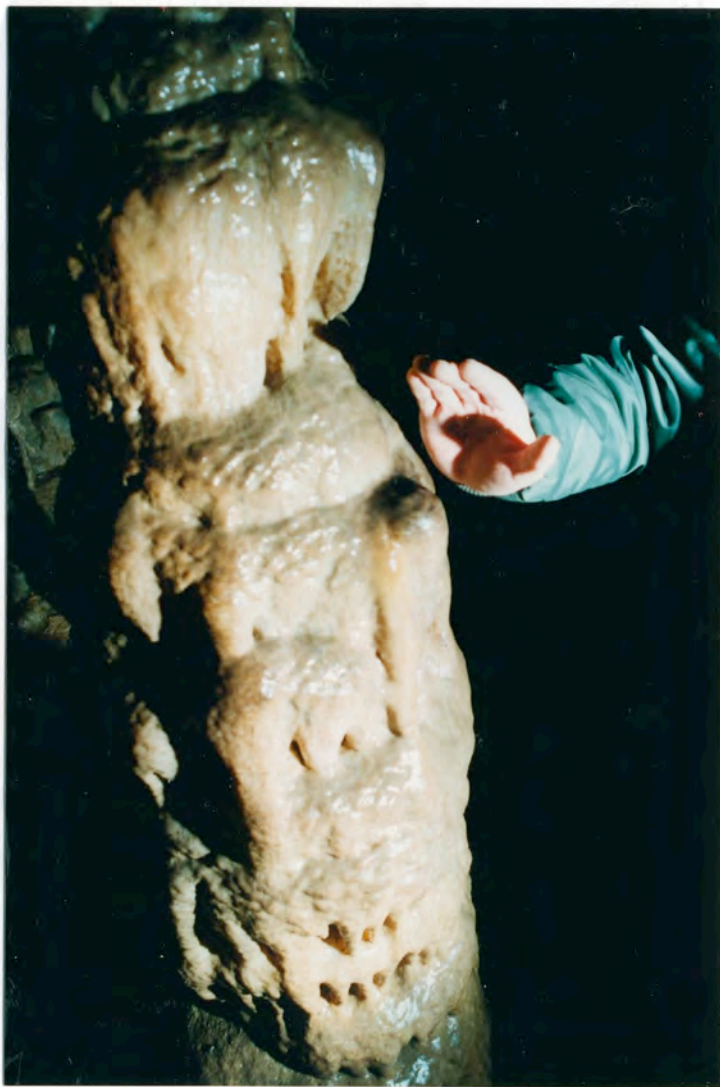
Section 2.3 Poor walkway definition allows unacceptable degradation of speleothems and cave sediments by visitors venturing outside acceptable access areas

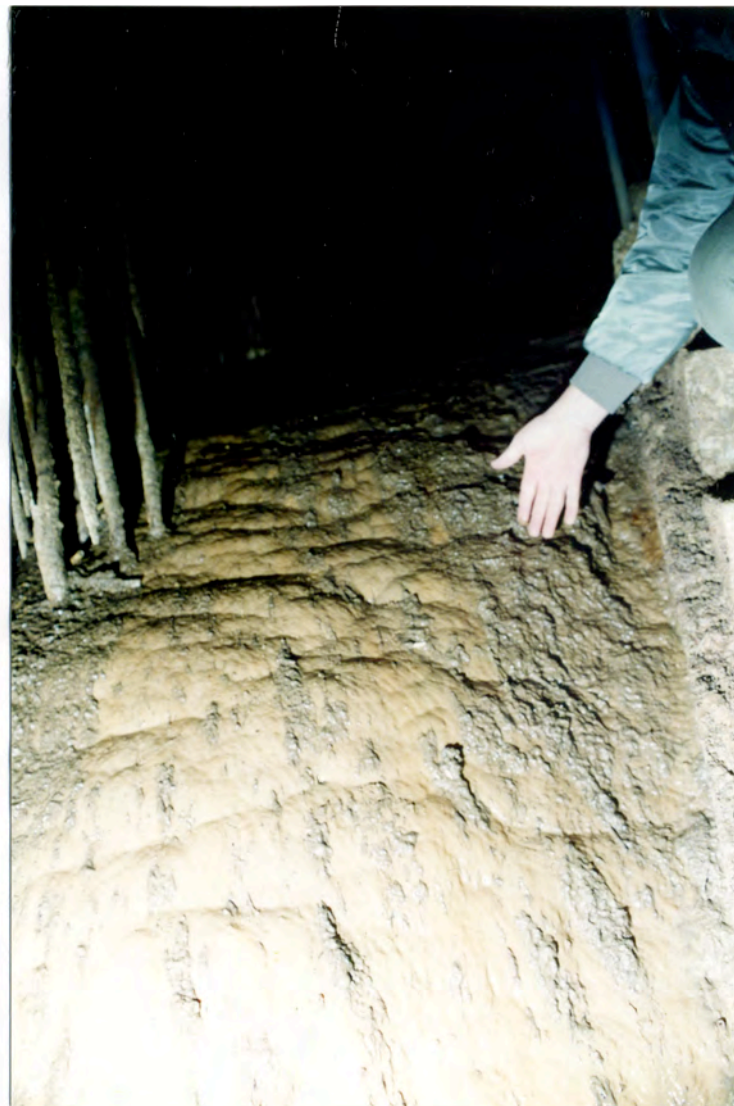
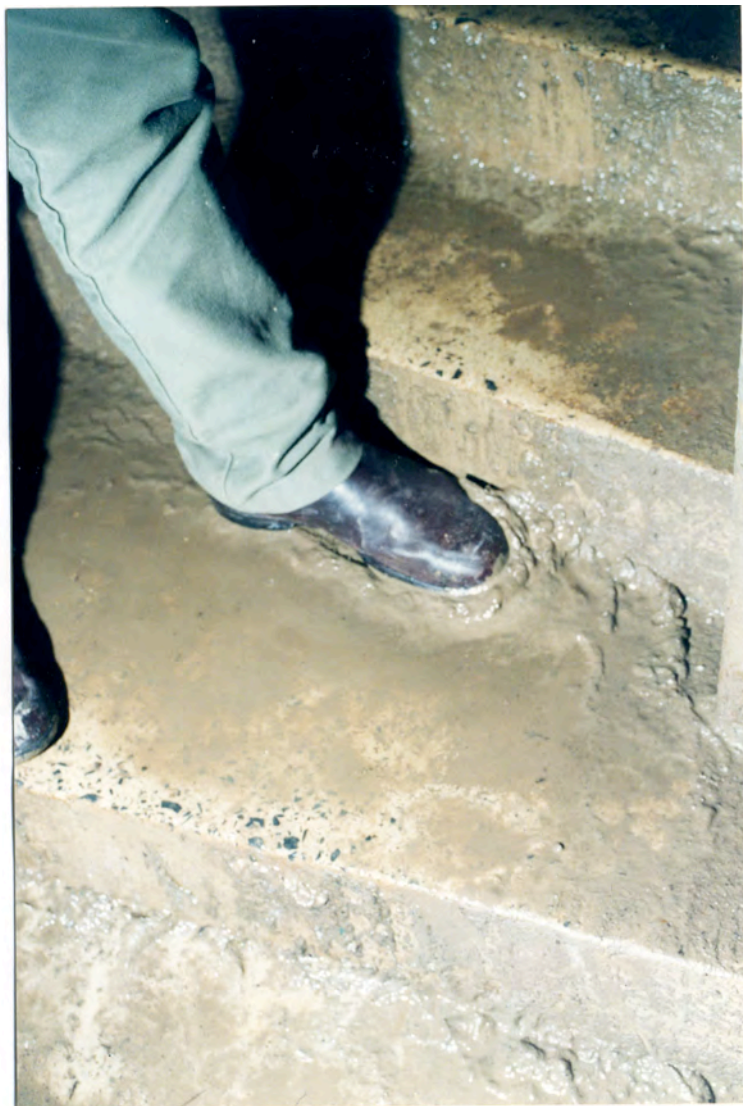
Section 2.4 Material introduced on visitors shoes is mobilised on wet walkways causing pathway slush to develop, accumulate and flow over natural areas.

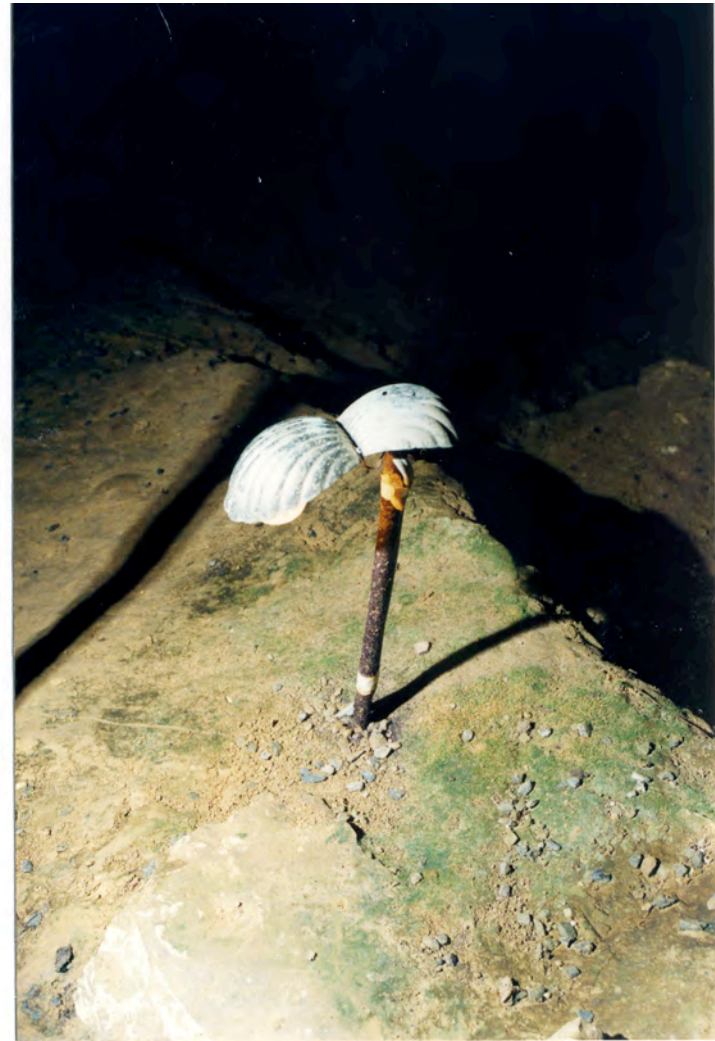
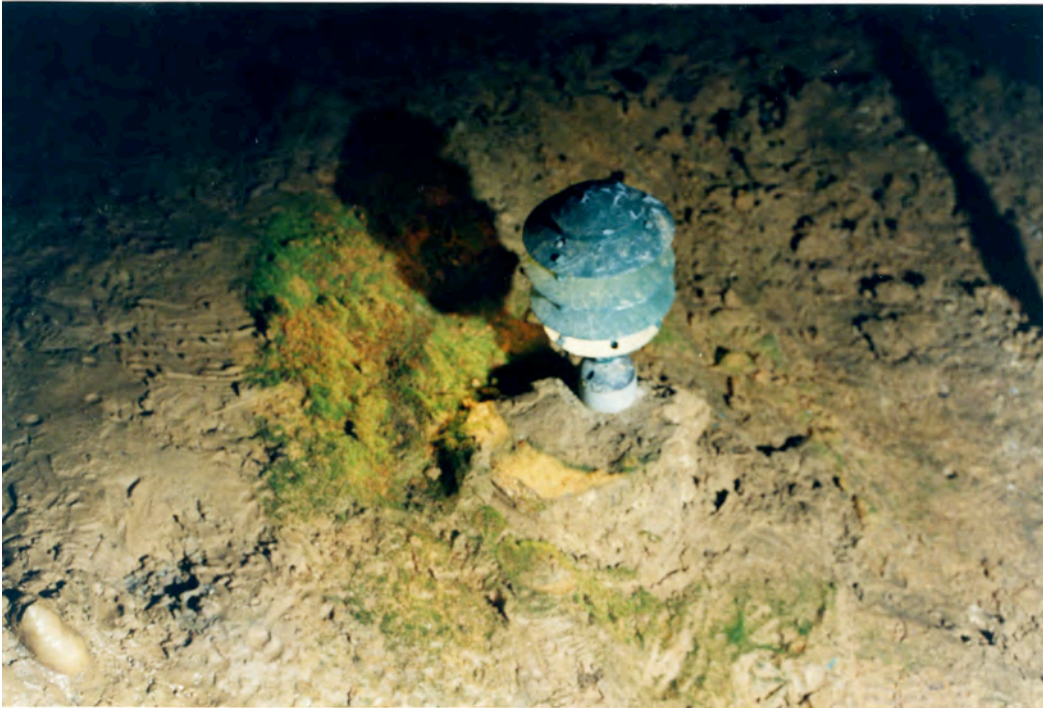
Section 2.6 Inappropriate pathway lighting, not solely directed to the illumination of walkways, is visually obtrusive and promote lampenflora growth

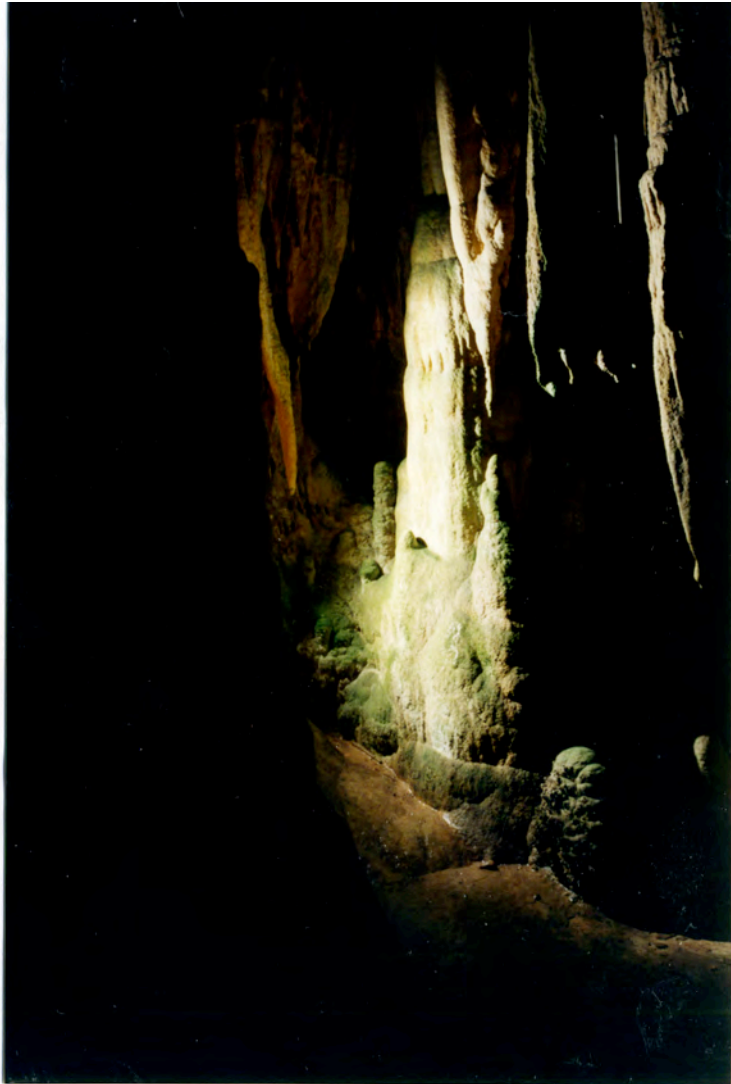
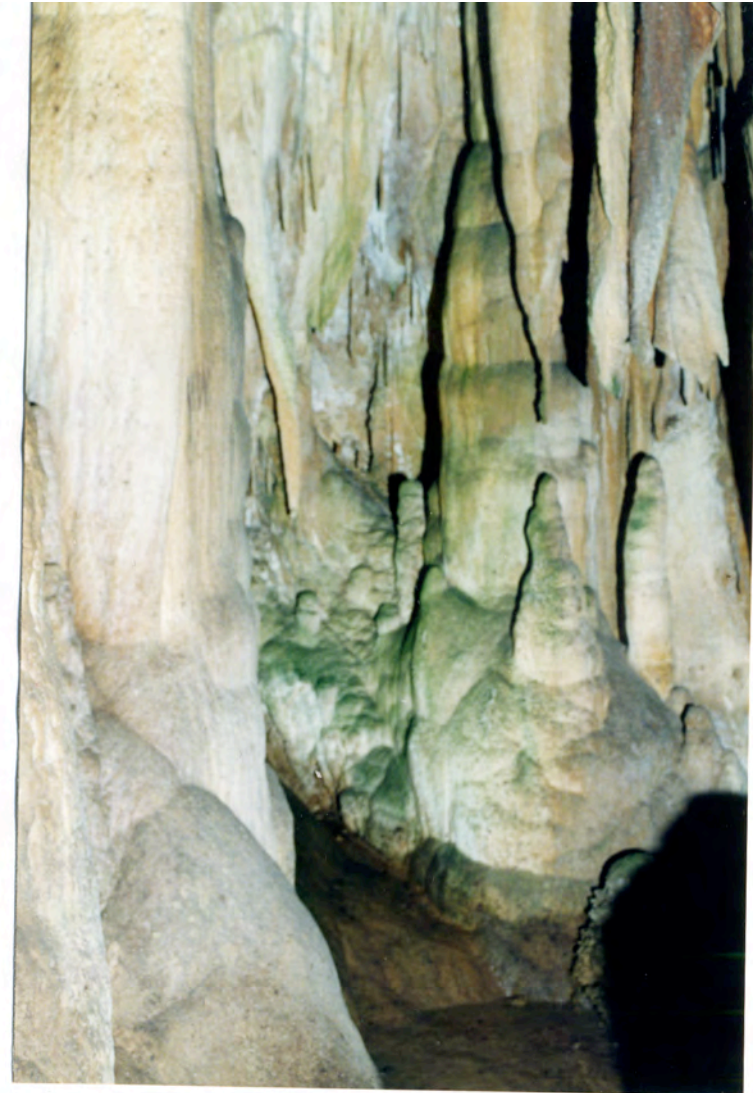
Section 2.7 Lampenflora; algae, mosses and sometimes ferns grow in artificially lit sections of the cave, degrading speleothems and sediments, and disrupting the cave ecology.

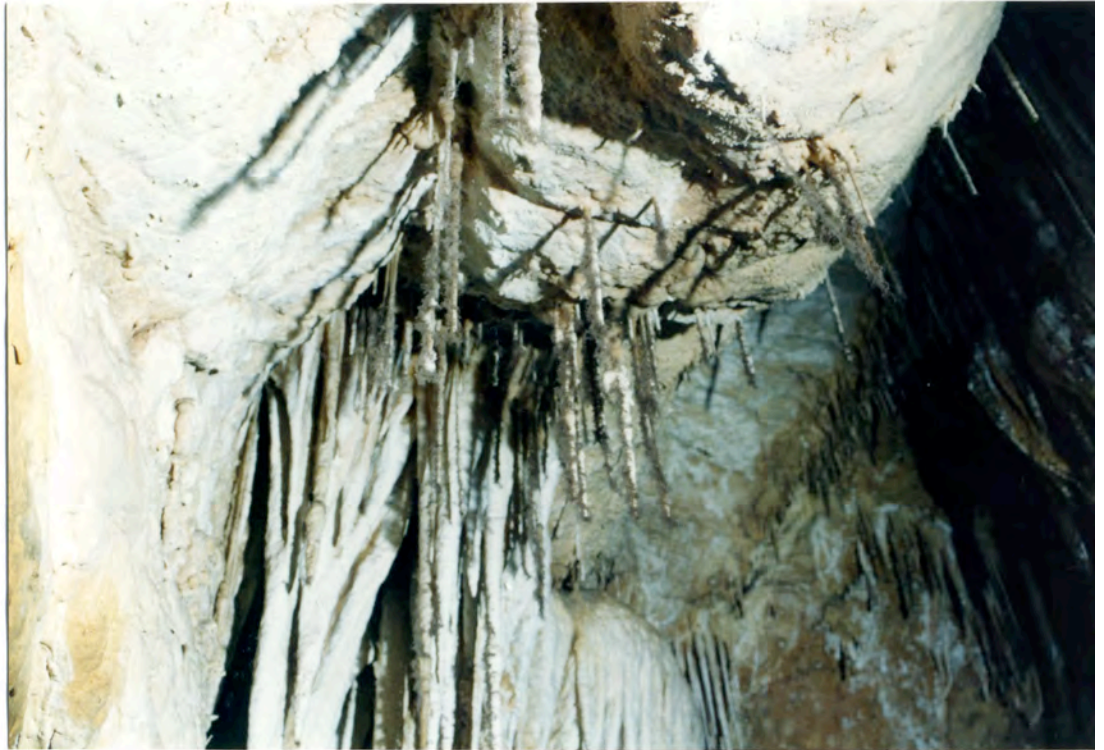
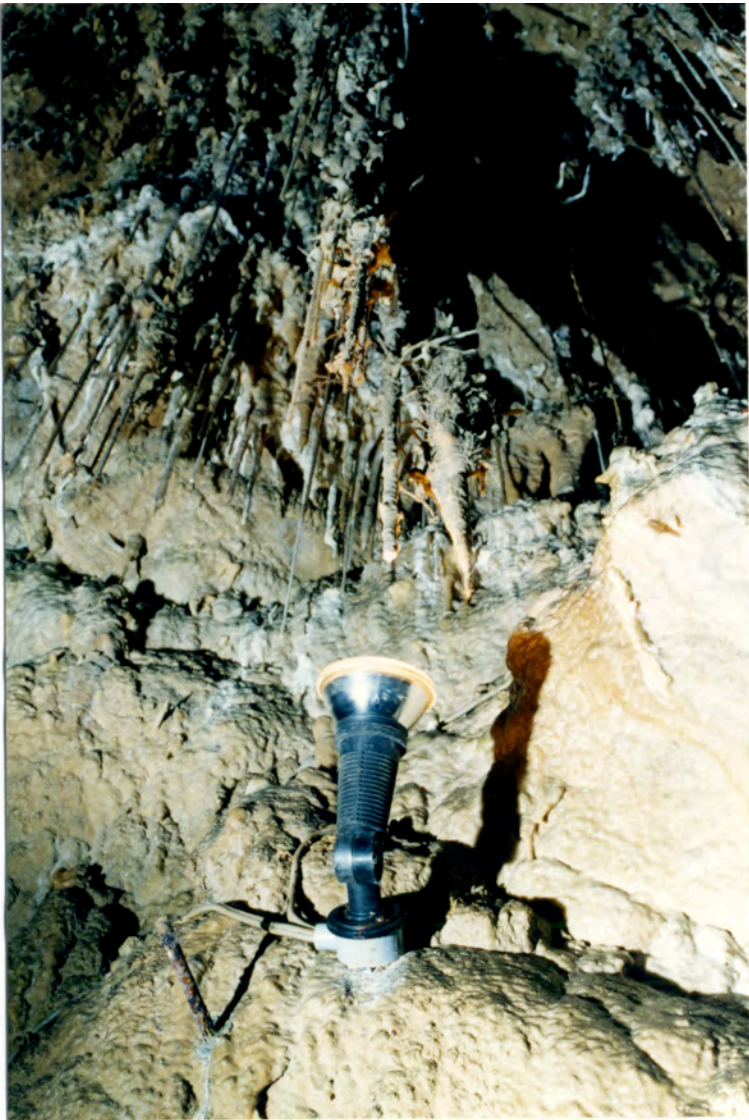
Section 2.8 Lint, hair, dust and other light particles introduced by visitors adhere to delicate formations throughout the cave. Convection currents from inappropriately sited lamps aid the concentration of these materials.

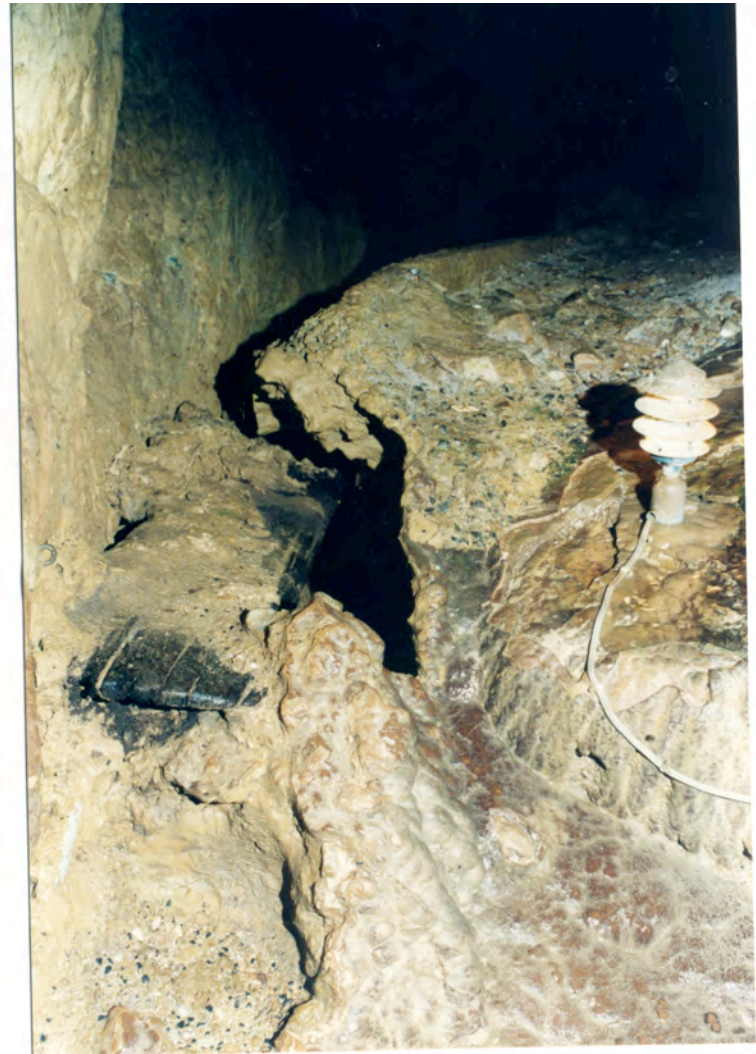
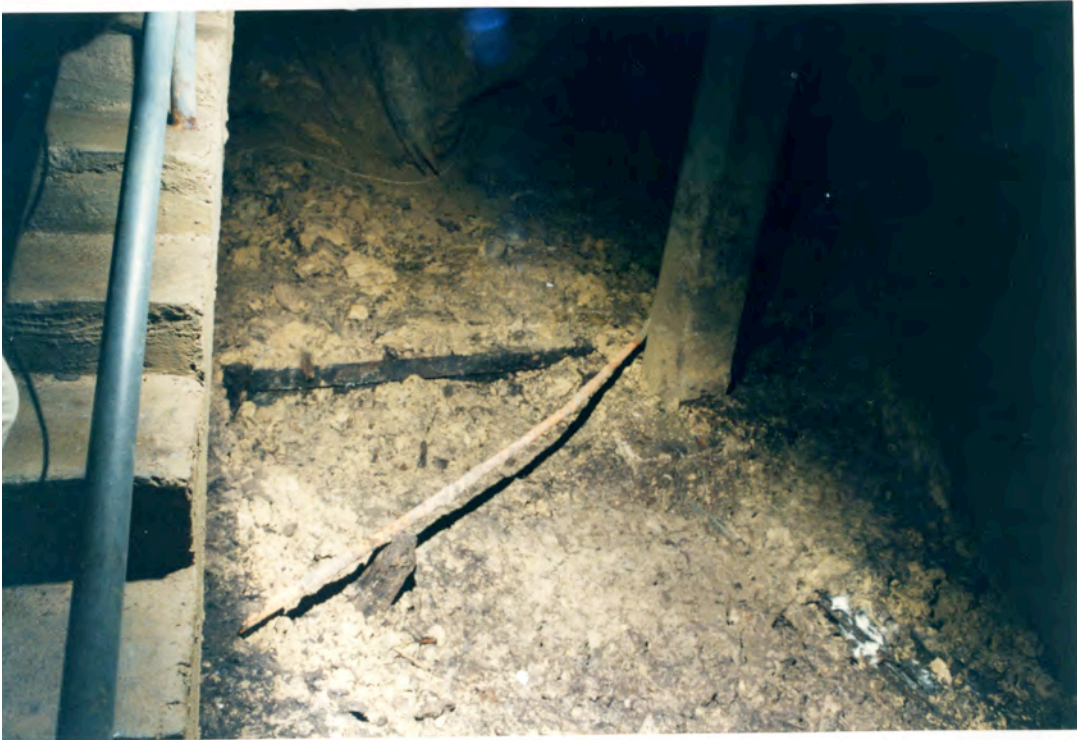
Section 2.9 Much bulk debris has been removed from the cave already. Many tons of rotting wood from disused stairways have been removed (above), whilst a large amount (right) still remains

Many parts of the cave have been used as dumping grounds, in this case for rubble following pathway development and disused light globes.

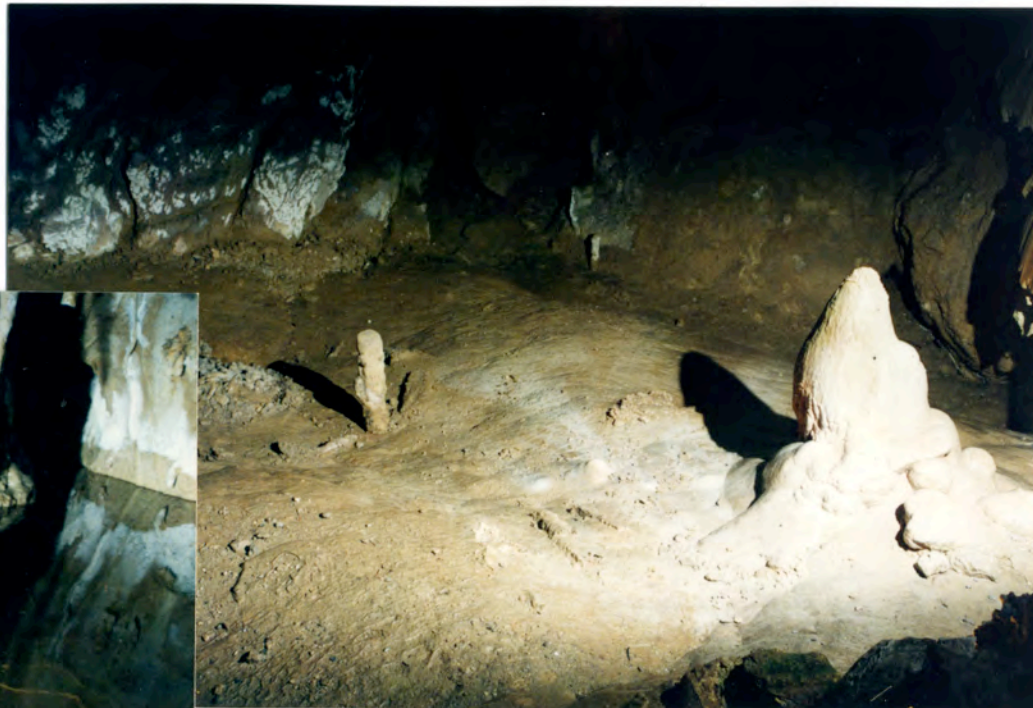
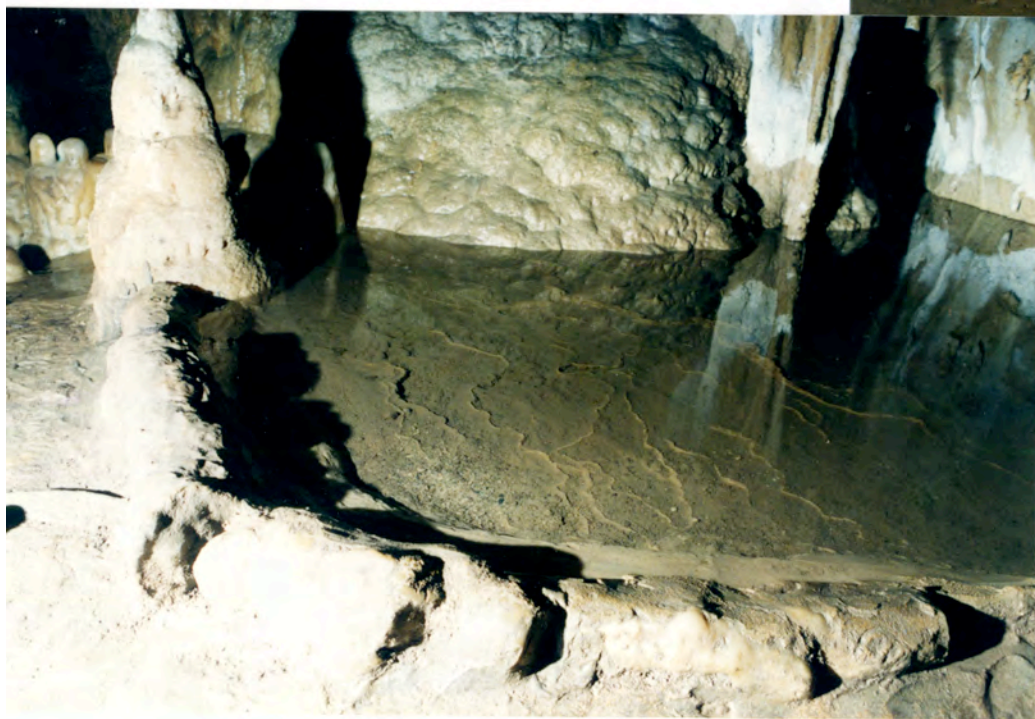
In some areas natural features have been “improved” on; in this case through the use of broken formations.

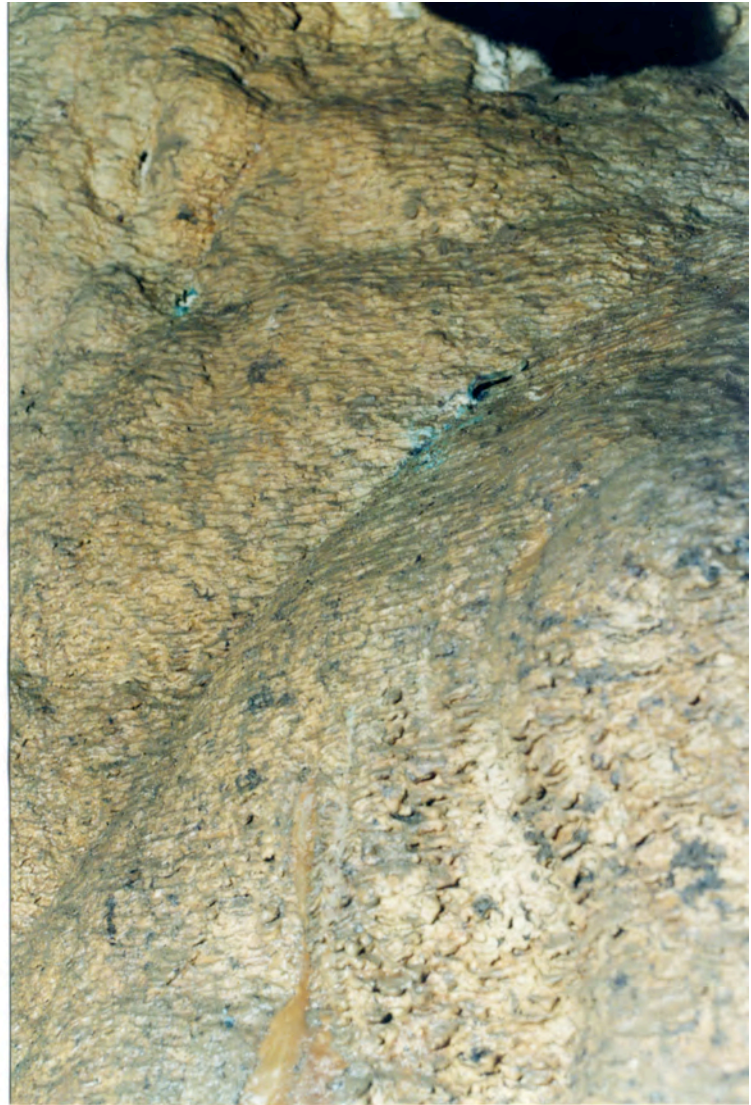
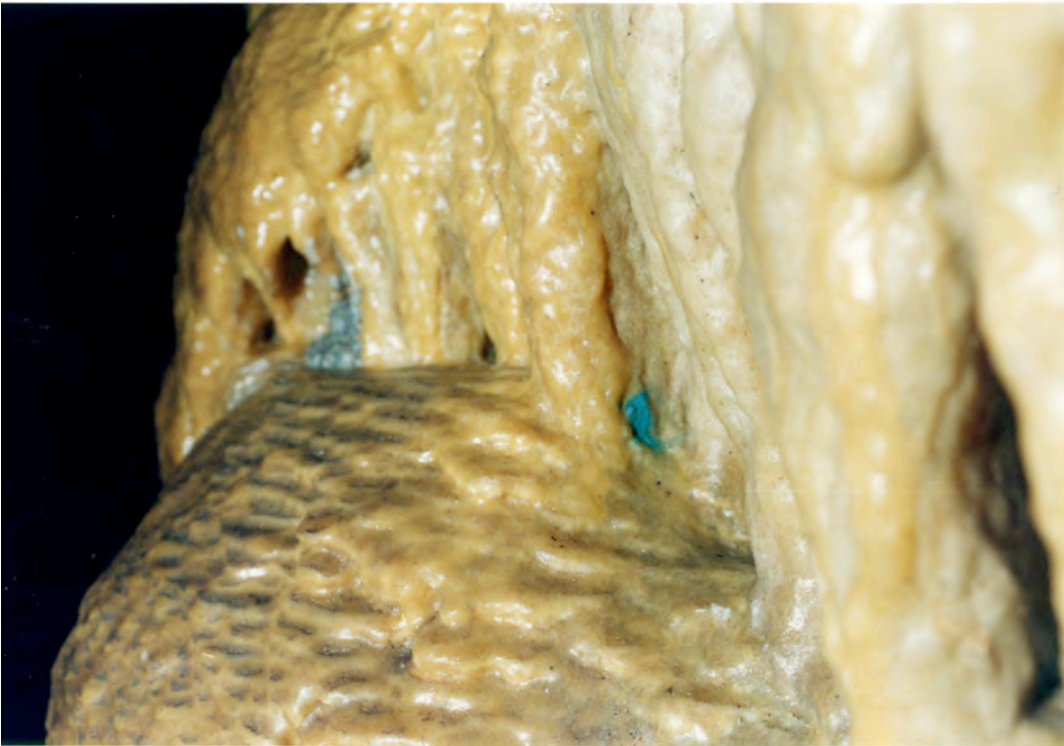
Copper and iron oxides from disused electrical systems and walkway fittings disfigure many flowstone areas.

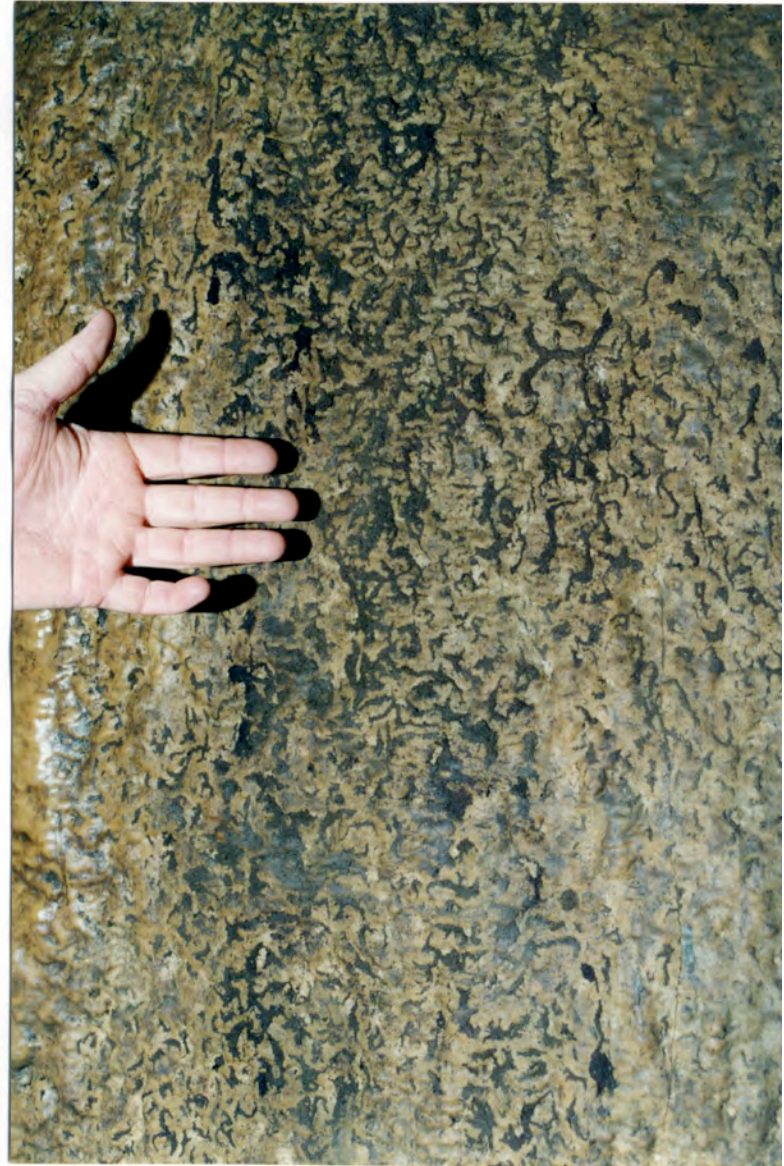
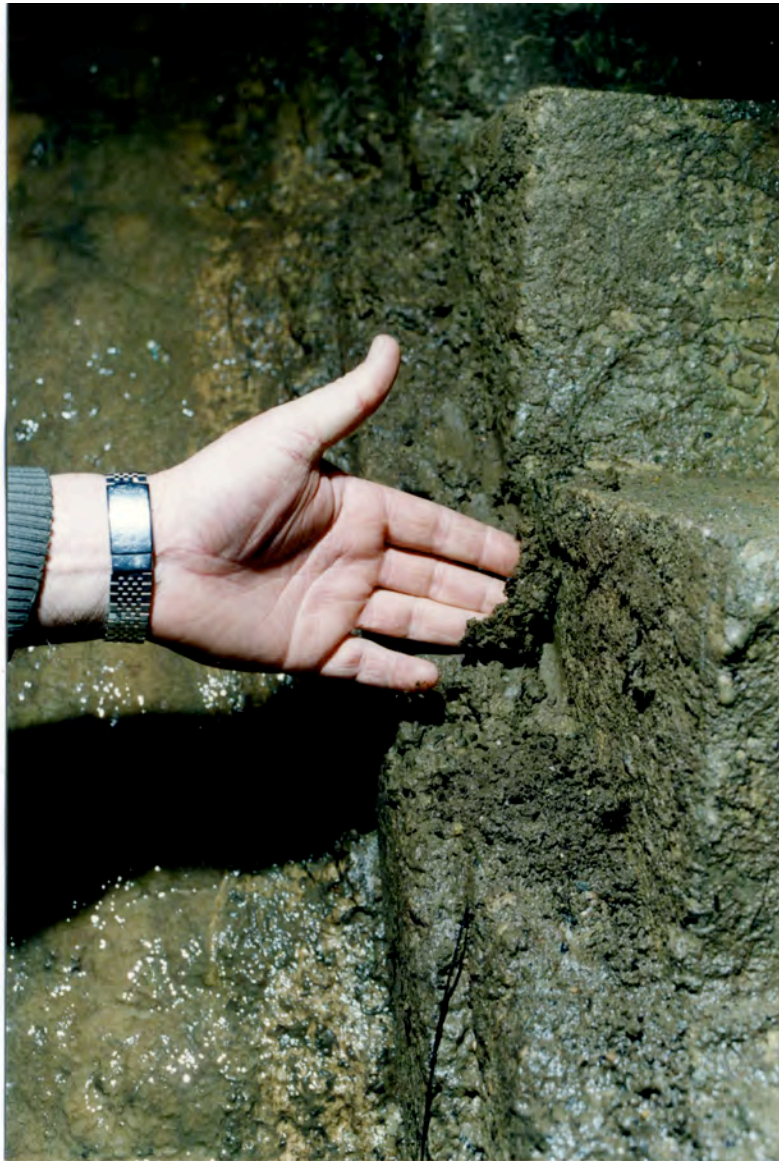
Section 2.10 Sediment from walkways has built up on path edges and is being transferred to speleothems.

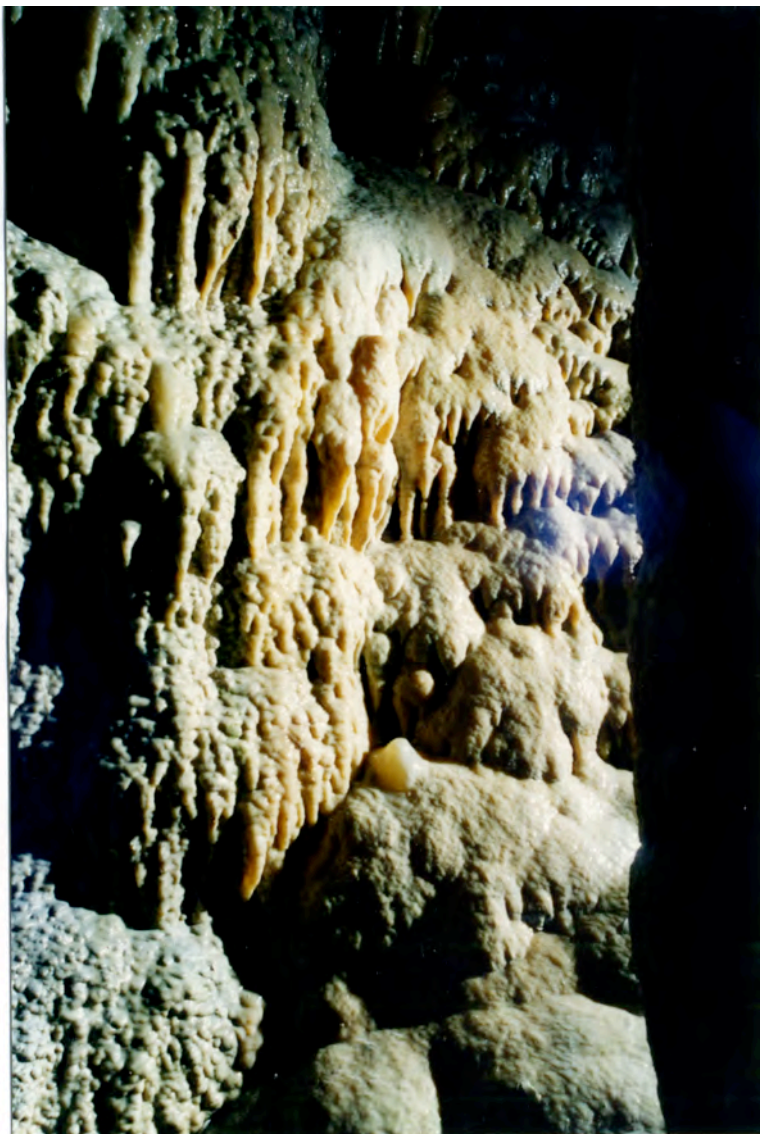
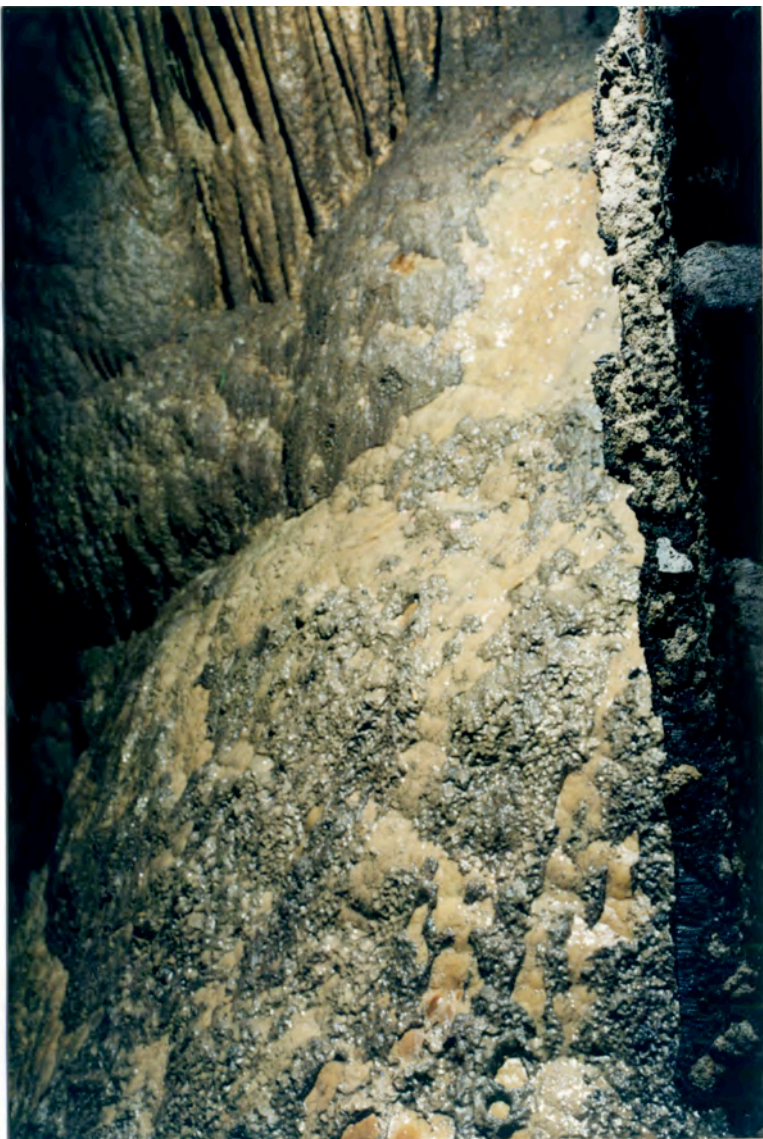
Much sediment and organic matter (sawdust) has built upon active speleothems (left). A clean flowstone for comparison (right).

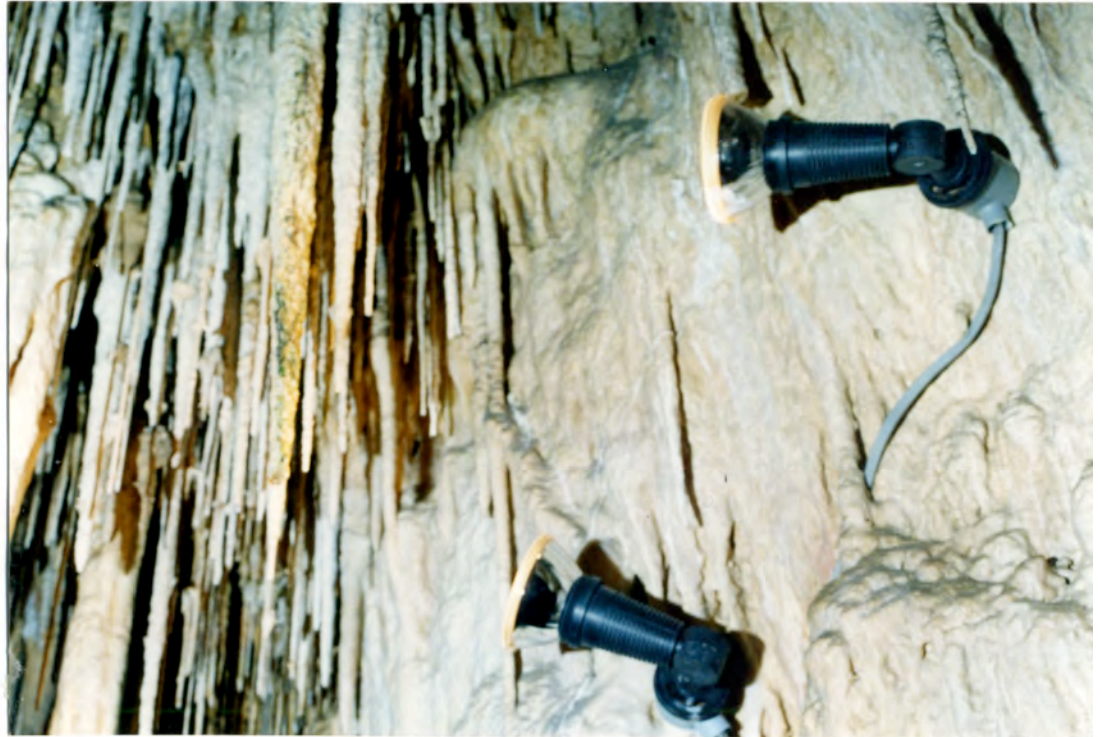
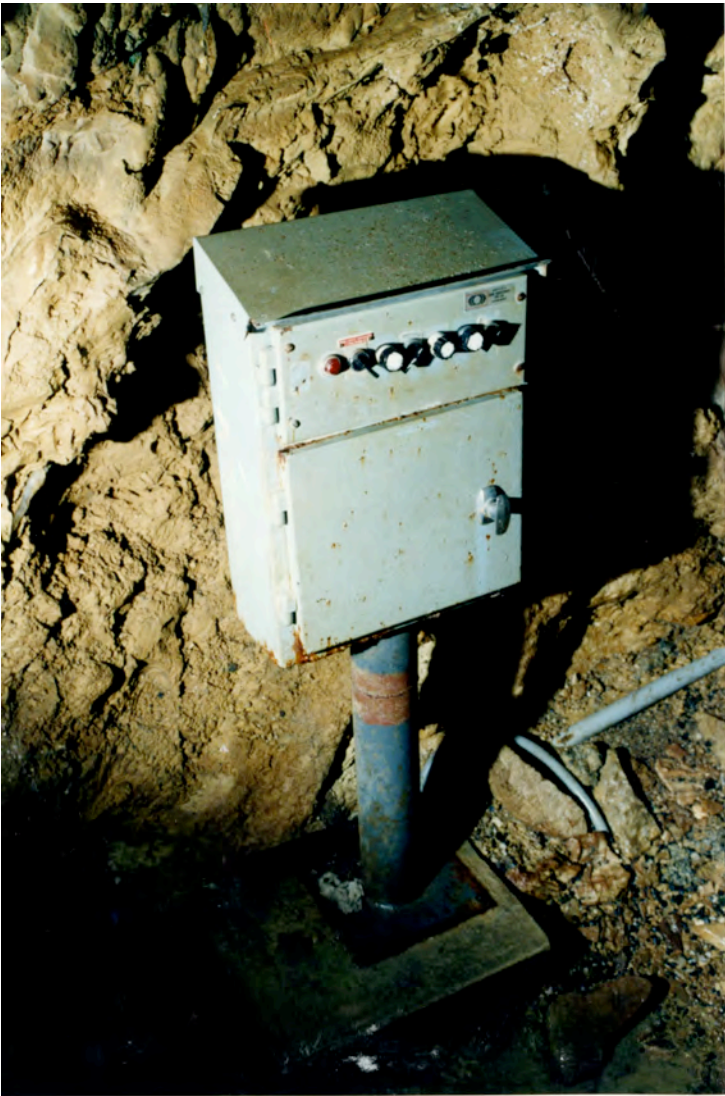
Section 2.11 Many outmoded, aesthetically obtrusive light fittings and switch stations are located throughout the cave. Environmental degradation through drilling, cable and conduit location and lampenflora growth is ongoing.

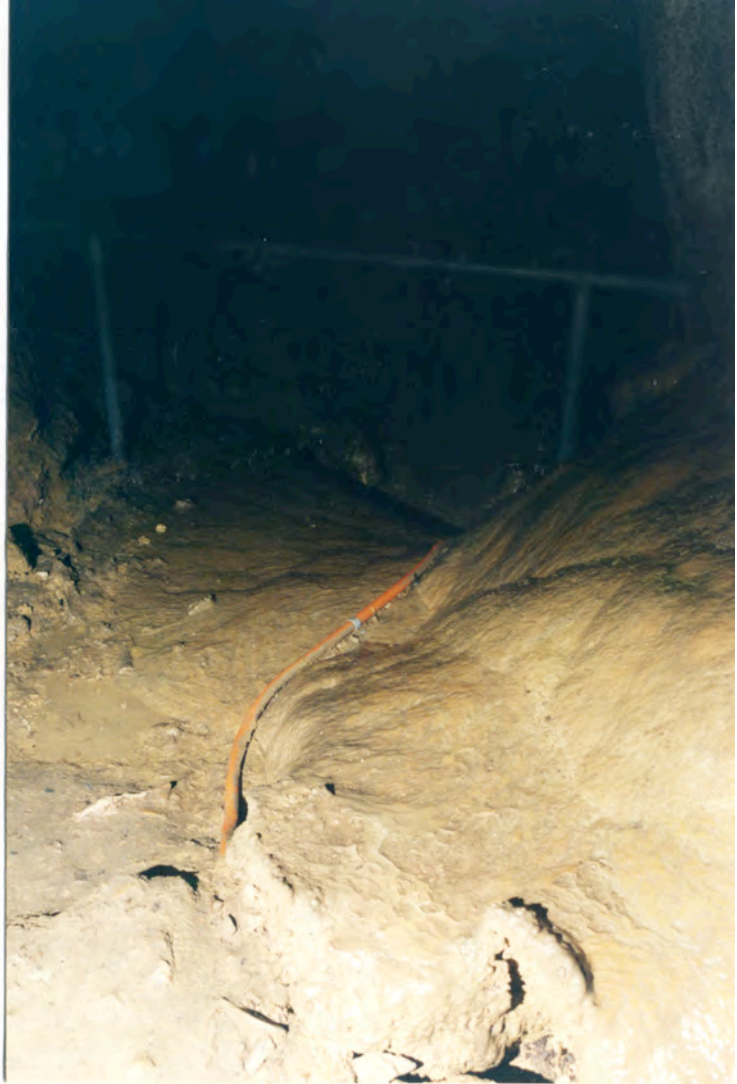
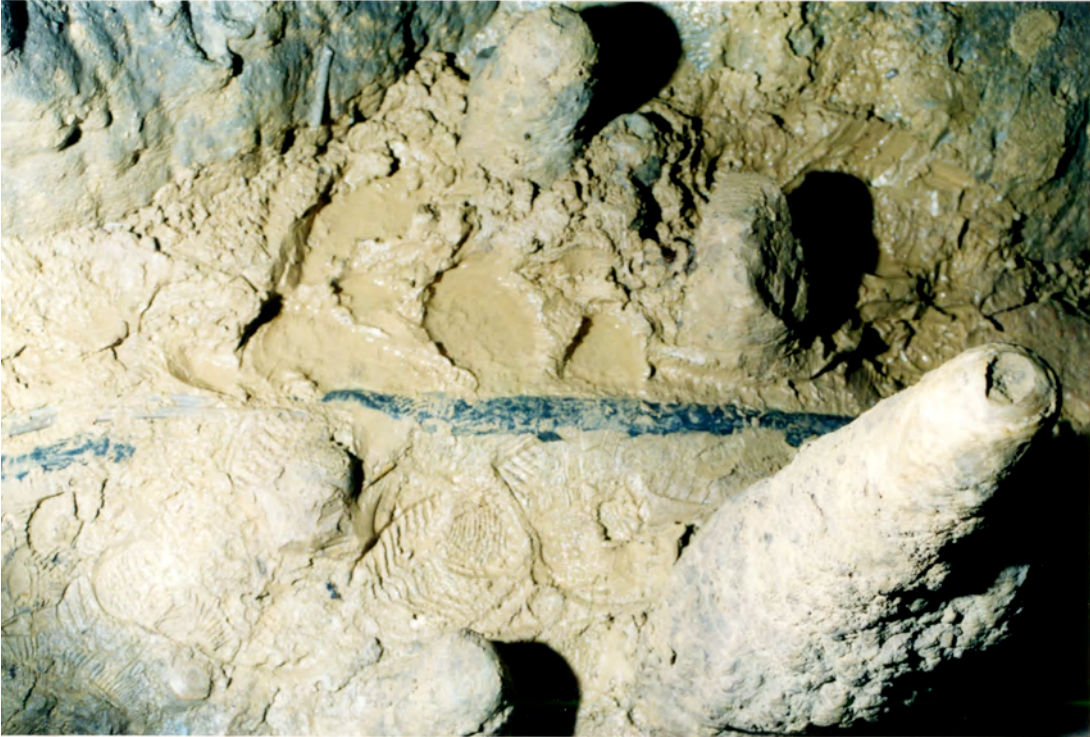
Many exposed conduits and cables are found throughout the cave.
