SOIL-COVER KARST COLLAPSE: A GEOLOGIC HAZARD IN MISSOURI

Missouri Department of Natural Resources

Division of Geology and Land Survey

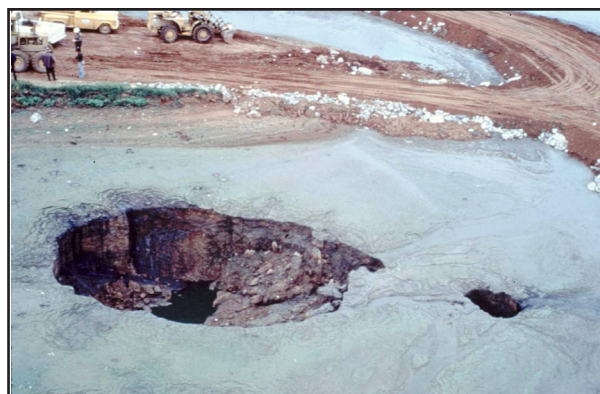
On or about May 5, 1978, the lagoon basin floor collapsed (Figure 3). Following the collapse more than 800 people living near West Plains reported illnesses ranging from flu-like symptoms, including severe nausea and diarrhea (DGLS unpublished files). Since the initial construction of the lagoon, small collapses had occurred at the site in 1964 and again in 1966 (Aley et al. 1972), providing evidence of active recurrence of collapse in these settings. In each instance the collapse features were repaired using cement, clay and bentonite, and then put back into active service.

Figure 3 *This post-collapse view of the West Plains Lagoon shows two sinkholes that developed as the lagoon drained.*

be threatened. The 1978 catastrophic failure led to the construction of a mechanical treatment plant for West Plains, which could meet applicable discharge standards for losing streams. These non-earthen structures, while expensive, are less likely to induce soil piping into bedrock conduits and are not as susceptible to damage from a catastrophic, soil-cover collapse. The series of collapses at the West Plains lagoon demonstrates that these soil-cover type collapses can and do recur, even when mitigating strategies are employed.

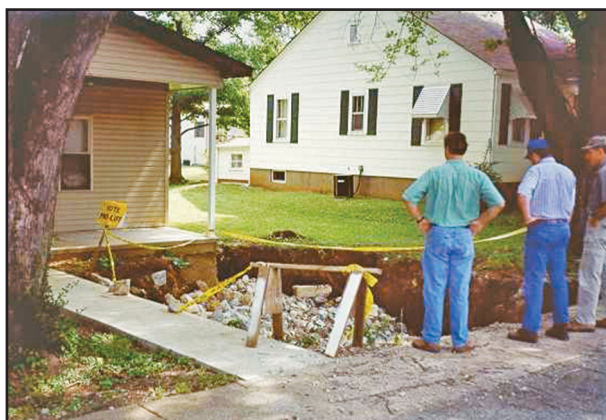
For more than 50 years soil-cover karst collapses have been reported in the city of Farmington, Missouri. Surface expressions of karst features are not common in this area (Figure 4). However, soil-cover collapses have damaged residential building foundations and collapsed sections of city streets resulting in broken municipal water, sewage, and gas lines. Known collapses have a diameter up to 9 m (30 ft.), and are rooted in karst joints as deep

Figure 5A Collapse in residential neighborhood, Farmington, Missouri. This collapse had been repaired with soil fill only, but it reactivated.

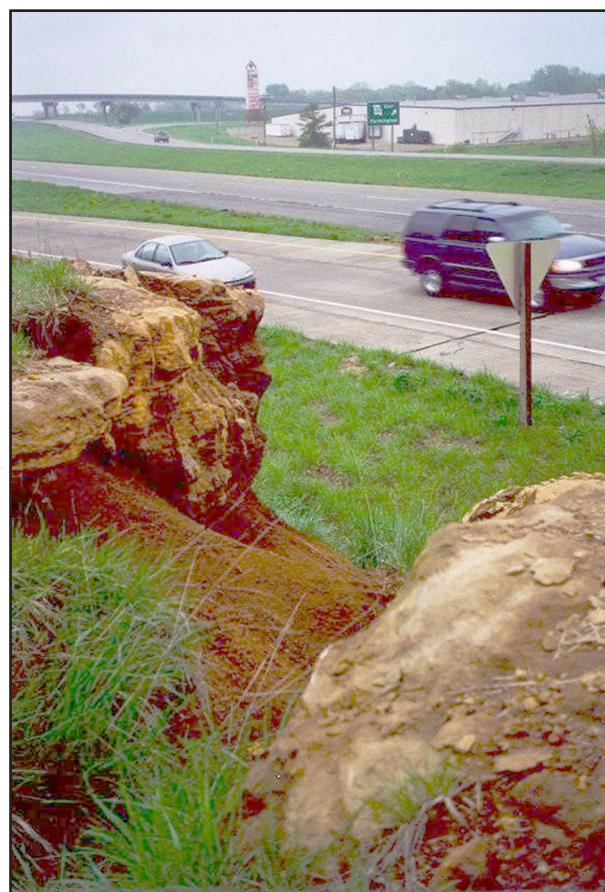
as 19 m (63 ft.). Poorly designed urban drainage may contribute to soil piping in these areas, but the karst joints were present prior to collapse (Figures 5a and 5B). Small soil pipes were observed at the surface at some locations prior to collapse,

Figure 5B Karst joint in Bonnetterre Formation dolomite in Farmington, Missouri. Red soils are clay-rich silt. Joint walls have irregular, scalloped surfaces typical of karst conduits in carbonate rocks.

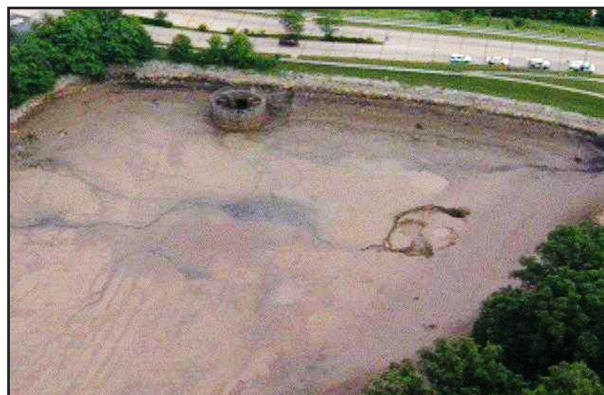
In June 2004, a large sinkhole formed in the lake bottom and completely drained the impoundment (Figures 6B and 6C). Reportedly, repairs of small collapses and excessive leakage had been made to the lake several times in the preceding years.

Figure 6B *Post-collapse aerial view of Lake Chesterfield showing sinks that formed at the cave beneath the lake.*

However, there was no physical evidence that a collapse of this magnitude was imminent. In an effort to repair the catastrophic collapse, an extensive drilling and grouting program was undertaken. To date, the small lakeside community has expended over \$650,000 in an attempt to remedy the situation.

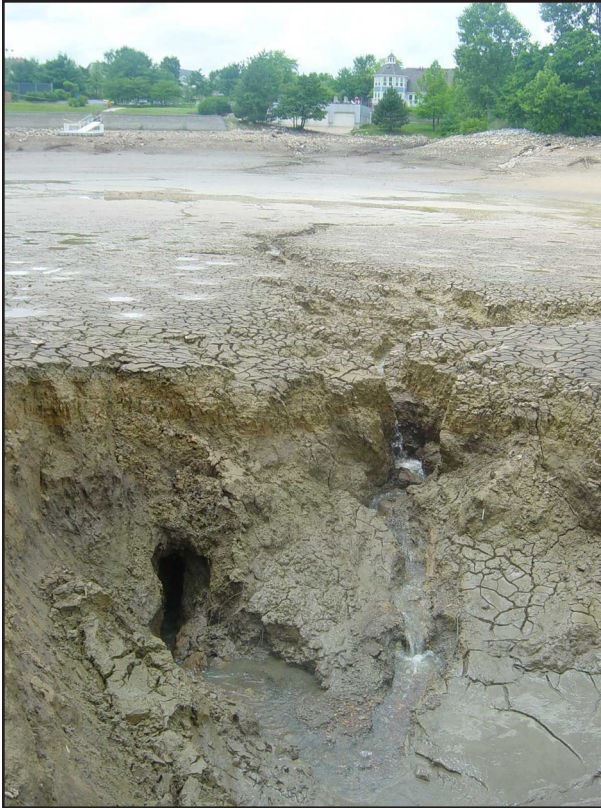
Figure 6C Soil cover collapsed beneath Lake Chesterfield into a well-developed cave.

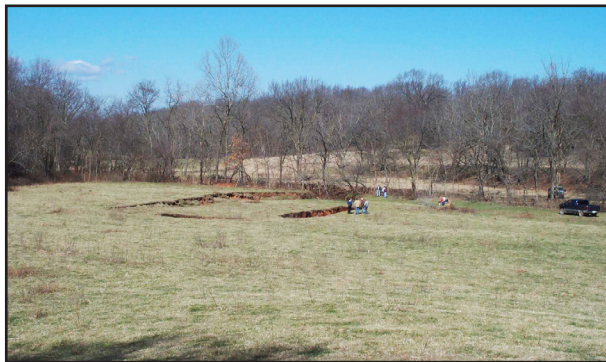
Figure 8A *Berg Sink, last week of February 2005. The collapse margin has a well-defined scarp. The near background tree line is along a county road.*

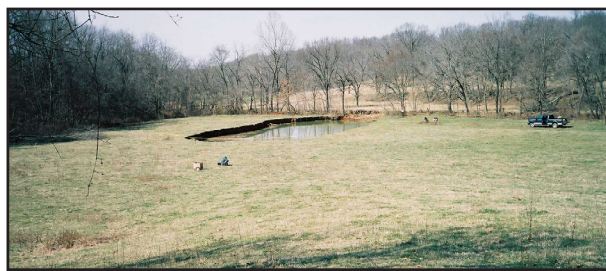
At one time in early March 2005, the collapse behaved as a spring discharging to the adjacent small channel. Since that time the water level reportedly fell below the level of the adjacent dry stream channel, as the collapse became a sinkhole. One end of the sink is within a few feet of a county road, which has been closed to all traffic. It seems likely that the road will be impacted by the formation of the sinkhole.

Figure 8B *Berg Sink, second week of March 2005. The collapse had developed to a water-filled "spring" and had dimensions of 76 by 30 m (250 by 100 ft.).*

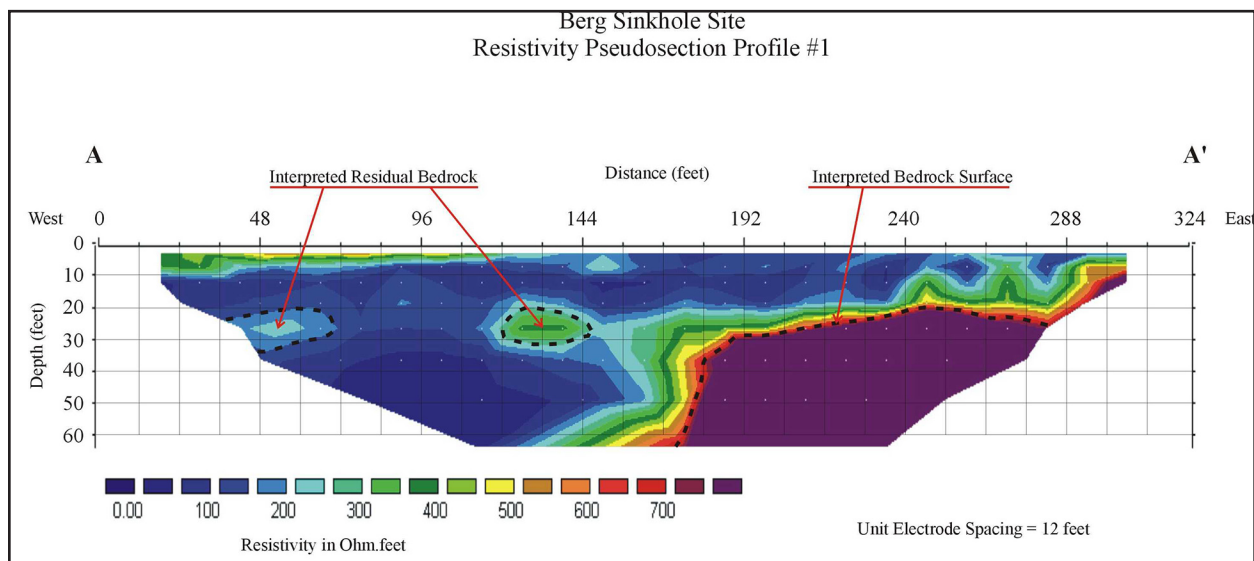
Figure 10A *Electrical resistivity pseudosection profile on the south side of Berg Sink.*

DGLS has also worked with local governments and individuals to better define and locate soil-cover karst collapse hazards. The recent Berg Collapse did not immediately threaten groundwater, but there was a need to address the potential threat to an adjacent county road. DGLS geologists completed a geophysical survey of the site using electrical resistivity methods to determine the depth of bedrock and locate possible extensions of karst conduits on either end of the collapse (Figure 10). These surveys suggest the road may be damaged through natural equilibration of the sinkhole walls, or through renewed collapse and expansion of the current sink margin.

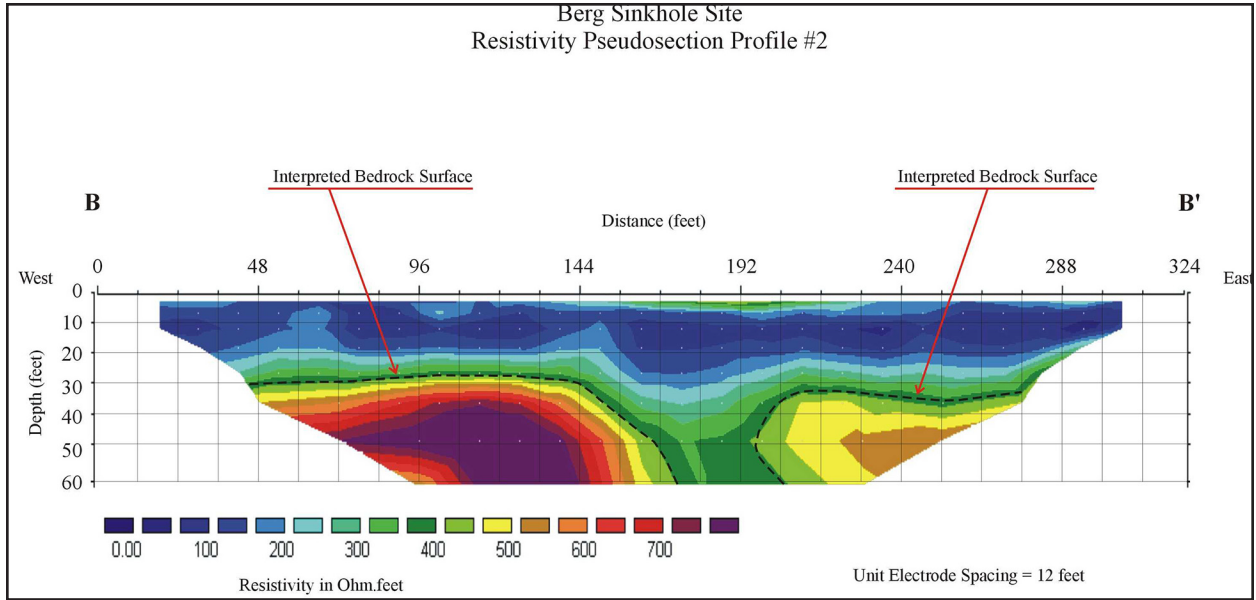
Figure 10B *Electrical resistivity pseudosection profile on the north side of Berg Sink.*

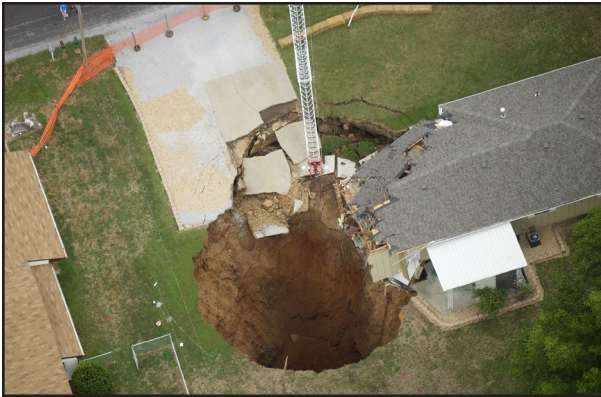
On the morning of August 13, 2006 a collapse occurred at 327 N. Delaware Avenue in the City of Nixa (Christian County) beneath part of a house owned by Mr. Norman Scrivener. On that day the depth of the structure was reportedly measured at about 25 m (75 ft.) (Figure 11). This was after engulfing the garage, which included a medium-sized

Figure 11 *Aerial view of the a collapse at 327 N. Delaware Avenue, Nixa, Christian County, Missouri, beneath part of a house owned by Mr. Norman Scrivener. The depth of the structure was measured at about 25 m (75 ft.). This was after engulfing the garage, which included a medium-sized sedan.*

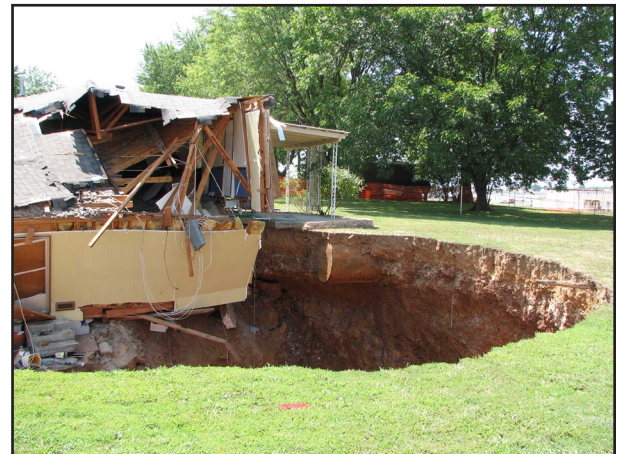
sedan. Neither groundwater nor bedrock was ever observed in the collapse. Bedrock beneath the structure is the Mississippian-age Burlington Limestone. The Burlington Limestone typically weathers severely along fracture traces to create a very irregular (cutter and pinnacle) bedrock surface. The collapse structure developed in a structured reddish-brown, cherty, and clayey residuum (Figure 12).

Figure 12 *The collapse structure developed in a structured reddish-brown, cherty, and clayey residuum as can be seen from this view. From the angle of this picture the lack of subsidence of the area is apparent. Also visible is an abandoned steel septic tank.*
