SUBSIDENCE HAZARDS AS A CONSEQUENCE OF DAM, RESERVOIR AND TUNNEL CONSTRUCTION

Petar MILANOVIC

KEY WORDS: karst, karst subsidence hazard

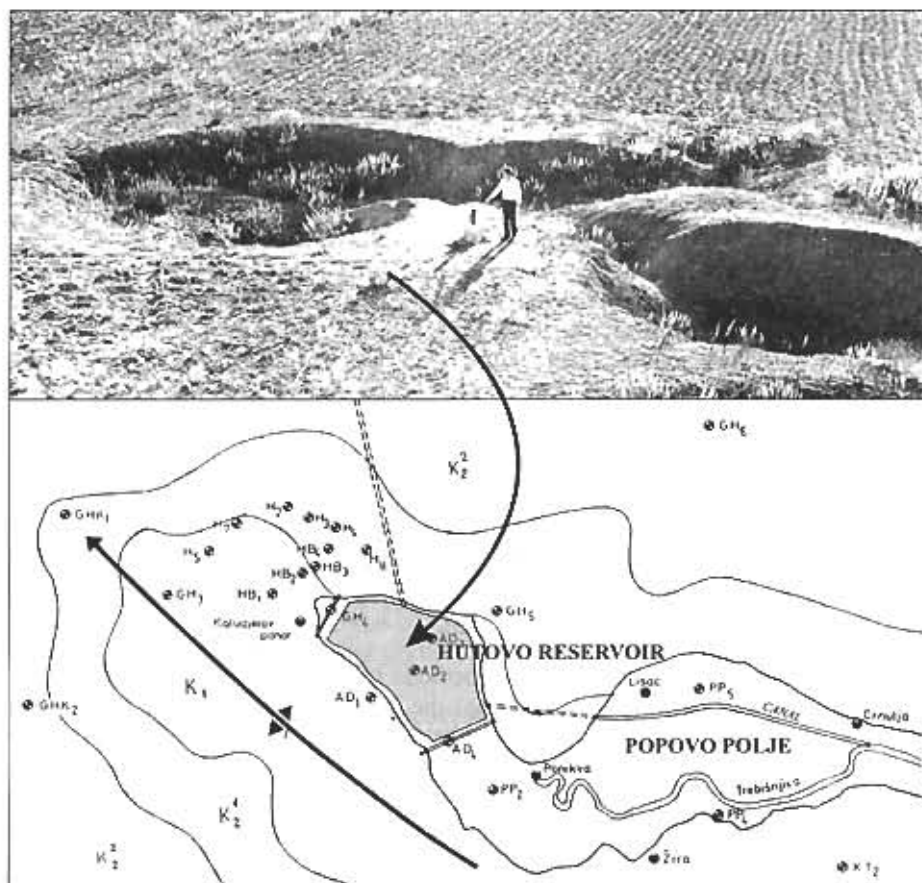
The reservoir area was losing water under natural conditions through 75 recorded ponors, represented by different sized subsidence. The largest was formed above the fossilized ponor of the river Trebisnjica (Fig. 2).

Fig. 2 - The main subsidence area in the Popovo Polje – Hutovo Reservoir.

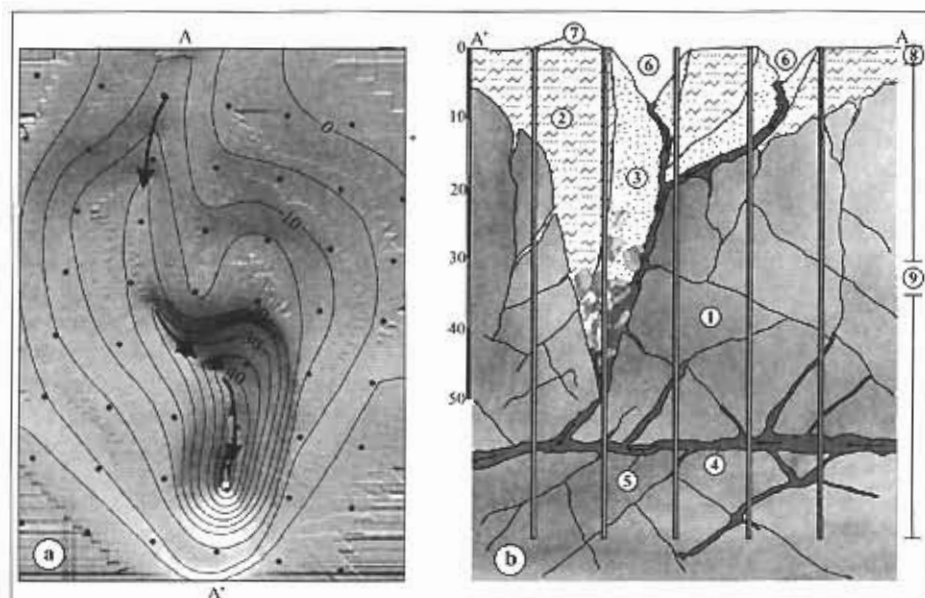
By applying different investigation methods (geological mapping, geophysical investigations and close spacing drilling) the fossilized opening of a ponor was detected at depth of 50 m beneath the floor level. Fig. 3 shows contour lines of paleo karst relief (a) and a cross-section (b) through the infilled karstic sinkhole with fossilized ponor at the very bottom. Presently, the swallowing capacity of the ponor is drastically limited.

Before the reservoir was filled the ponor was only active from time to time. During the reservoirs operation, despite surface treatment, a number of large subsidence occurred. 38 new subsidence developed after the first impounding, followed by 44 in the next year and 36 during the third year of operation.

Fig. 3 - Main subsidence – temporarily active ponor (Hutovo Reservoir): (a) = Contour lines of paleorelief and locations of investigation boreholes. Arrows indicate trace of fossil river bed toward the main ponor; (b) = Cross-section: 1 = Karstified limestone, 2 = Alluvial deposits; 3 = Degraded zone in alluvial deposits; 4 = Karst channel; 5 = Direction of underground flow; 6 = Subsidence; 7 = Investigation boreholes; 8 = Zone treated by compaction, and 9 = Zone treated by grouting.

The subsidence zone was rendered impermeable by grouting the karstified paleo-relief. Pressure grouting with a cement mixture was introduced from the surface. After grouting of the bedrock, the channels in the alluvial parts of the ponors were filled in with grout mix. A grouting mix with the approximate characteristics of the surrounding material (the proportion of clay was increased with respect to cement) was used.

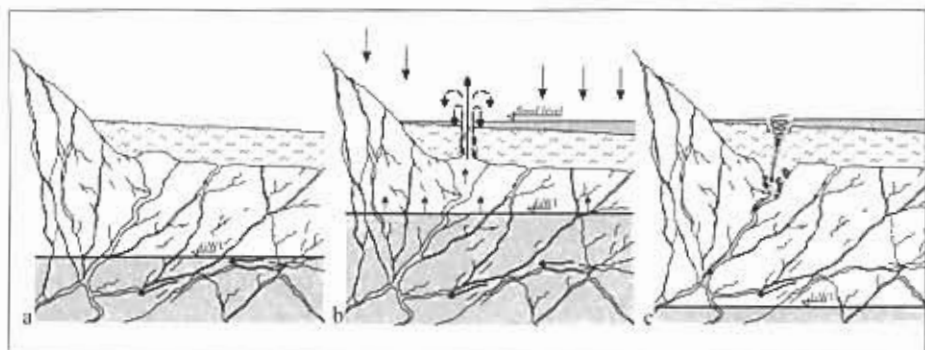
As a consequence, large volumes of air become trapped in some caverns, as shown in Fig. 4a. This air does not have time to escape, because the surface layer of soil is rapidly saturated with water. Therefore, air becomes entrapped and pressurized (Fig. 4b). When the pressure exceeds the strength of the overlying alluvial layers, air

eruption destroys this zone. At the surface this has been observed as fountain-like eruptions. After water table depression beneath the area of destroyed sediments, water sinks through newly created ponors (c).

Fig. 4 - Subsidence created by air-hammer effects

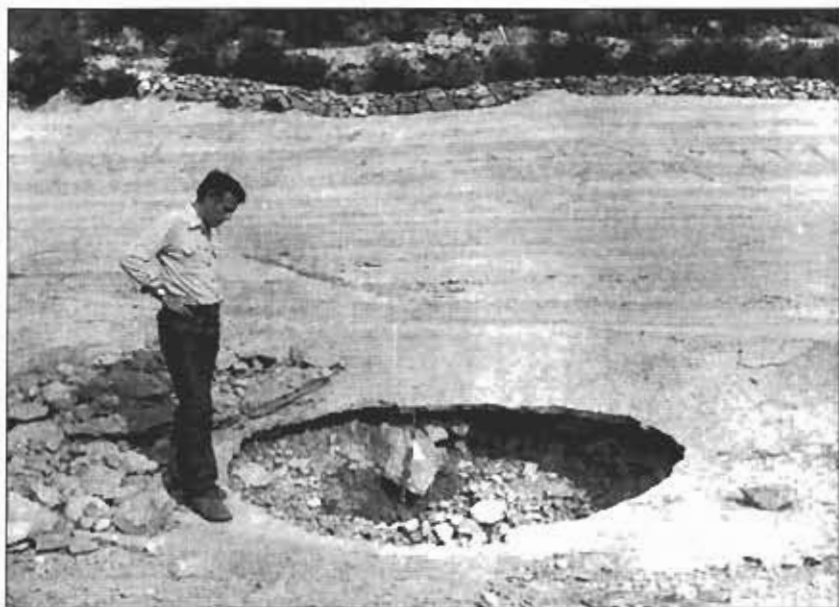
In some cases reinforced shotcrete is not sufficiently resistant against strong uplift pressures (Fig. 5).

Fig. 5 - Subsidence created in a shotcrete protective layer by strong groundwater uplift.

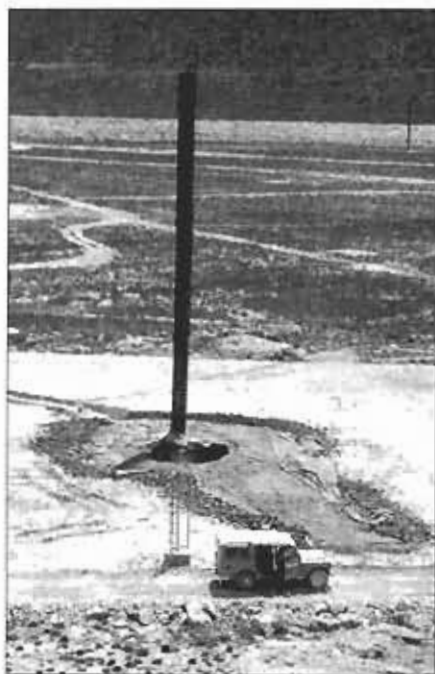
Fig. 6 - Aeration pipe.

A need was foreseen to introduce aeration pipes through the alluvial cover and down to the karst channel in the bedrock, to allow timely evacuation of confined air. The tops of these pipes were set above the maximum expected levels of water in the reservoir (Fig. 6).

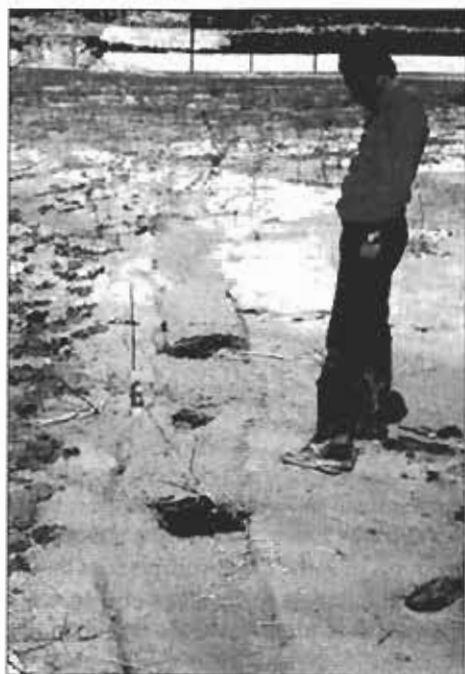
After rendering the reservoir floor impermeable by compaction, two-dimensional defects developed, in the form of wide and long fissures in alluvium. Fissure widths ranged between 1 and 30 cm, and lengths from a few meters to a hundred meters. Such features were found even under the protective plastic membrane. New subsidences also originated along some of the fissures, especially at points of fissure inter-

section. In some cases subsidences developed between two parallel cracks (Fig. 7).

Fig. 7 - Subsidence developed between two parallel cracks.

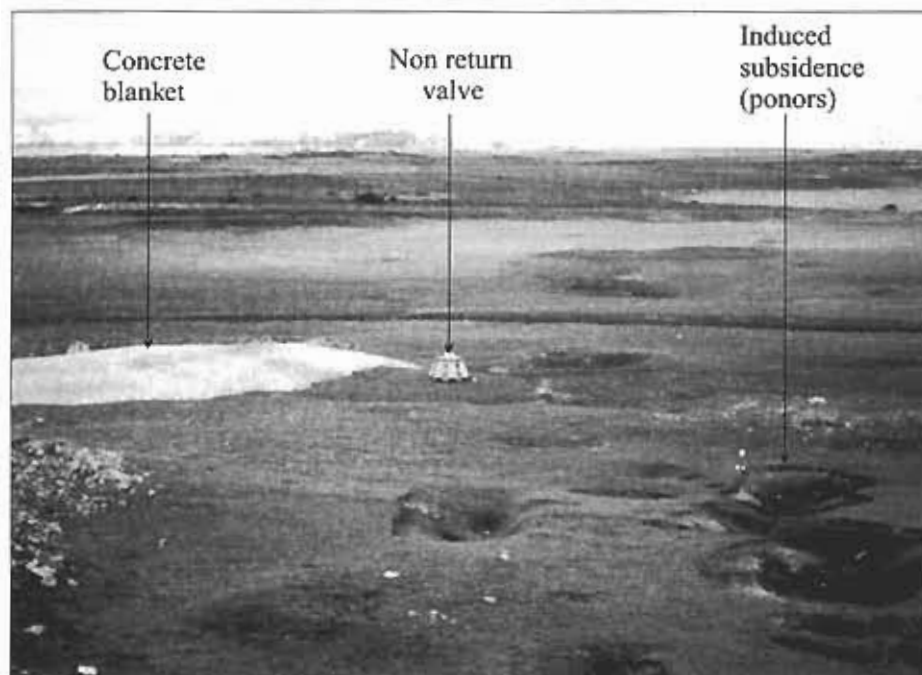
A particular problem is presented in the case of estavelles in the storage reservoirs. Because of its double hydrogeological function every estavelle is a potential subsidence site. In order to improve the water-tightness of Vrtac reservoir in Niksic Polje, Yugoslavia, several sealing methods were applied (cylindrical dams, plugging of ponors, non-return valves and concrete blankets). Unfortunately, all these measures were unsuccessful. After the first reservoir filling and a strong water table rise during the wet season, the groundwater could not discharge through the natural estavelle openings. As a consequence more than 100 new subsidences were formed in the reservoir floor (Fig. 8).

Fig. 8 - Niksic Polje, Subsidence induced by reservoir operation.

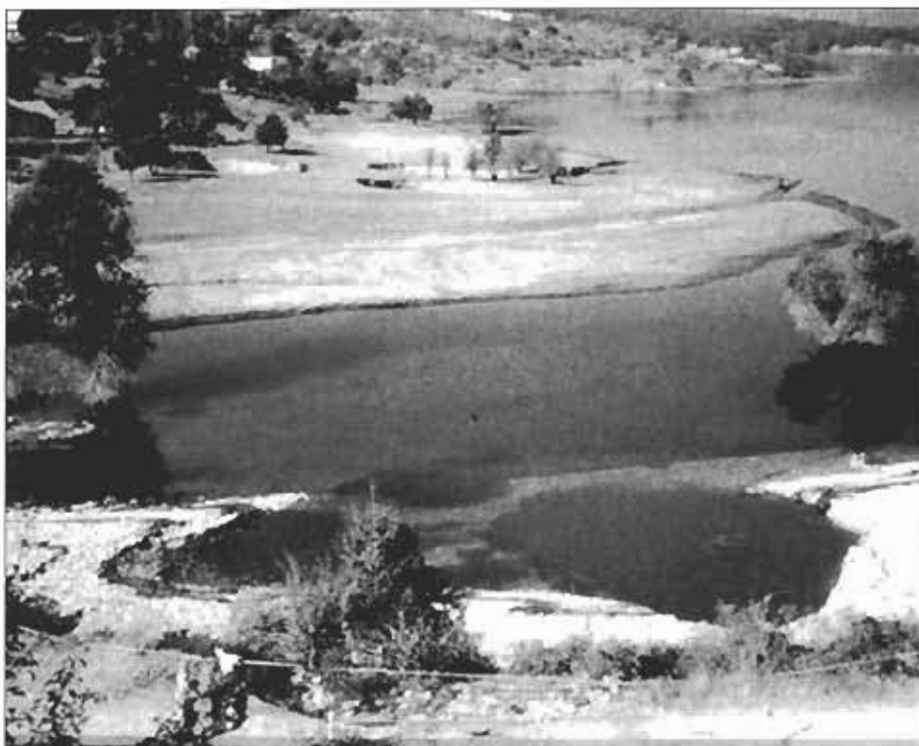
fill sediments, finally creating erosion channels in the alluvial cover. During the very rainy year of 1986, abrupt water level increase served as a trigger to development of subsidences (Fig. 9).

Some of the subsidences were formed within the blanket zone, but more of them developed in the natural deluvial cover overlying the marbleized limestone. These subsidences provoked considerable environmental impact in the form of heavy damage to local roads and surrounding houses. A wide range of geological and geophysical investigations have been carried out to determine the actual conditions, to ensure selection of an appropriate impermeability treatment. Finally, the subsidence (ponor) zone was isolated from the reservoir by construction of an earth filled dyke.

Fig. 9 - Mavrovo Reservoir. Subsidence induced by reservoir operation.

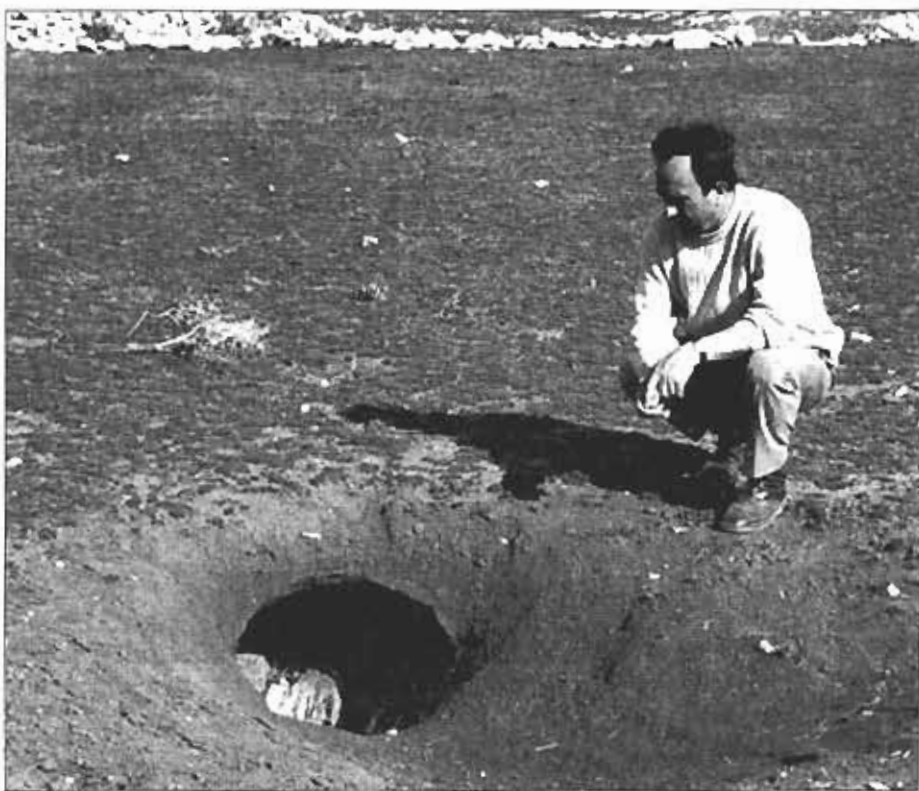
In some cases subsidence development is not a consequence of groundwater filtration out of a reservoir. It occurs as a consequence of frequent and high amplitude fluctuation in deep reservoirs, particularly if the amplitudes are more than 50 m . Intensive, but local, suffosion processes between the upper and lower parts of the same bank of the Bileca reservoir (Herzegovina) provoked a few subsidences in the upper section (Fig. 10).

Fig. 10 - Bileca Reservoir. Subsidence created by local water filtration.

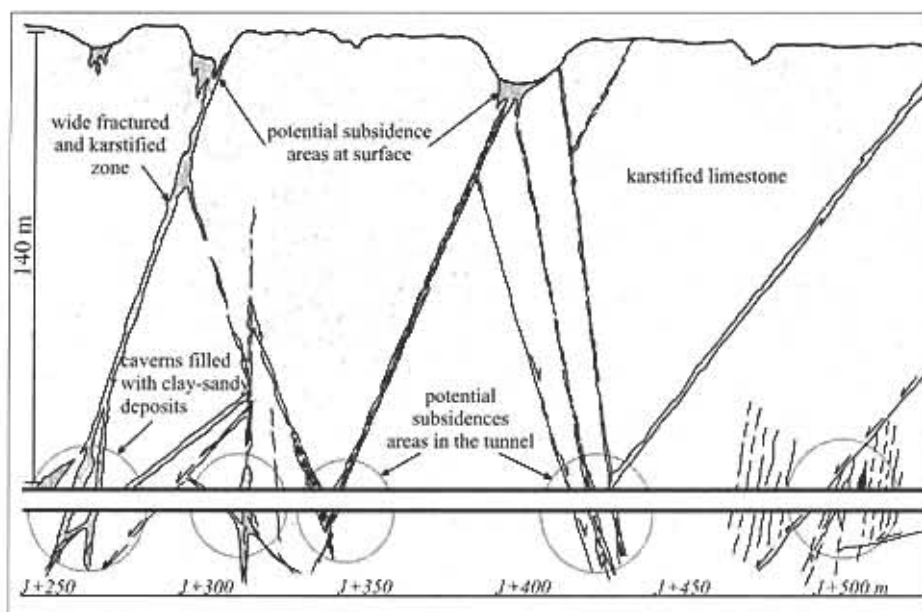
Defects encountered during underground excavations and tunnelling operation in karst can provoke undesirable effects at the surface. Any fault or cavernous zone that connects a tunnel section with the surface holds potential for subsidence, especially in the case of thin overburden (Fig. 11). The collapse prone areas are particularly susceptible in the case of hydrotechnical tunnels, especially derivation high-pressure tunnels.

Fig. 11 - The Dabar - Famica Tunnel. Potential subsidence zones.

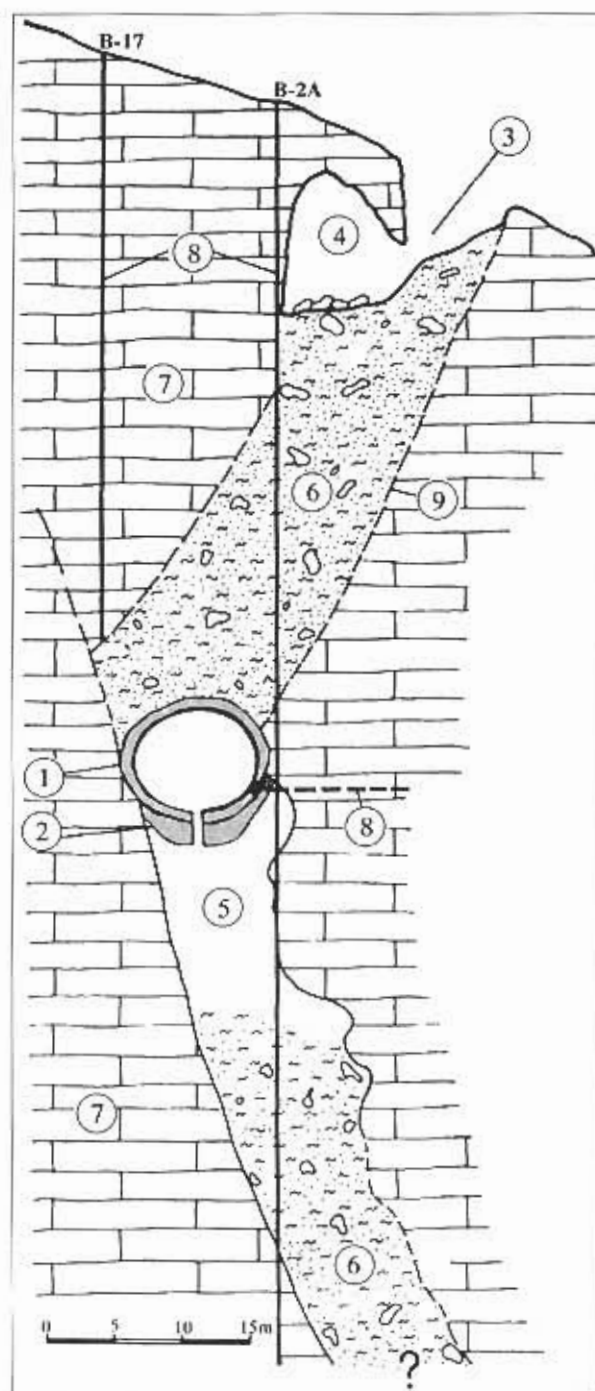
Subsidences created during tunnelling operations are illustrated by the following example. Water leakage from a headrace tunnel tube eroded and washed away unconsolidated cave deposits in the section where the tunnel intersected a large filled cavern (Fig. 12).

Percolation through the tunnel lining caused intensive erosion and transport of great volumes of sandy-clay cave deposits toward deeper channel sections over time. This resulted in the development of an empty space around the tunnel tube, and formation of subsidence at the surface. Particularly dangerous was the washed-out part of the cavern situated below the lining, with a length of 16 m, a width of about 7 m and a depth of 8 to 15 m. The loss of support seriously endangered the stability of the tunnel tube.

Fig. 12 - Headrace tunnel for HPP Capljina. Subsidence as a consequence of tunnelling operations: 1 = Tunnel lining; 2 = Part of lining additionally reinforced; 3 = Collapse; 4 = Cave origin as a consequence of collapse; 5 = Empty cavernous space below tunnel tube; 6 = Cave deposits (clay, sand, and limestone blocks); 7 = Limestone; 8 = Borehole; 9 = Fault.

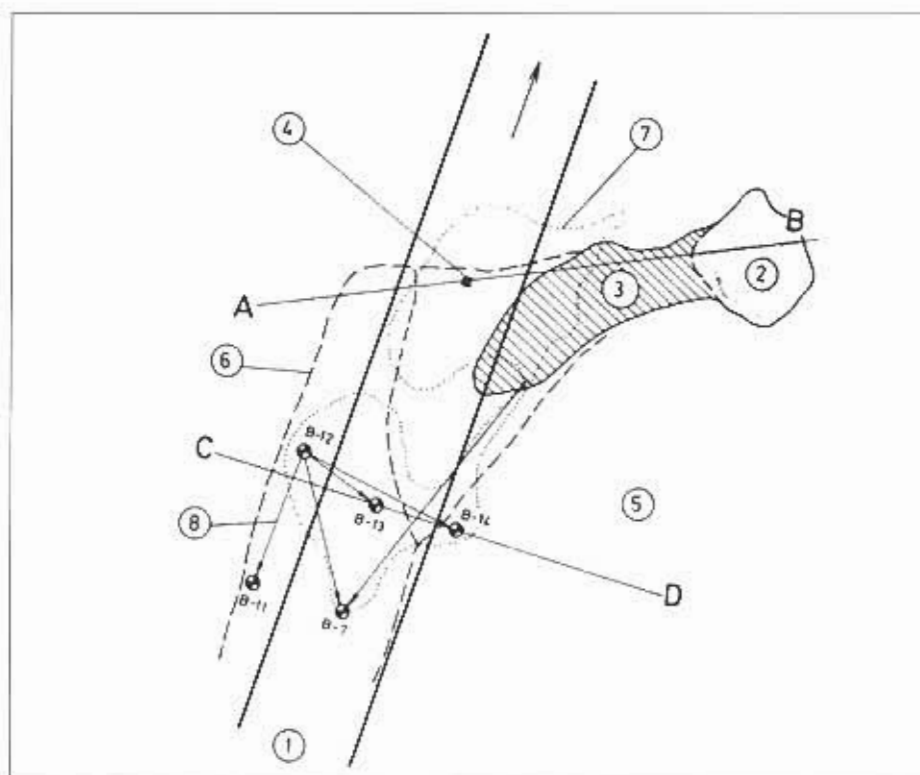
Complex investigation work has been carried out, including drilling, water level monitoring, measurements of leakage, geological analysis, speleological investigations, TV logging and tracing tests by dye and smoke tracers (Fig. 13). Speleological investigations, including detailed mapping of surface subsidence and underground collapse, were very successful.

Fig. 13 - Headrace tunnel for HPP Capljina. Cavern contours.

1 = Tunnel; 2 = Subsidence; 3 = Cavern, originated as a consequence of subsidence; 4 = Shaft cut through the lined invert; 5 = Limestone; 6 = Cavern contour line below the tunnel lining; 7 = Cavern contour line above the tunnel tube; and 8 = Connection established by smoke tracer.
