Hit or miss could mean life or death for juvenile Southern Bent-wing Bats

YVONNE INGEME^{1,2}, AMANDA BUSH³, LINDY LUMSDEN³,
EMMI VAN HARTEN⁴, STEVE BOURNE⁵, TERRY REARDON⁶

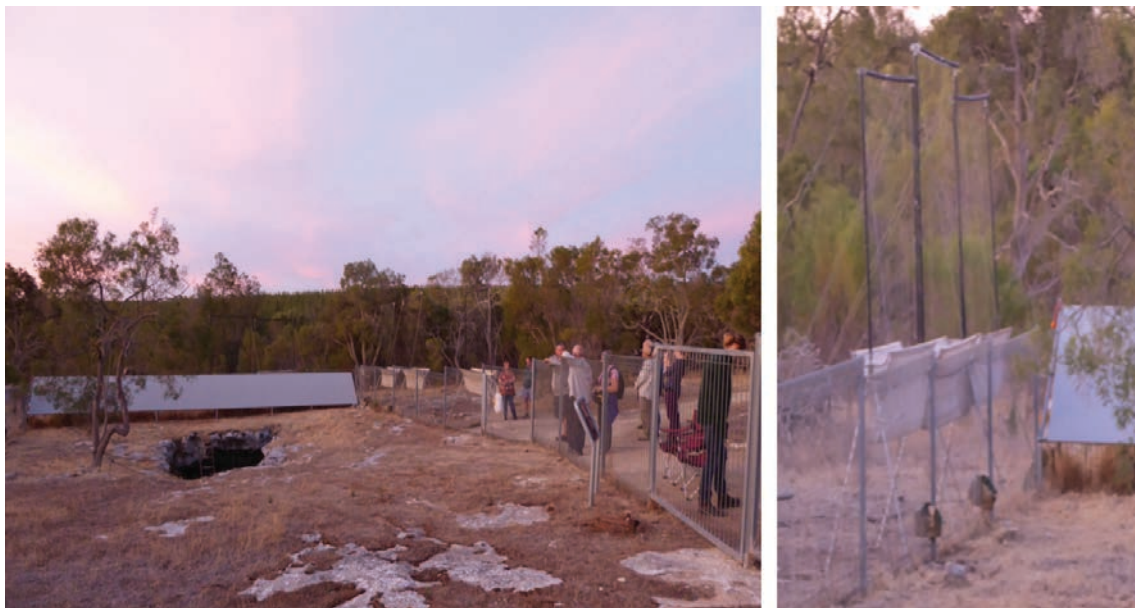
The fence around the entrance to Bat Cave is a standard 1.5 m high galvanised iron fence with vertical rungs (typically used to fence swimming pools). It is positioned 2–5.5 m from the entrance (Figure 1). In addition, there is a smooth metal panel 12 m long and 1.5 m wide, located between the fence and cave entrance (about 1.5 m from the cave entrance). The metal panel is fixed on a 45 degree angle sloping away from the entrance. It was installed in 2012/13 to assist with undertaking population estimates by recording bats emerging from the cave using thermal imagery, but is now rarely used.

Figure 1. Left: Infrastructure surrounding Bat Cave, including the metal fence and smooth metal panel, and temporary set up of padded harp traps. Right: Harp traps set up to trap bats during January 2016-18 field sampling. Photos: Yvonne Ingeme

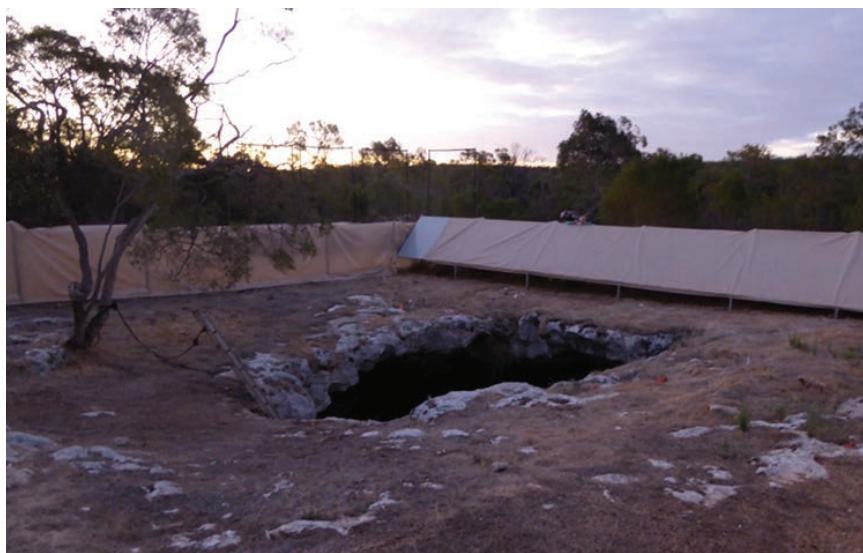
The Naracoorte Caves park staff were provided with an incident report following this trapping weekend. Park staff then installed temporary measures to reduce potential bat collisions, covering both the fence and the metal panel with shade cloth (Figure 2). No collision injuries were recorded during the trapping on the weekend of 19 and 20 February 2016, however by this time the young had been flying for over a month and may have been more adept in avoiding obstacles.

Figure 2. Temporary protection measures installed in 2016 with the infrastructure covered with shade cloth. Photo: Y. Ingeme

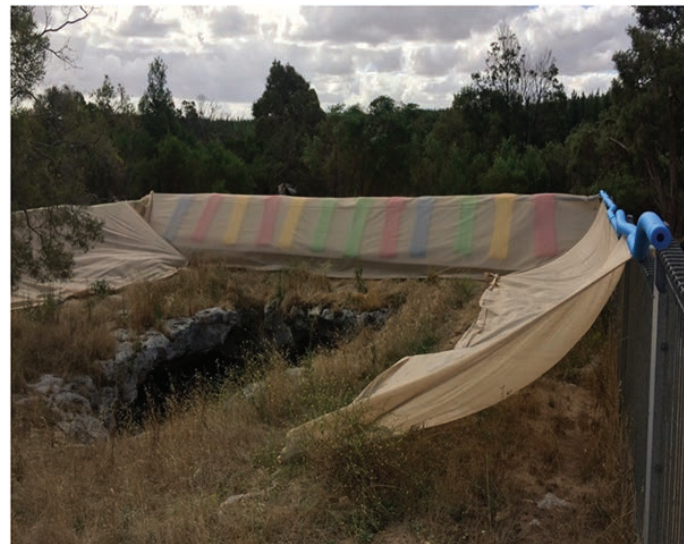
In January 2018, further padding was added. The shade cloth was angled away from the fence to provide more ‘give’ and the top rung of the fence was padded with lengths of pool noodle foam (Figure 4). The metal panel was padded with inflated air mattresses and covered in shade cloth. No injured bats were found and no bat strikes were heard during four nights of trapping over two weekends, including in early January when the young had just commenced flying.

Figure 4. Additional padding on the smooth metal panel in the form of (colourful) inflated air mattresses and pool noodles on the top of fence. Photo: Yvonne Ingeme

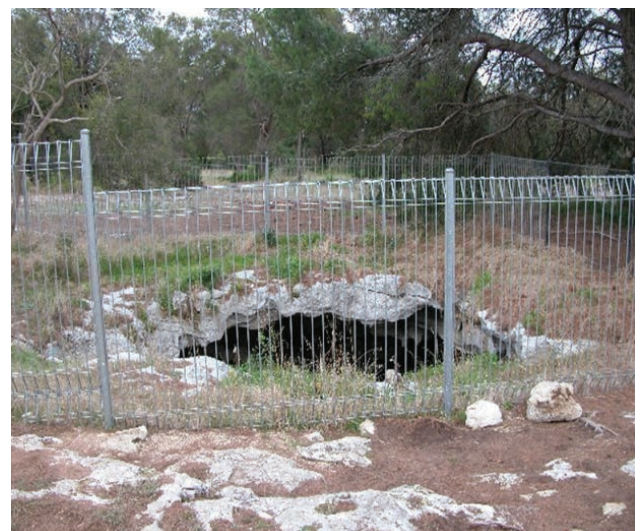
The fence was upgraded in about 1986 by Brian Clark (previous manager of the reserve), with a standard pool fence design that was located close to the cave entrance (Figure 6). Based on our current observations it is likely that this would have impacted the survival of some juvenile bats each year, however it is unknown how many.

Figure 6. Fence upgrade dating back to 1986 located close to Bat Cave entrance. Photo: Steve Bourne.

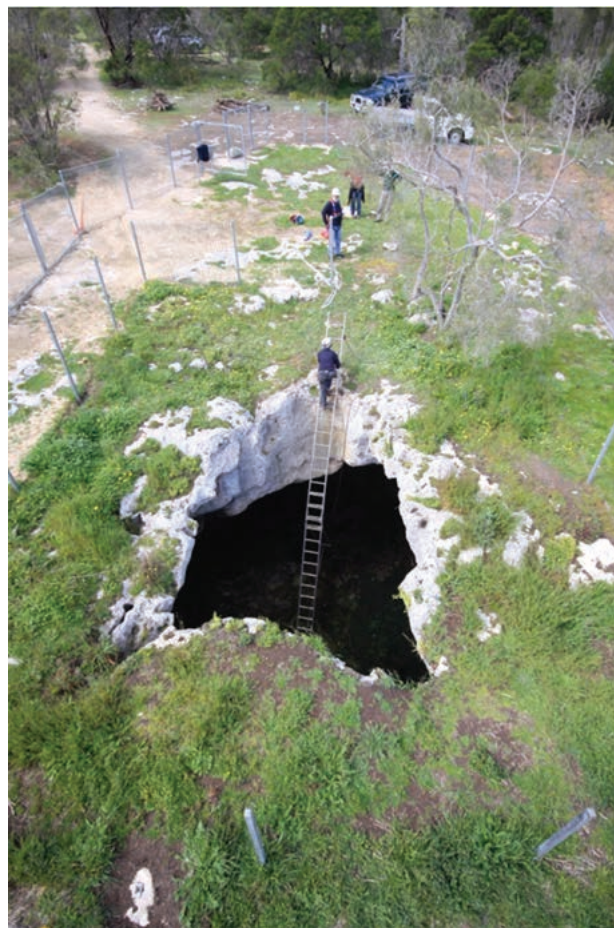
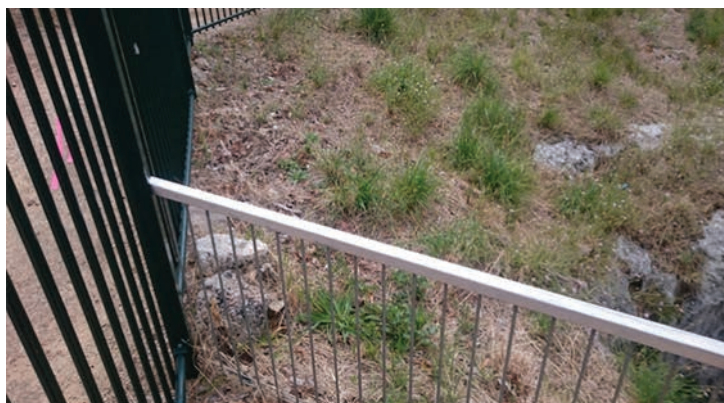
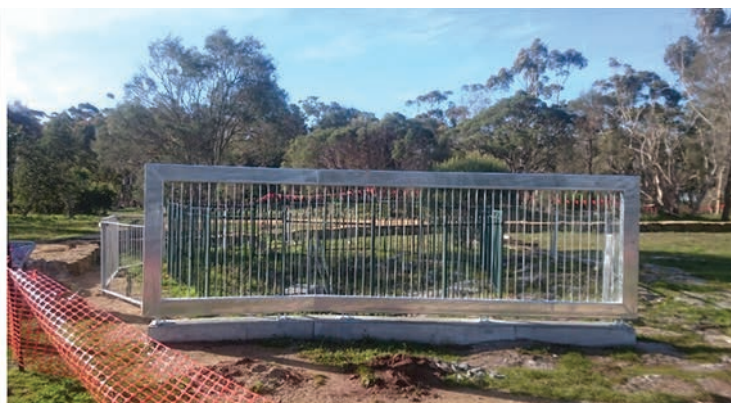
Naracoorte Caves management has recently installed new fencing around other caves in the park (Figure 8), some of which have also resulted in fatalities.

A juvenile Southern Bent-wing Bat was found dead at the fence junction at Wet/Stick Tomato Cave (Figure 8), nine days after being PIT-tagged. This individual may have had less than three weeks flying experience. A necropsy by Dr Peter Holz found that the bat was in excellent condition, with a stomach full of invertebrates, but had brain trauma, likely due to collision with the fence.

Figure 8. Fences at other caves within the Naracoorte Caves National Park. Left: Wet/Stick Tomato Cave. Photos: Emmi van Harten.
