Cultural Features Overview & Description

3.1 The ~~Yarrangobilly Caves Precinct~~Yarrangobilly Caves House Precinct

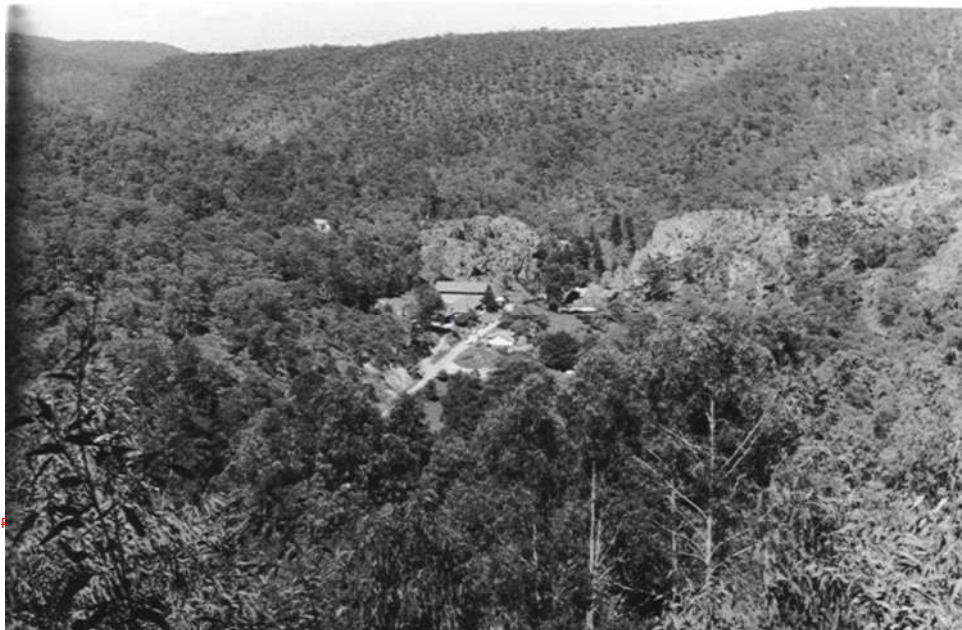
Figure 3.5 A distant c.1920 view of the Caves House complex showing rugged bush setting including the cleared areas around the complex planted with exotics and the avenue of poplars along the road leading to the caves west of the complex. In this photograph the two storey wing is complete and the 1919 caretakers cottage

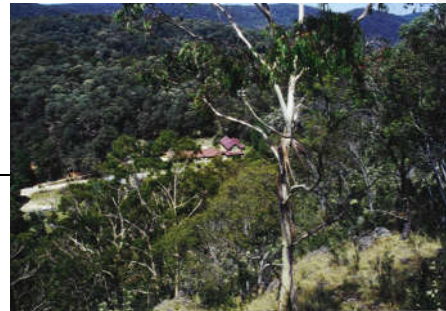
Figure 3.6 A current view from the Bluff Lookout down to the Caves House complex showing the dense understory and ~~thick~~thick surrounding bush. [Photograph by Sheppard, February 2000]

The current situation is that these communities have an understorey where the shrub layer is more dense and the ground layer less dense. This change may be due to the following causes or a combination of these causes:

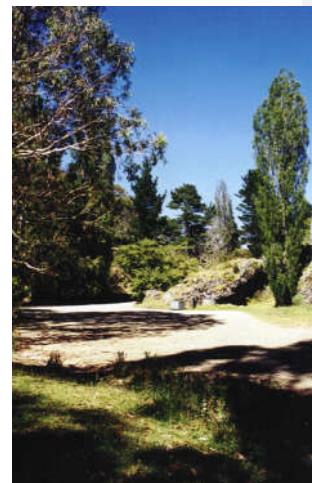
Figure 3.7 A current view looking west from the carpark at the exit from the Self ~~—~~Guiding Cave, showing the mature surviving poplars from the avenue and other exotics. [Photograph by Sheppard, February 2000]

The developed area in the Rules Creek valley includes a number of planted exotic deciduous trees of significant size. [See Figure 3.7] The main exotic species are Elm (*Ulmus* sp.) and Pine. There is an avenue of trees extending from the Leo Hoad Memorial Gates towards Caves House. On the existing access road to Caves House, this avenue gives a sense of arrival, although individual trees are in decline or have died (apparently due to disease).

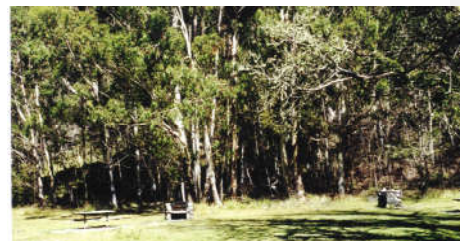
Figure 3.8 A current view of the Picnic grounds looking north west and showing the dense new growth. [Photograph by Sheppard, February 2000]

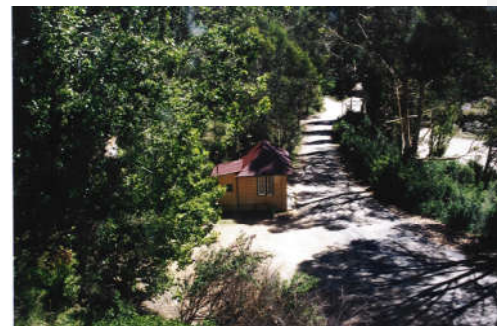
Figure 3.9 A current view of the road west of Caves House showing the dense vegetation along the sides of the roadway. [Photograph by Sheppard, February 2000]

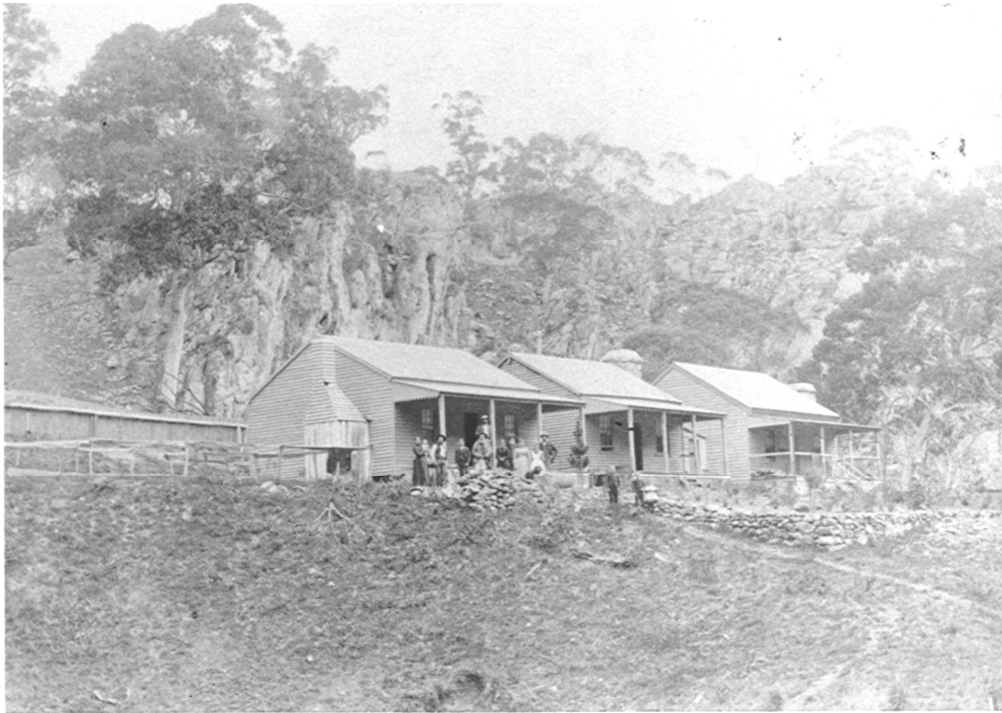
Figure 3.165 Photograph c.1892 showing the three cottages on the banks of Rules Creek with the Murray and Bradley families. Note the stone retaining wall, the timber fence and the garden frames.

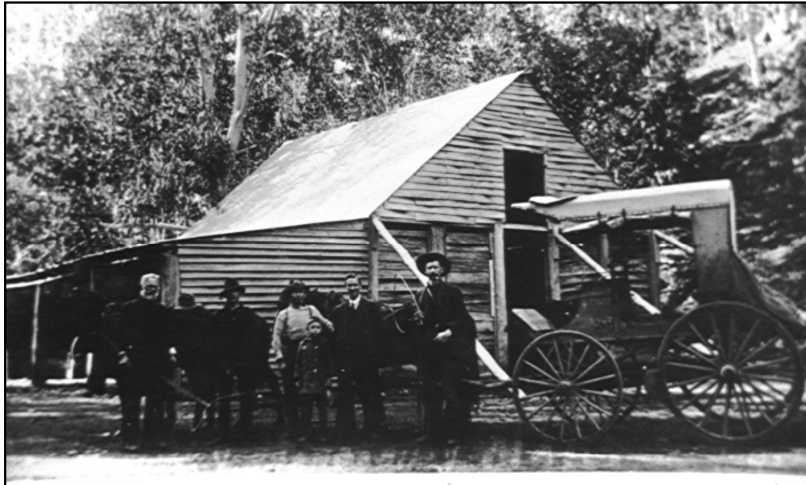
Figure 3.16 An early photograph of the main stable building with a group of men possibly including Walter Hoad senior. [The tall man on the right hand side is Norman Buchanan, driver of the mail coach \(P.Dowling pers comm\)](#) [Photograph from the [NPWS Yarrangobilly PhotographicHoad](#) Collection]

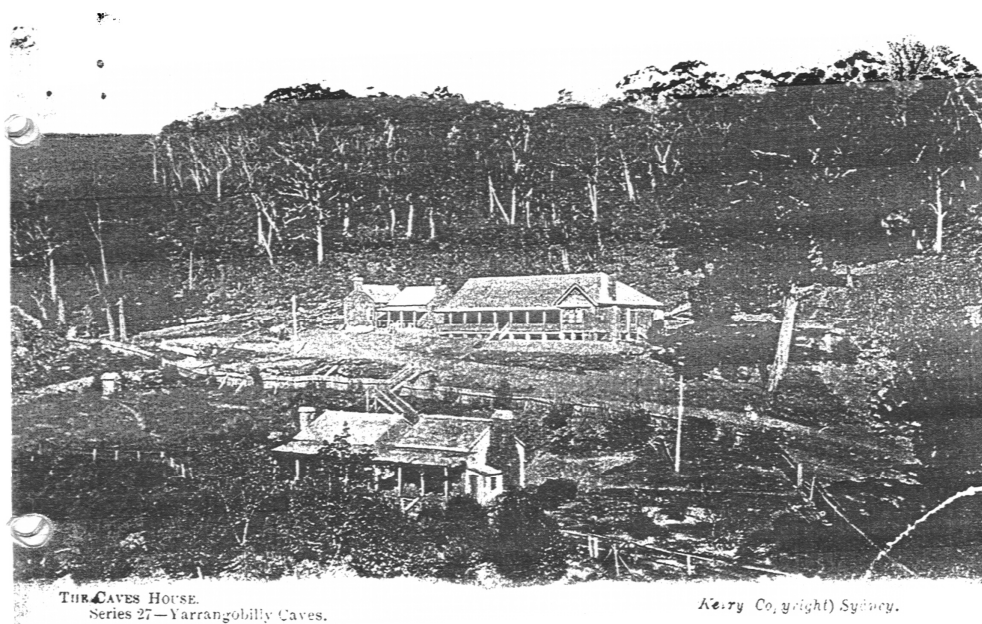
Figure 3.17 A c.1903-4 Charles Kerry postcard view showing the new 1901 Caves House and the relocated Jersey Cottage and the Kitchen building. [Photocopy held in the Yarrangobilly file Collection]

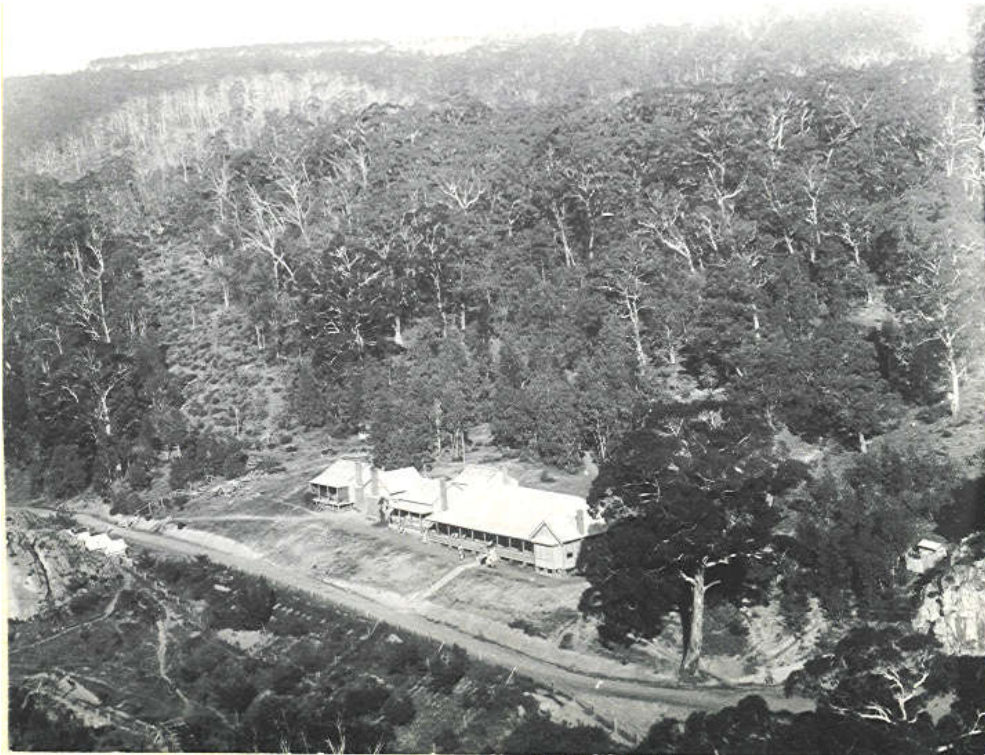
Figure 3.18 A photograph looking down on the 1906 Caves House complex showing the additional dining room and giving a clear view of the semi-permanent tents, of the telephone and telegraph line and of the garden. [Photograph courtesy of the Tumut Historical Society]

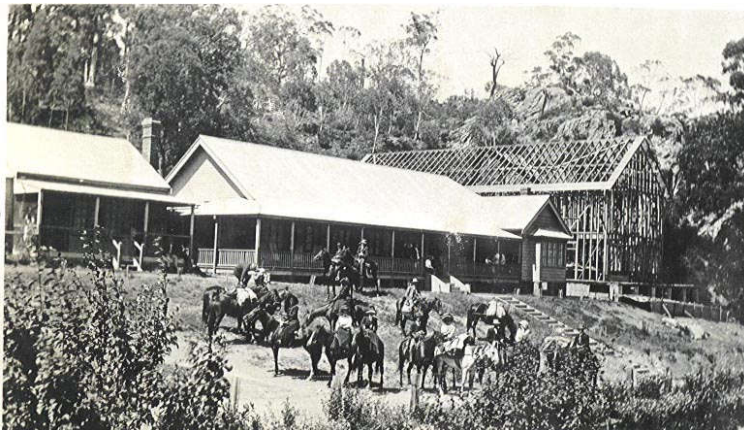
Figure 3.19 showing the Two Storey Wing under construction with Caves House (note the narrow verandah) and Jersey Cottage adjacent to the new building. [Photograph from the [NPWS Yarrangobilly PhotographicHoad Collection](#)]

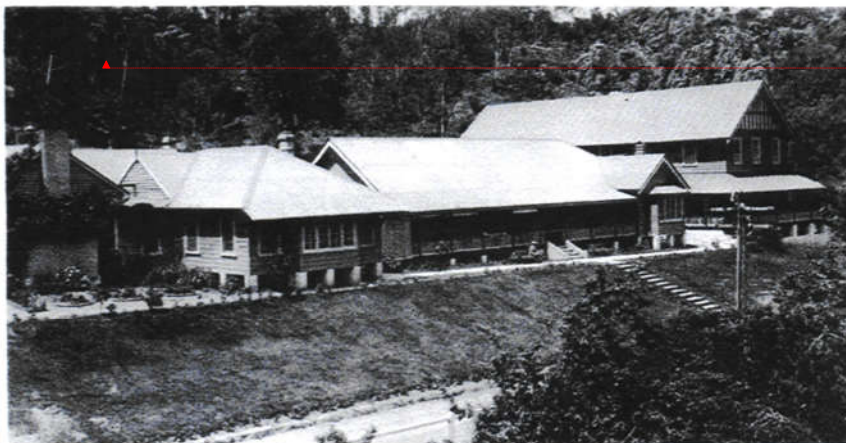
Figure 3.21 The Yarrangobilly Caves House complex with the new dining room constructed c.1937, but prior to the major alterations in 1938 which included a new bar and widened verandah. [Photograph from the NPWS Yarrangobilly Photographic Collection]

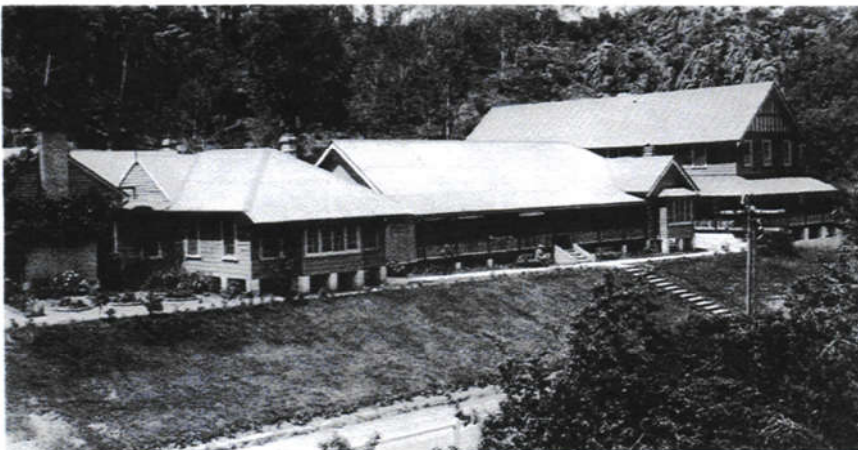
Figure 3.21 The Yarrangobilly Caves House complex with the new dining room constructed c.1937, but prior to the major alterations in 1938 which included a new bar and widened verandah.

[Photograph from the Hoad Collection]

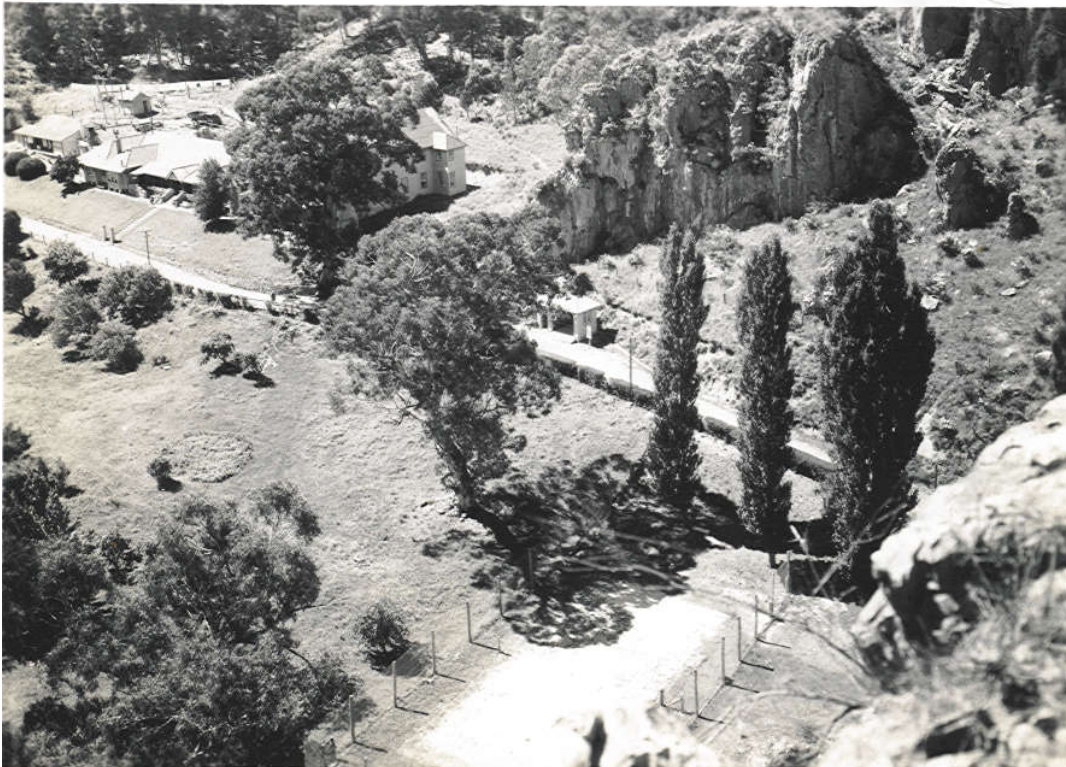
Figure 3.232 A view of Caves House with the c.1920s tennis court in the foreground. Note the pair of hipped roofs over the new dining room [c.1937] to the east and over the new bar between Caves House and the new dining room. The verandah has been widened to 11'6" as part of the 1938 works. [\[Photograph from the Hoad Collection\]](#)

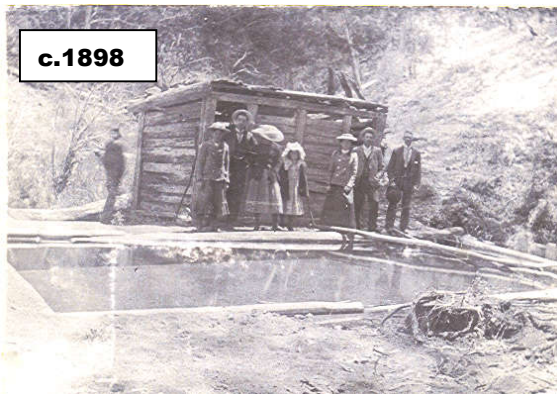
c.1898

C.1898 photograph showing a slab sided change room and the pool lined with timber.
[Photograph courtesy of the Tumut Historical Society]

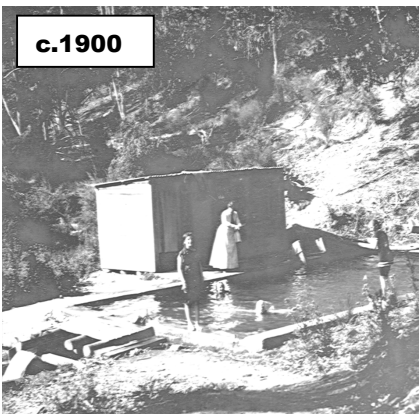
c.1900

C1900 photograph showing improved dressed timber changing rooms with the pool still sided with large timbers.
[Photograph from the [NPWS Yarrangobilly Photographic Hoard](#) Collection]

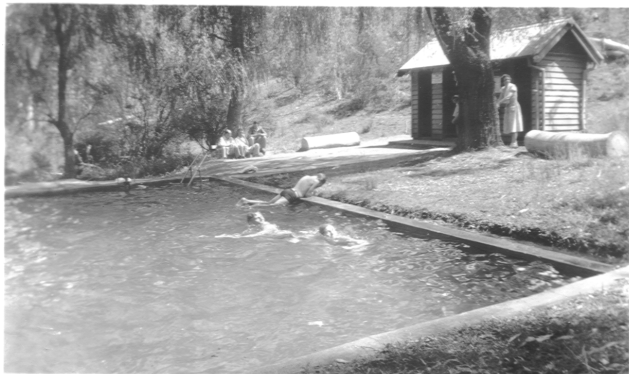
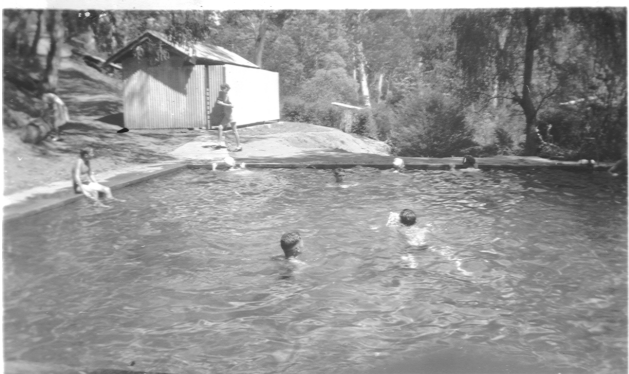
1947 photographs showing the enlarged cement sided pool and gable roofed changing rooms. One being weatherboard and the other corrugated iron.

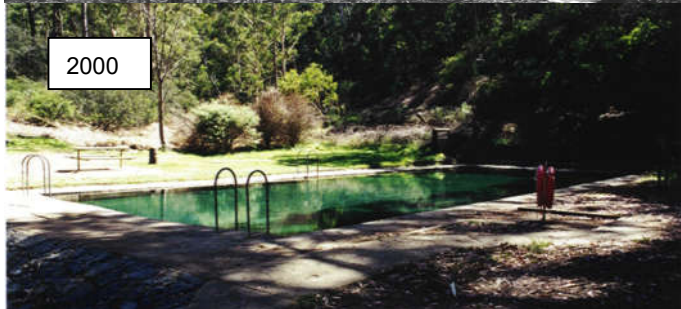
2000 photograph showing the wading pool located below the out flow.
[Photograph by Sheppard]

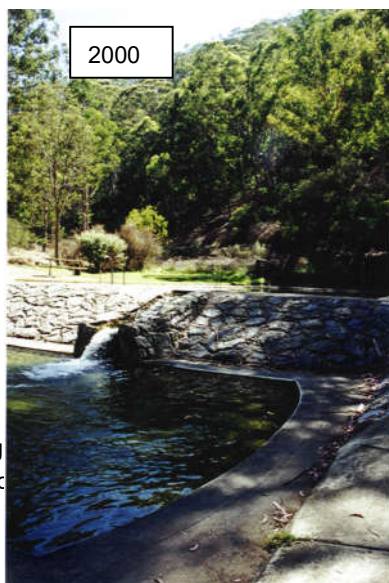
2000 photograph showing the wading pool located below the out flow.
[Photograph by Sheppard]
