Restoration of Skull Ice Cave, Lava Beds National Monument

*Kelly Fuhrmann
Lava Beds National Monument*

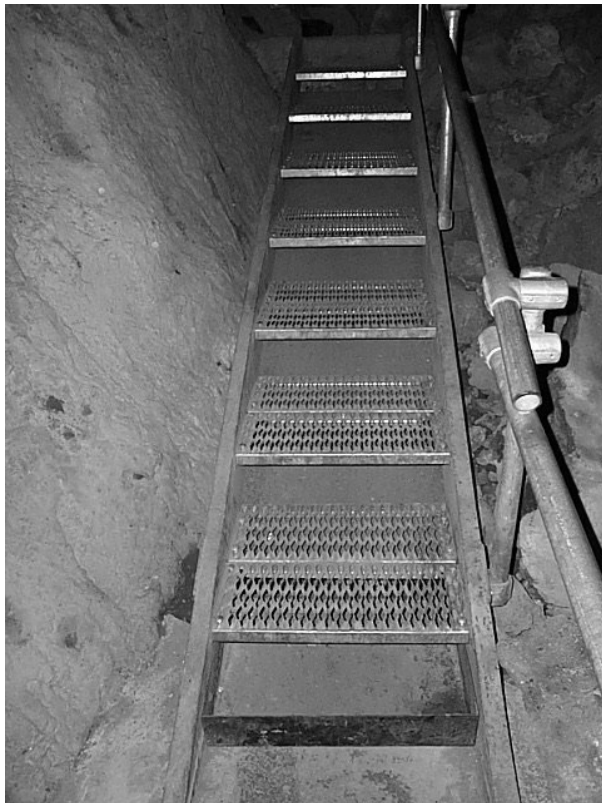
Figure 3. New stairs in Skull Cave made of galvanized steel with $\frac{1}{2}$ -inch mesh. Also notice the steel tray under the structure and catchment trough at the base of the stairs (photo by Kelly Fuhrmann).

During the first stage of the project, four stairways were refurbished. The original 47 steps that accumulated dirt and debris on three of the stairways were replaced with open mesh metal steps on stairway frames that allowed dirt and debris to filter through the stairs (Figure 3).

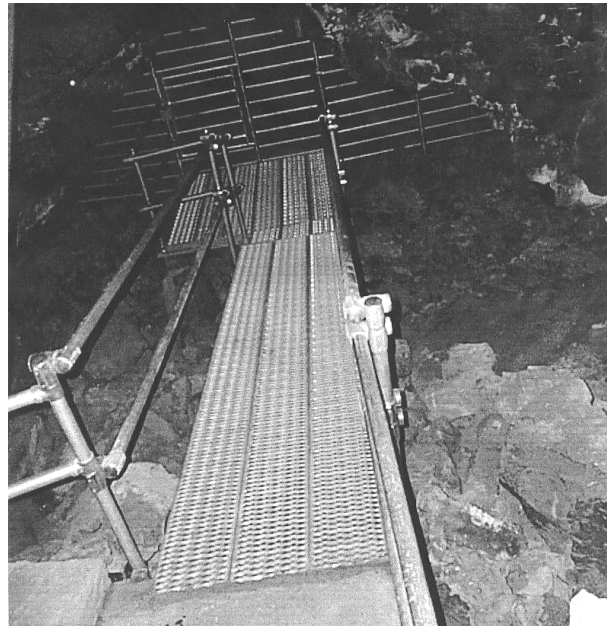
Figure 4. Viewing platform and gate in lower level of Skull Cave. The gate spans the entire passage width of four meters (14 feet) (photo by Kelly Fuhrmann).

An interpretive viewing platform was built in front of the gate to provide access for visitors to view the ice floor (Figure 4). This platform also provides an area for displaying interpretive signage explaining the processes of ice formation and cave conservation practices. A tarp was affixed under this platform to catch debris from foot traffic.

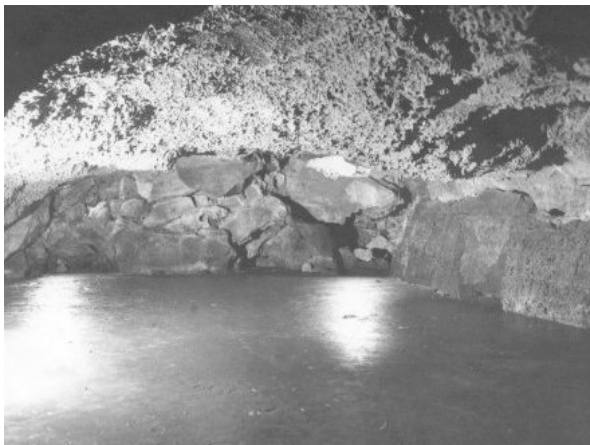
Figure 7. View of the inner ice floor looking towards the back of Skull Cave in 1961. (National Park Service photograph)

The following photographs (Figures 7 to 10) shows the inner ice floor from 1961 to November 2000. They depict the ice floor before heavy usage, the accumulation of 38 years of debris, and the restored ice floor in 1999.

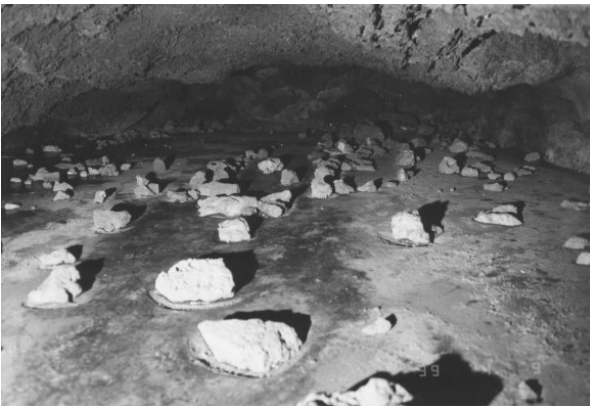
Figure 8. View of the inner ice floor in Skull Cave. This photograph was taken just before cleaning started in April of 1999. It shows heavy accumulation of debris consisting of breakdown and dust mantle carried onto the floor by visitors to the cave. (Photo by Kelly Fuhrmann)

During the summer of 1999, accumulated rock and dust debris was removed from the ice floor. The cleaning of the ice floor involved removing 816 kilograms (1,800 pounds) of rock and 45 kilograms (100 pounds) of sediment from the ice floor. After all the larger debris was removed by hand picking, the surface of the ice was washed by sponging with chlorine-free water to remove remaining sediment from most of the ice in an attempt to restore it to a more pristine condition. With the addition of new ice, one can now see 20 centimeters (8 inches) into the ice floor, where before an opaque film of sediment in and on top of the ice obscured any view into the floor.

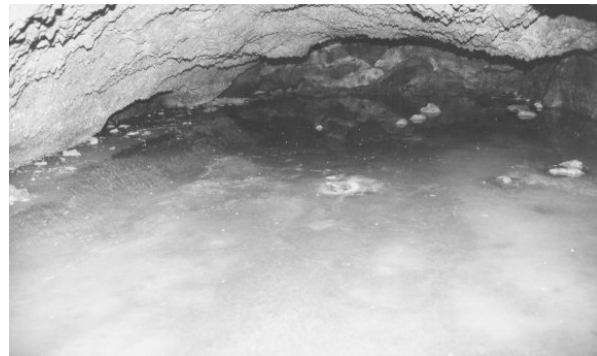
Figure 9. Same view of the inner ice floor as Figure 8 after clean up of nearly 862 kg (1,900 lbs) of debris and dust by the end of October 1999. (Photo by Kelly Fuhrmann)

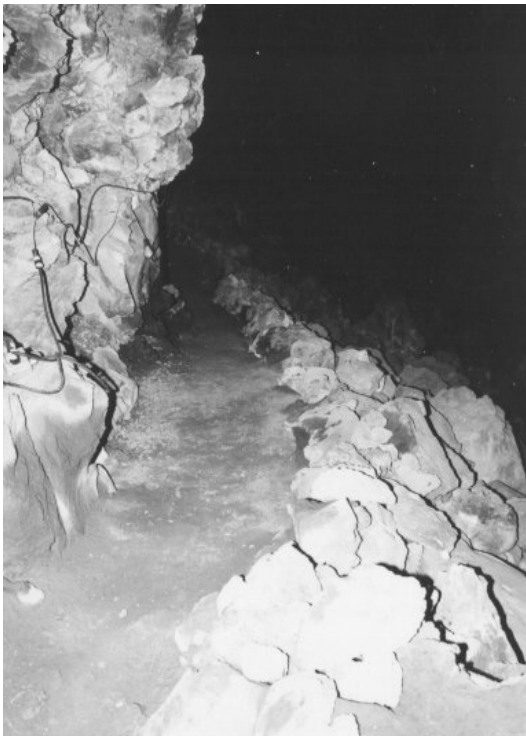
Figure 11. View of the upper level trail with the original trail tread.
(Photo by Kelly Fuhrmann)

The upper passage trail was reconstructed by covering the original dirt trail with sand. Flat lava rock slabs were then laid on top of the sand. Dry mortar was added to the spaces between the lava rock and then water was used to set the dry mortar. This phase of trail construction was completed by September 2000. The following photographs (Figures 11 to 14) show both before and after views of this reconstruction process.

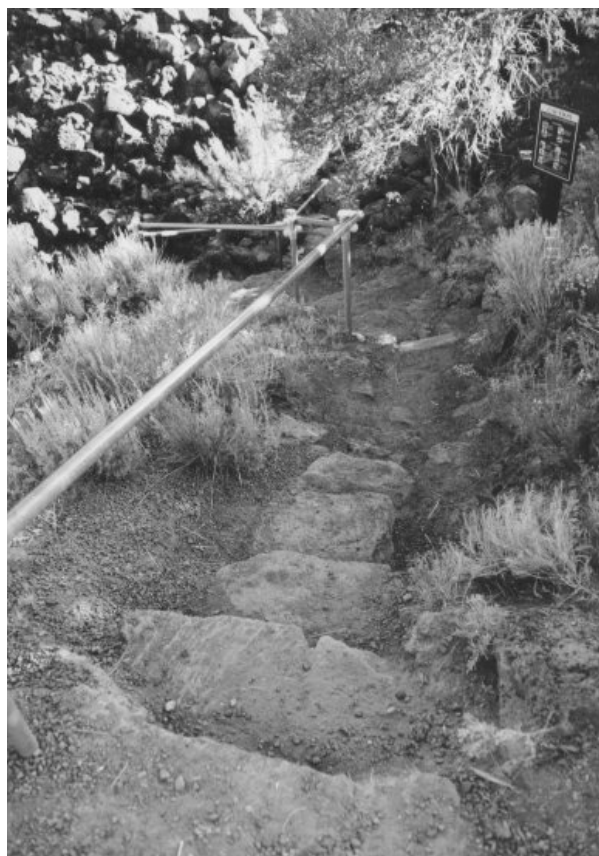
The surface trail leading into Skull Cave consisted of lava rock covered with gravel that had migrated down onto the trail from the trail head. This material proved to be a major source of dust and soil tracked into the cave on visitor's shoes.

Figure 15. This photo, taken in June of 2000, shows the trail leading down into the collapse sink entrance of Skull Cave. This nearly 30-meter (100-foot) trail leads to the cave entrance just out of the picture to the upper right. The trail in the foreground is approximately a meter (three feet) wide. Note sagebrush (*Artemisia tridentata* ssp. *tridentata*), desert sweet (*Chamaebatiaria millefolium*), and rabbitbrush (*Chrysothamnus viscidiflorus*) plant community in and around the cave collapse. (Photo by Kelly Fuhrmann)
