# HUMAN MODIFICATION OF KARST IN THE ST. LOUIS AREA, MISSOURI

*Robert E. Criss  
Washington University  
1 Dunleith  
St. Louis, Missouri 63124  
criss@wustl.edu  
314-935-7441*

### Urban Karst Field Trip, St. Louis County, Missouri

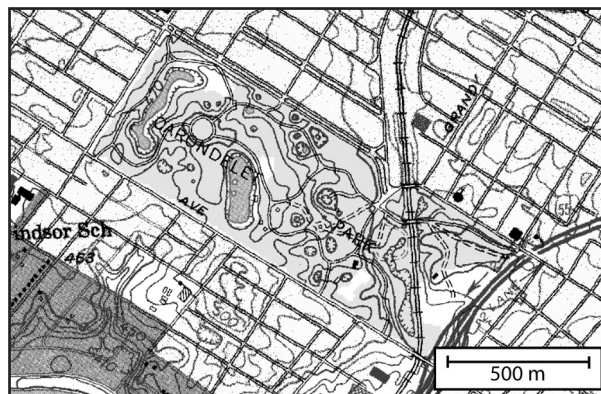
Figure 1

Map of Carondelet Park (light grey), showing the preservation of several sinkholes and other karst features within its rectangular boundary, and the comparatively featureless topography outside. Just west of the railroad tracks is a sinuous depression that may represent collapsed cave passage, that formerly included features called Carondelet Park Cave (now blocked) and Big Spring (Light 2007). Modified after part of the USGS Webster Groves 7.5" topographic quadrangle.

Farther from downtown, in areas that have not been settled quite as long, several parks and other protected areas preserve remnants of the original topography (Table 2). A good example is Carondelet Park (Figure 1), pockmarked by sinks, yet surrounded by developed expanses that are topographically featureless. Clearly, much land has been grossly modified and leveled. The Webster Grove area has many similar examples (Table 2), but also includes some subdivisions where sinkholes remain.

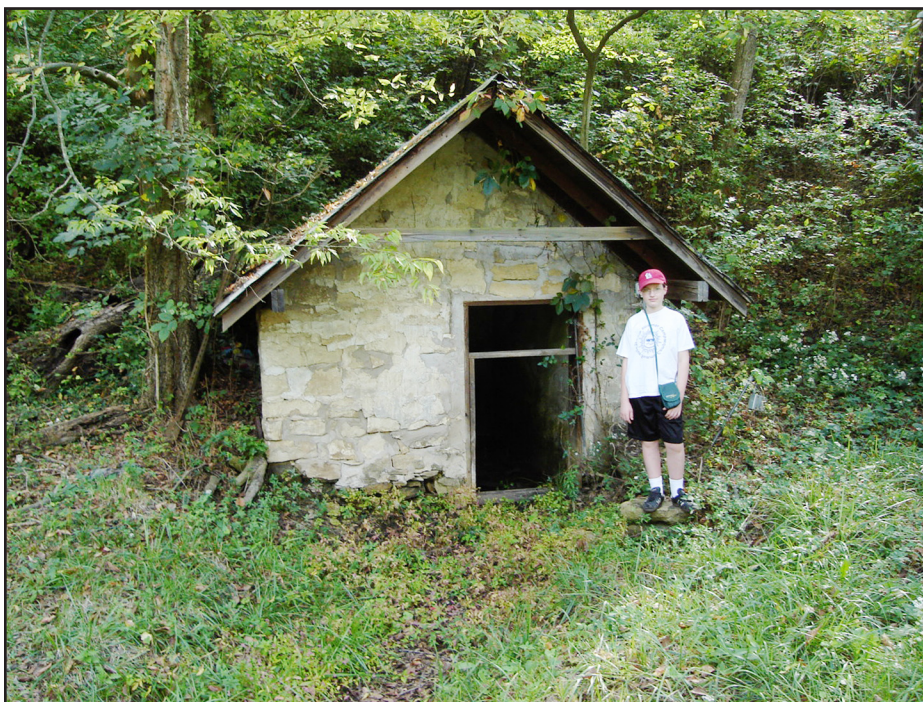
*Figure 2 The antebellum Rott Springhouse has survived much development in St. Louis County, though its watershed has been impacted (Stop 1).*

Rott Spring emerges from what is arguably the best surviving example of an antebellum springhouse

in St. Louis Co., on the property of Clarence Morrison, 9268 Rott Rd. (Fig. 2). The watershed for this remarkable spring clearly includes forested hillsides and low-density suburban areas to the northeast, but development has had several impacts. First, the watershed was greatly modified by the construction of I-270, located only 100 m to the northeast of the springhouse, and this has visibly decreased the flow of the spring according to field trip participant Earl Biffle. Second, the spring has conductivity in excess of normal values, perhaps due to road salt, and was contaminated in 1994 by oil from a leaking tank located a few thousand feet to the NE. This leak caused a fish kill in the pond and imparted a petroliferous odor that is still noticeable today, though the fish have returned. The host rock at the springhouse is mapped as Warsaw Fm. (Harrison 1997).

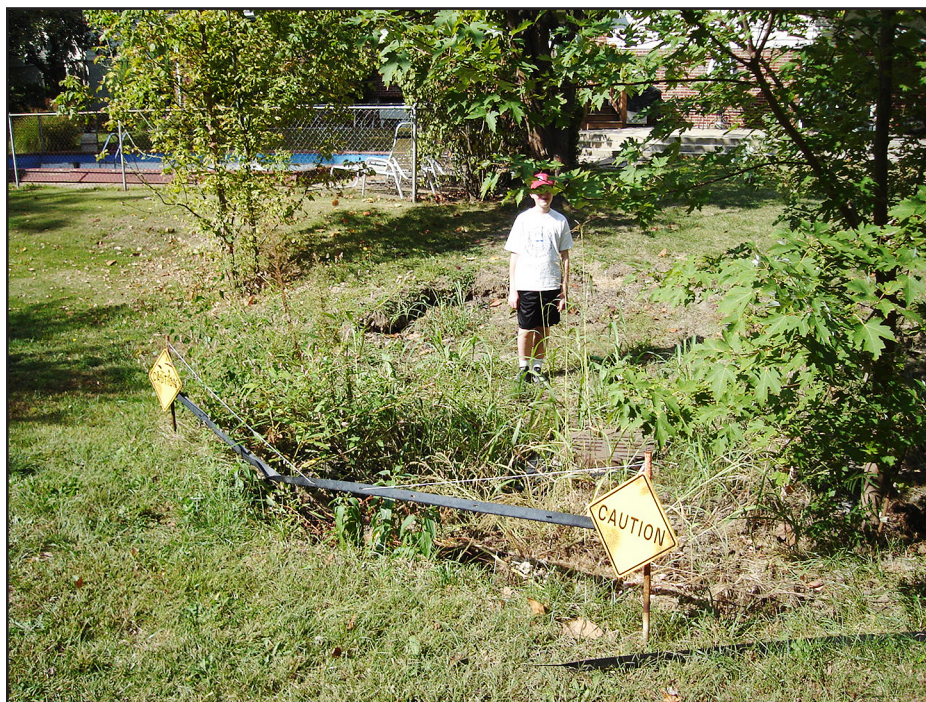
Figure 3. Collapse near a storm drain situated in a sinkhole in the Concord area. The capacity of the natural bedrock conduits is too small to drain storm water as fast as it is delivered, so this yard frequently floods to depths of several feet (Stop 3).

The residence of Alice Bradenberg at 11606 Tescord Drive has experienced repeated flooding since 1966 due to backflow from a sinkhole into which too much storm water has been diverted (Fig. 3). Ms. Bradenberg reports that the water from the "drain" can "geyser" several feet into the air following storms. MSD has attempted to excavate, rebuild and relocate the drain into the limestone several times, but has not been able to correct the problem, and commercial development on proximal Lindbergh Ave. has probably exacerbated the situation. Note the 6 m-diameter, 25 cm-high, circular subsidence "scarp" around one of these drains. The neighborhood was converted from septic systems and connected with the municipal sewer system ca. 1997.

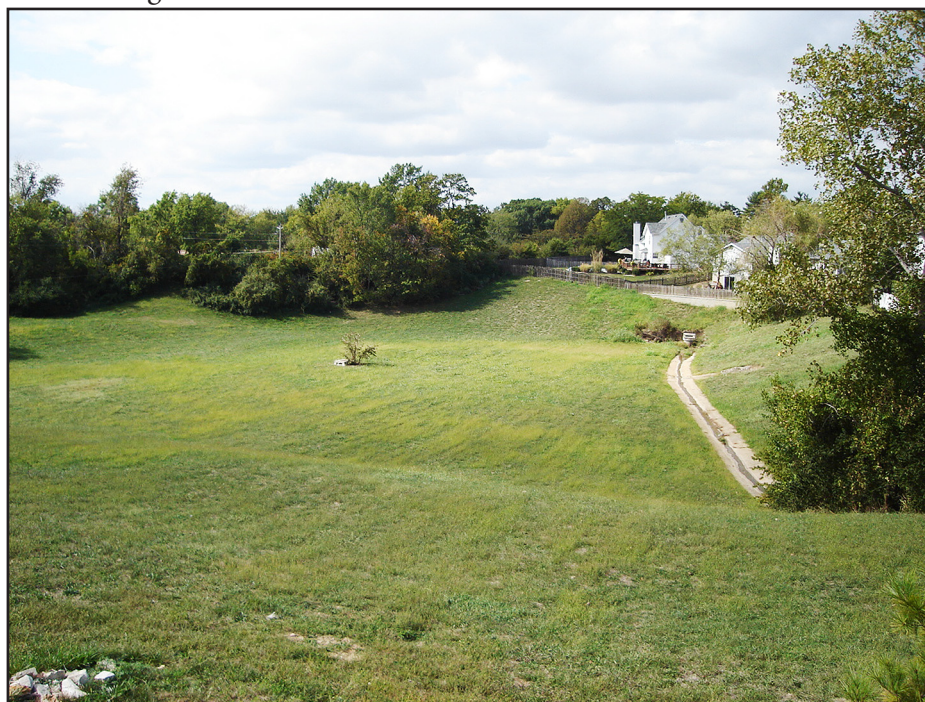
Figure 4. This detention basin near Telegraph Road in Oakville diverts storm runoff into culverts that intersect two caves, including the longest cave in St. Louis County (Stop 4).

This 1.5-ha detention basin (Fig. 4) is developed above a large composite sinkhole that formerly contained two cave entrances, Cave of the Falls (SLO 98; see Vandike et al., 1989), and Jagged

Pit (SLO 86), that are not now enterable through these concrete drain structures. Though little information is currently available, the Cave of the Falls is alleged to be the largest cave in St. Louis County, with more than 2 km of passage.

Cave of the Falls terminates about 1 km to the northwest at a natural entrance hosting a flowing cave stream. Thus, this detention basin exemplifies the routing of urban storm water into caves. These cave conduits of course provided drainage for waters entering the large sinkholes that originally occurred in this location, so the argument is commonly advanced that this

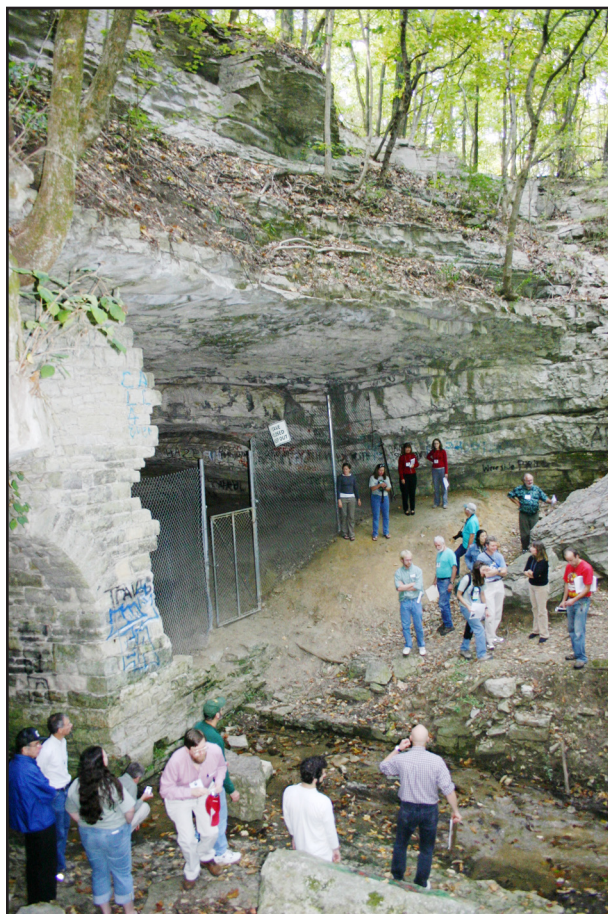
Figure 6 NCKMS field trip participants at the main entrance to Cliff Cave (Stop 6). Photo by Bill Elliott.

County Park, preserving a topographic remnant of the forested sinkhole plain. At least 10 caves occur in this section. Best known is Cliff Cave (SLO 13; Fig. 6), the second longest cave in the county with more than 4700 feet of passage (MSS 1966, Marty et al. 1982). The picturesque entrance to this cave, some 16 m wide and 7 m tall, contains a stone archway that is a remnant of its former use as a storage area. Before that, Cliff Cave was used by native Americans. Eastern pipistrelles (*Perimyotis subflavus*) and Big Brown bats (*Eptesicus fuscus*) hibernate in the cave (William R. Elliott, pers. comm.), and the perennial cave stream that exits from the main entrance hosts abundant flatworms, isopods, and amphipods.

west. These are part of the overlying sinkhole plain which clearly lacks an integrated, dendritic system of surface streams. The cave clearly serves as the subsurface drain of this sinkhole plain, and was probably developed at the water table in this setting. The cave mostly consists of air filled passages above a flowing stream with either a gravel or bedrock floor. The cave walls have well-developed scallops, and the ceiling has remarkable cupolas, but speleothems are uncommon, particularly in the main passage, probably because they are broken by subterranean flash floods. Cliff Cave was gated following a fatal incident in 1993 that involved several spelunkers caught in such a flood.
