COLLAPSE ABOVE THE WORLD'S LARGEST POTASH MINE (URAL, RUSSIA)

Vjacheslav ANDREJCHUK

This paper reports the results of the study of a huge collapse that occurred in June 1986 within the area of the 3rd Berezniki potash mine (the Verkhnekamsky potash deposit, Ural). Processes that took place between the first appearance of a water inflow through the mine roof and the eventual collapse are reconstructed in detail. The origin and development of a cavity that induced the collapse are revealed. Two factors played a major role in the formation of the collapse: the presence of a tectonic fold/rupture zone within both the salt sequence and the overburden (the zone of crush and enhanced permeability), and the ductile pillars mining system.

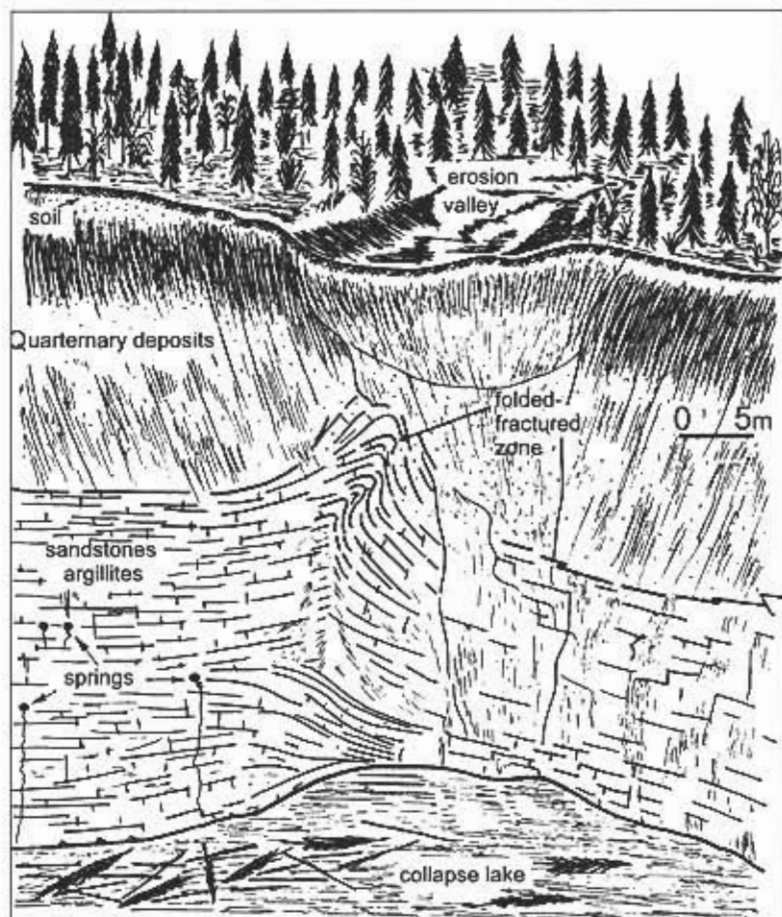
Fig.5 – Sketch of the northwestern side of the Berezniki Collapse (June, 1987). Arrows point to the fold deformation in the variegated complex

Most likely the interception of a weakened zone in the cover salt by an anthropogenic fissure caused activation of the former and the opening of flow paths along it. These paths allowed brines from above to penetrate into the mines. The existence of such a weakened zone is suggested by several geological observations. The most important one is a fold deformation in the overburden, observed in the wall of the collapse. This fold is marked by a high level of fissuring and high permeability (Fig.5).

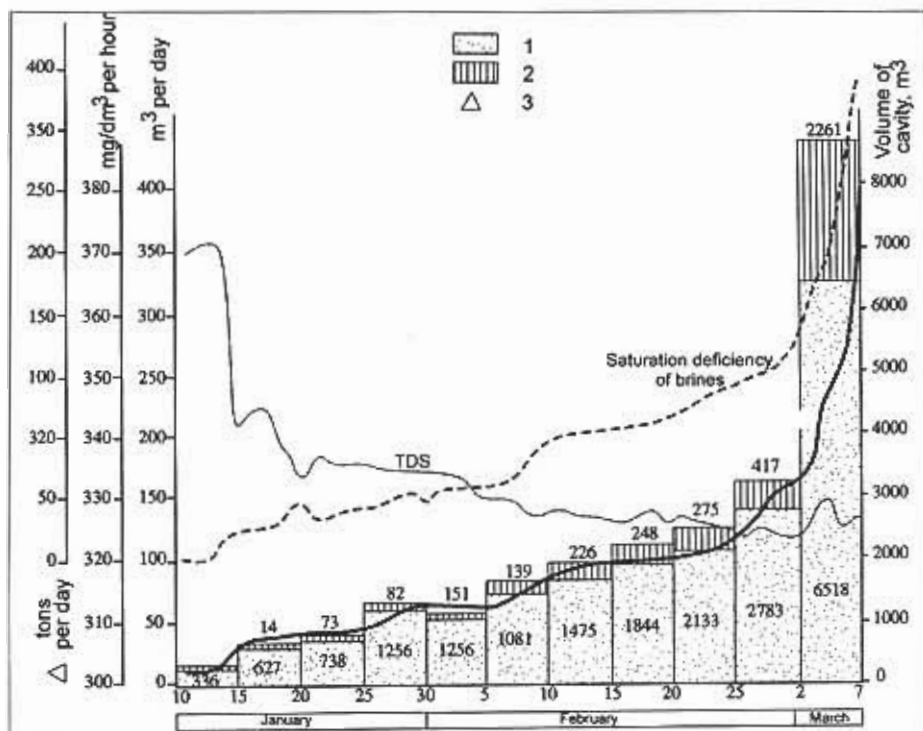
Fig.8 – Dynamics of salt dissolution and cavities formation in the damage zone of mine № 3 between January 11 – March 8 1986. 1 = the volume of cavities formed above the mine by inflowing undersaturated brines (20,500m³), the volume of cavities formed at the mine level (4,221m³), 3 = saturation deficiency of brines arrived to the mine.

Fig.8 depicts the formation of cavities by dissolution of salts during the period between January 11 and March 8 1986, when regime observations on the water inflows to the mine were carried out. During the first period the volume of cavities formed was 336m³. During the second period a volume of about 10,000m³ was added. Approximately the same volume was added during the third period, when discharge of brines was growing abruptly. By March 9 cavities with a total volume of 20,500m³ had formed. Most likely, a single cavity continued downwards as a system of bifurcating vertical conduits. However, the shape of the cavity formed by this stage had no significant influence on subsequent events, as later the cavity enlarged by two orders of magnitude.

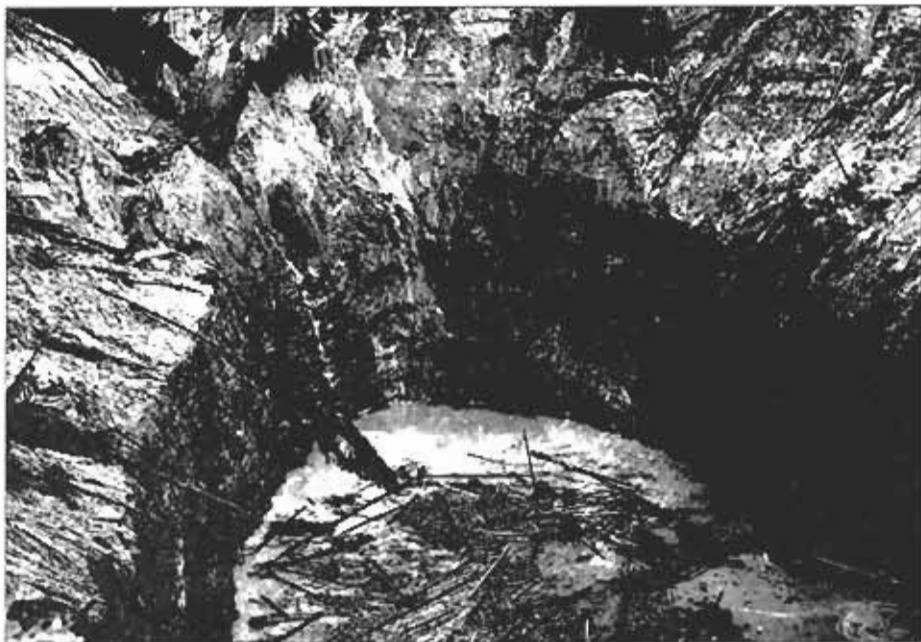
Fig.15 – View to the northwestern side of the collapse (June 1987).

After the collapse occurred, a deep asymmetrical doline appeared, with steep slopes at the level of the fluvioglacial sequence and vertical walls at the level of the variegated complex (Fig.15). Its initial ground plan dimensions were about 80m along the long axis and 40m along the short axis (Fig.16). The long axis was oriented northwest-southeast, which coincided with the orientation of the fold and an associated ravine. For short period the doline assumed a cone shape in the upper part, at the level of the Quaternary sediments.
