Parks & Wildlife Service, Tasmania
Newdegate Cave
Rehabilitation Plan 1994

HASTINGS NEWDEGATE CAVE REHABILITATION PLAN

Parks and Wildlife Service
July 1994

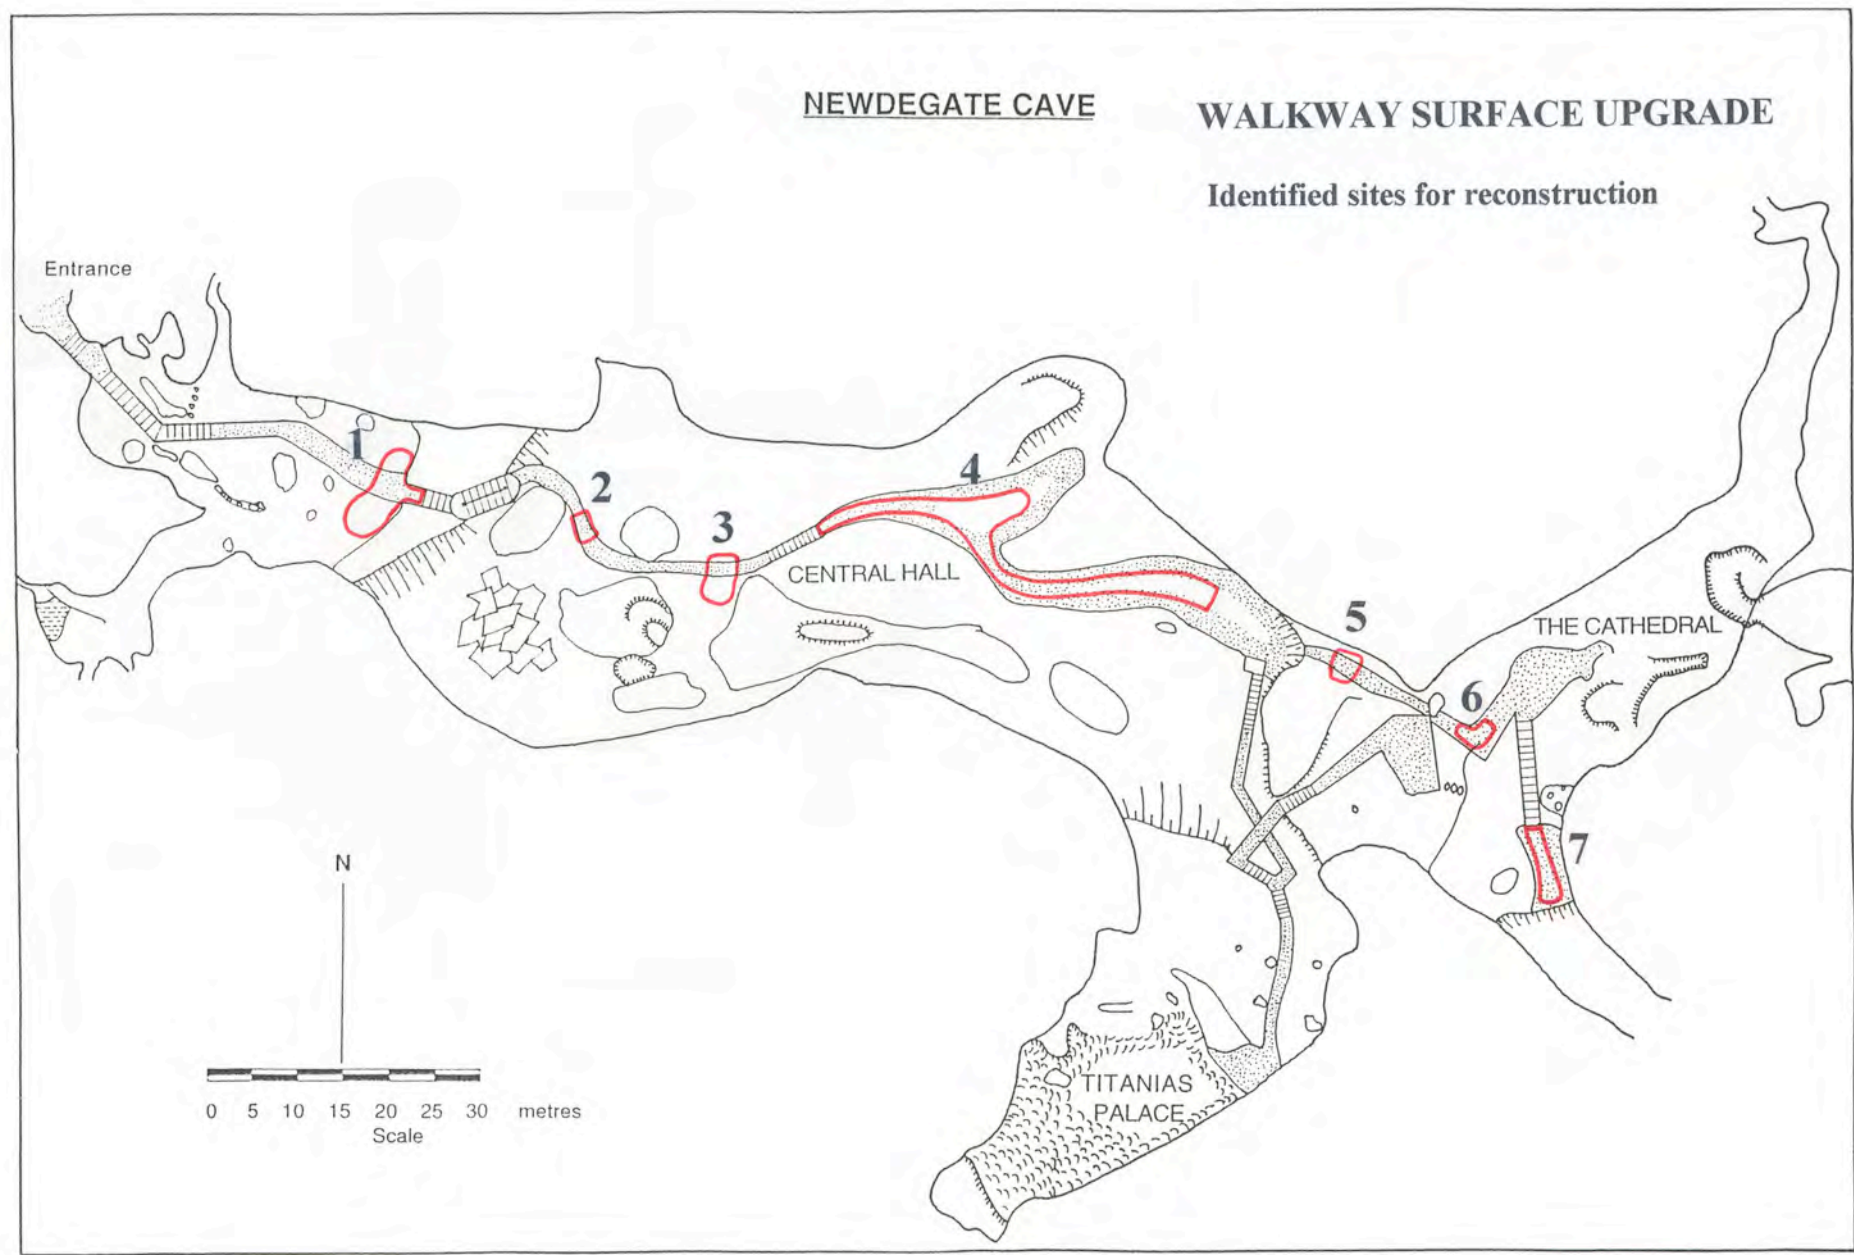
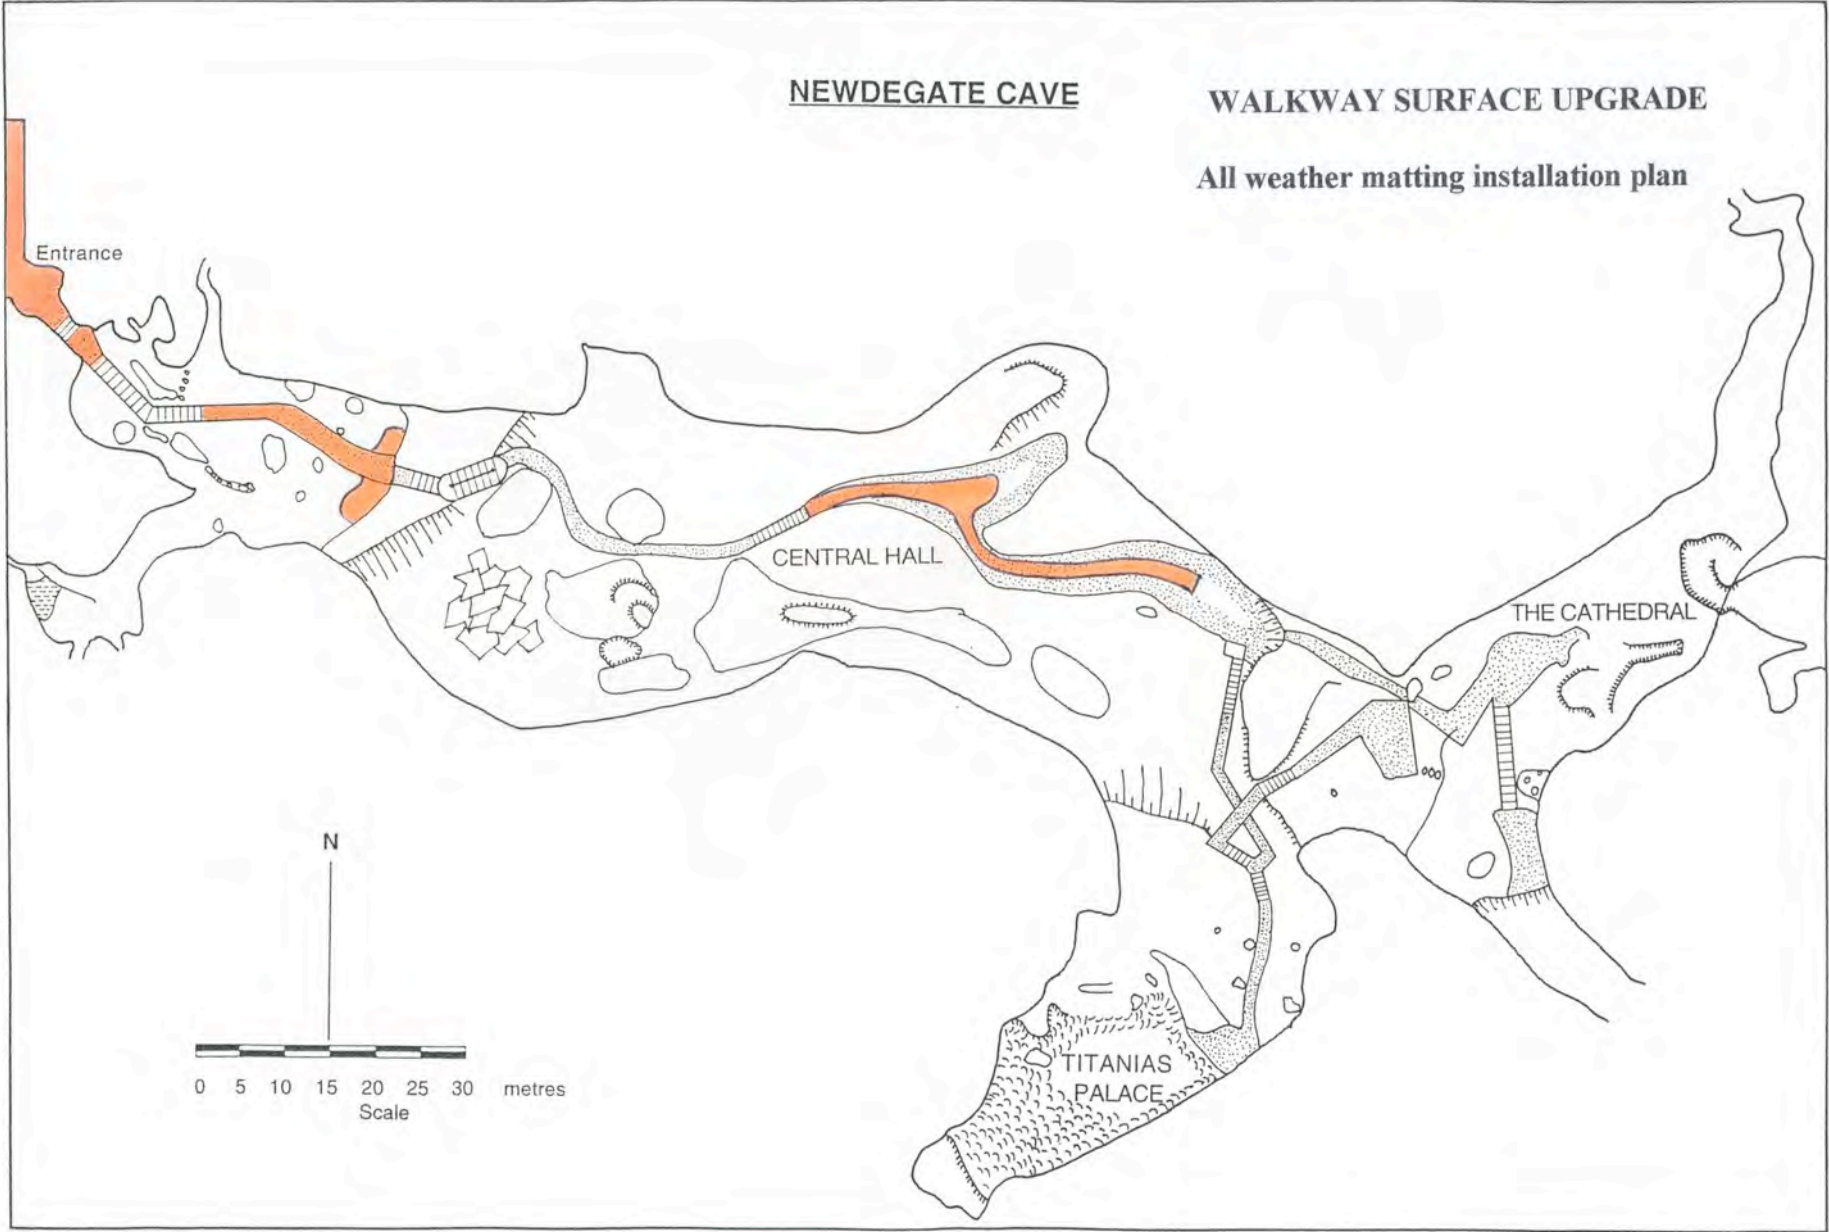
Section 2.2. Unconsolidated material from unstable areas such as these is transferred on visitors shoes throughout the cave system, particularly when surface are wet. Rough surfaces are potential safety hazards for visitors.

OBJECTIVES	ACTION	\$	PRIORITIES	ESTIMATED TIME	COMMENTS
Eliminate distribution of foreign matter throughout the cave system	Seal visitor carpark	20000	C	2 Days	
	Install elevated boardwalk access track to cave entrance	38000	A	30 Days	Completed
	Install visitor shoe wash facility and interpretation material	500	A	4 Days	Work-force - 2
	Clearly define appropriate visitor pathway and assembly areas by installing concrete curbing designed to meet other objectives in the rehabilitation plan	40000	A	30 Days	Work-force - 8
	Install all weather matting in strategic areas as identified	6000	A	4 Days	Work-force - 2
Provide safe uniform surfaces on walkway and assembly areas including stabilising mobile surfaces to prevent transfer of cave sediments	Level and reconstruct concrete surfaces as identified	4000	A	6 Days	Work-force - 4
	Level, stabilise and install all weather matting on identified surfaces	3000	A	4 Days	Work-force - 3

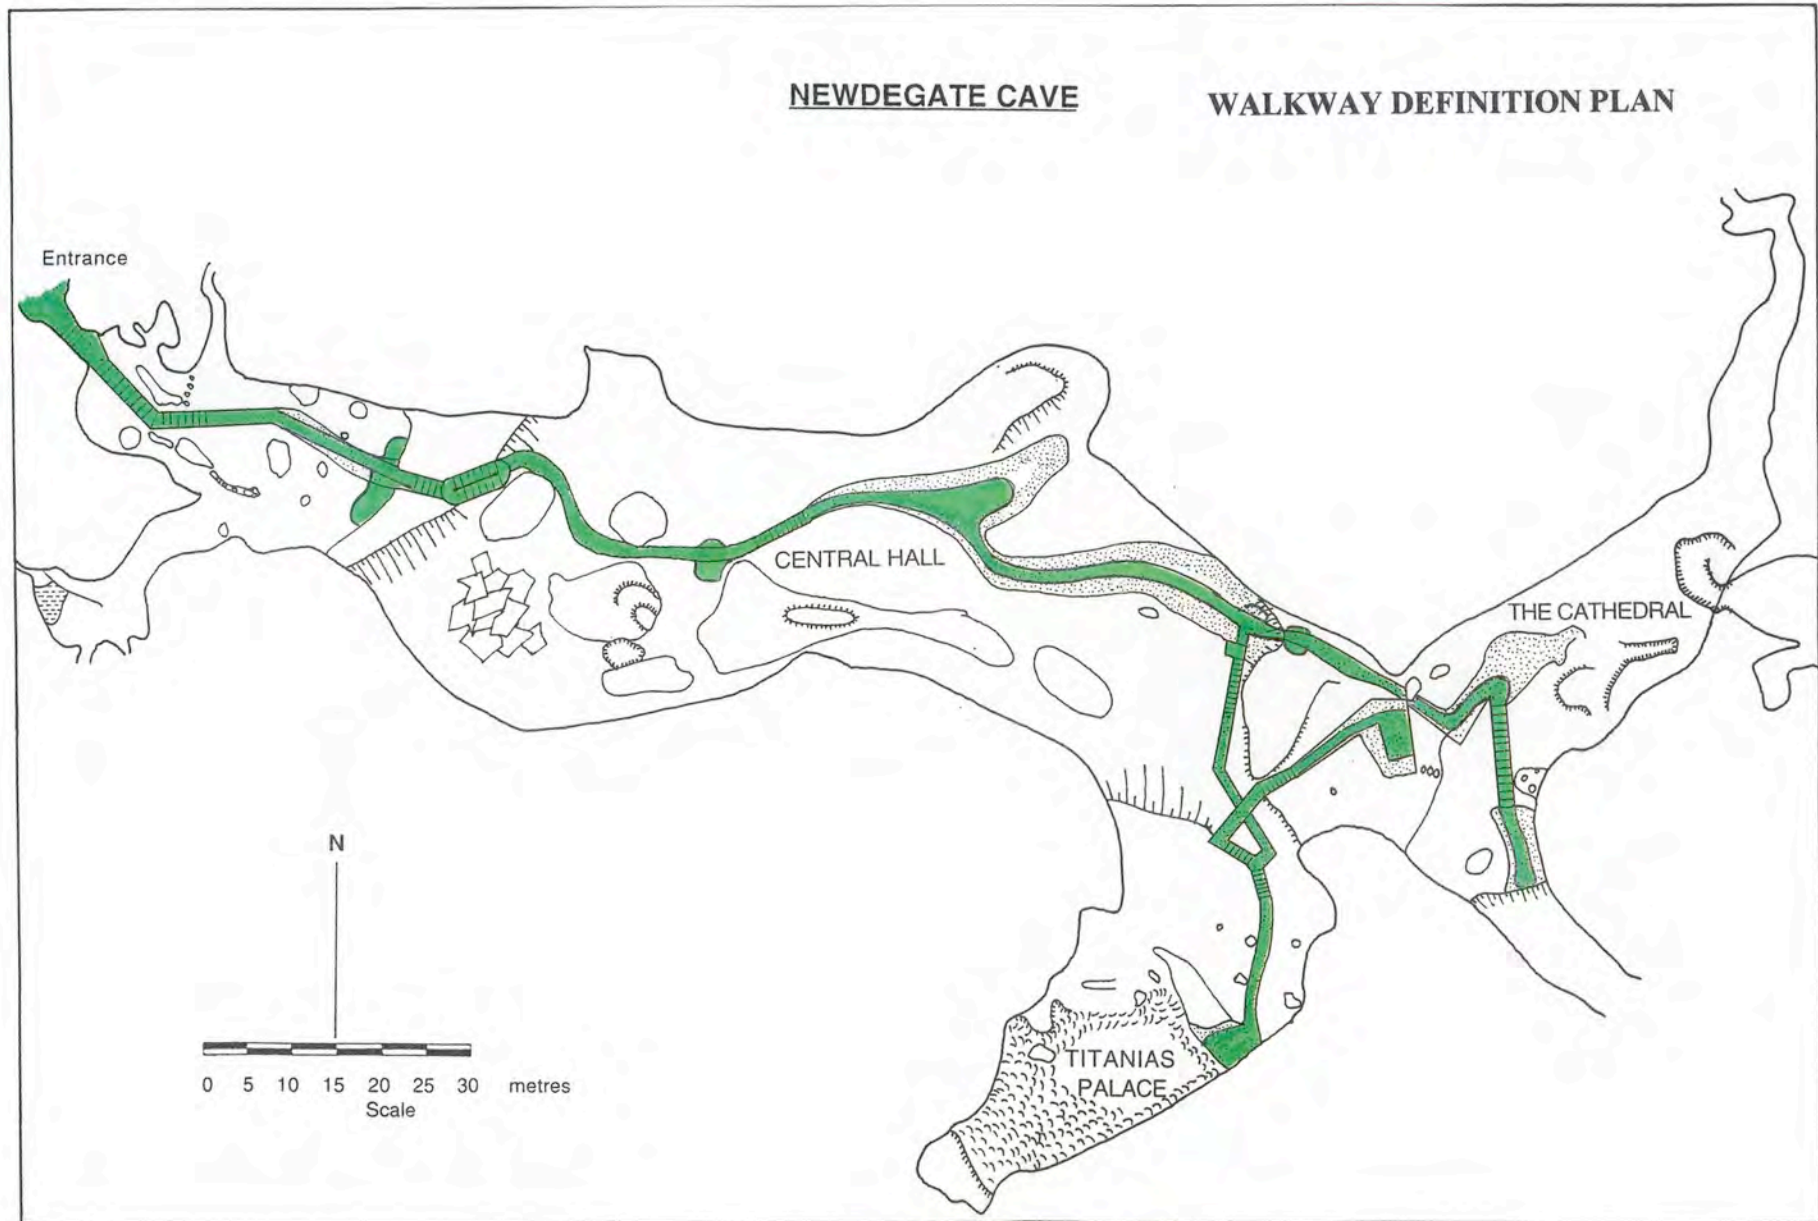
Section 2.3 Poor walkway definition allows unacceptable degradation of speleothems and cave sediments by visitors venturing outside acceptable access areas

OBJECTIVES	ACTION	\$	PRIOR- ITIES	ESTIMATED TIME
Define walkway and assembly areas in order to prevent tracking of cave sediments, erosion and irreparable damage to speleothems caused by visitors stepping outside acceptable access routes	Utilise concrete curbing to surround visitor access areas as identified		A

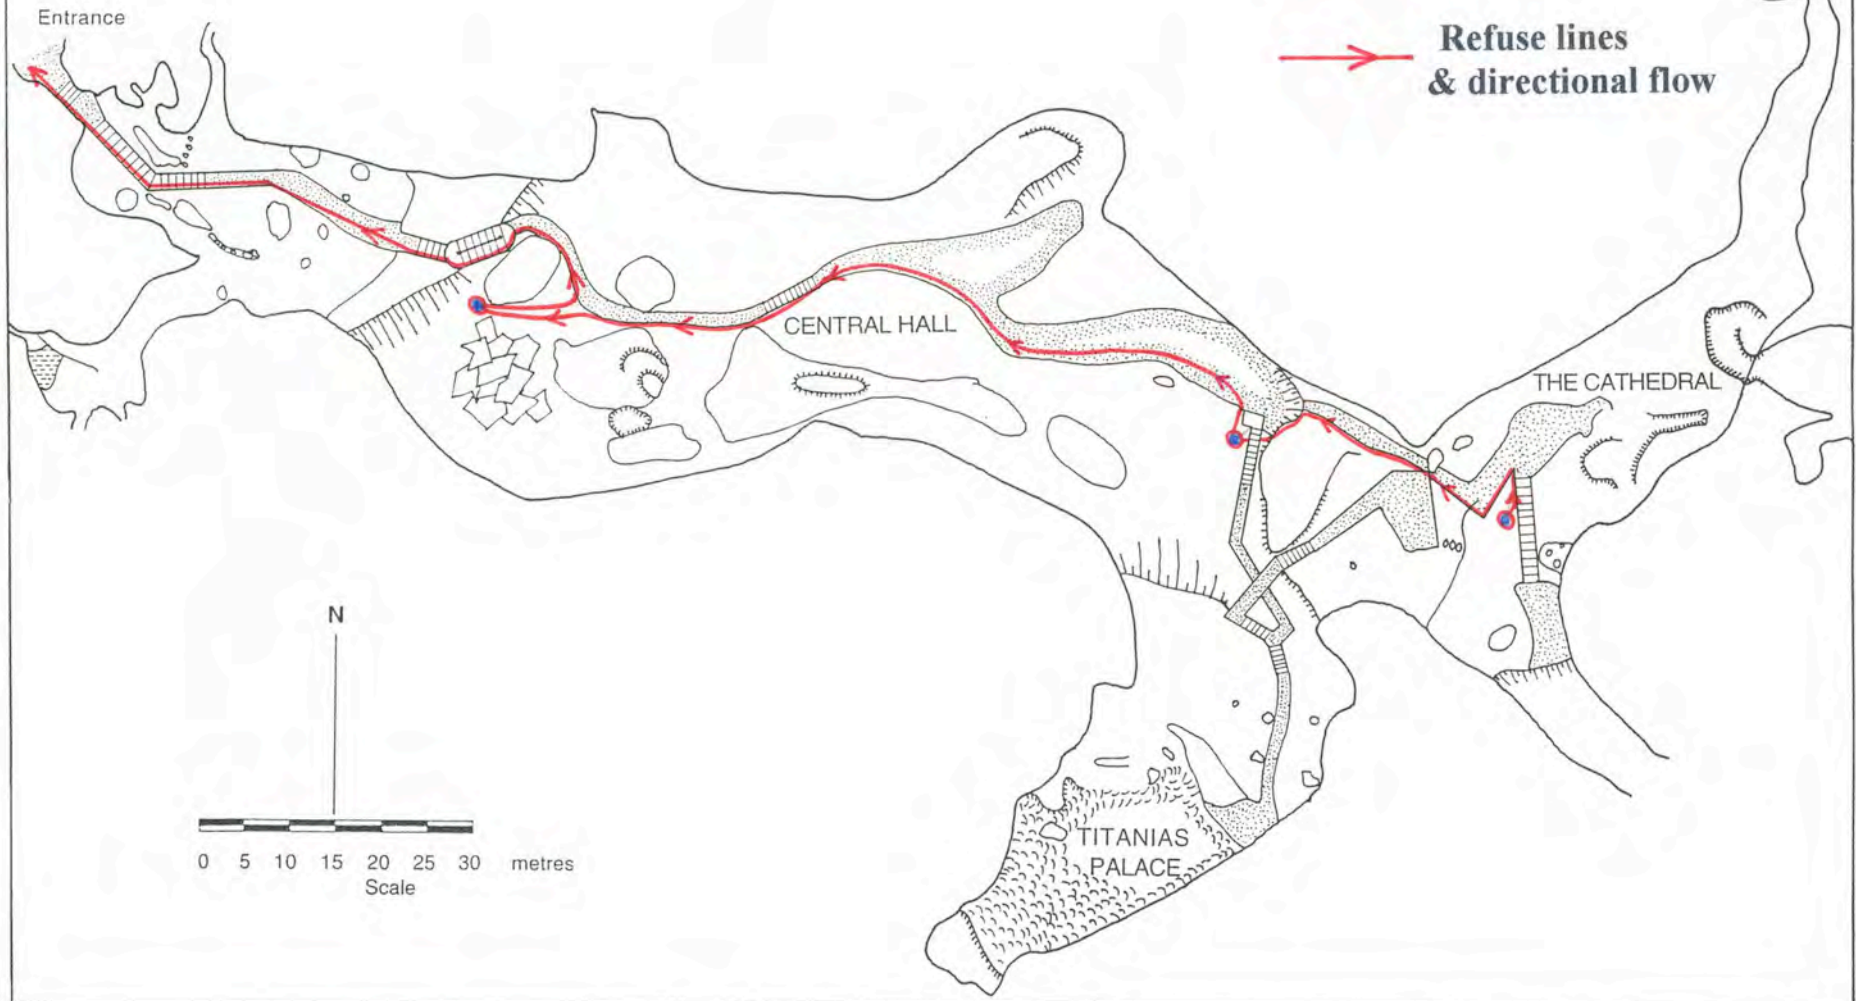
Section 2.4 Material introduced on visitors shoes is mobilised on wet walkways causing pathway slush to develop, accumulate and flow over natural areas.

OBJECTIVES	ACTION	\$	PRIORITIES	ESTIMATED TIME	COMMENTS
Confine introduced foreign materials to visitor walkways	Utilise concrete curbing to surround visitor access areas as identified		A		
Channel Pathway slush and cleaning residue into drainage sumps	Utilise concrete curbing to drain all visitor access surface areas to sumps locations as identified		A		
Remove pathway slush and residue from cave system	Install sump and pumping units connected to a reticulated draining system as identified		A	8 Days	Work-force - 4
Conceal plumbing and electrical services associated with pathway drainage and refuse system	Install plumbing and electrical services in pathway curbing		A
