SOIL-COVER KARST COLLAPSE: A GEOLOGIC HAZARD IN MISSOURI

Missouri Department of Natural Resources

Division of Geology and Land Survey

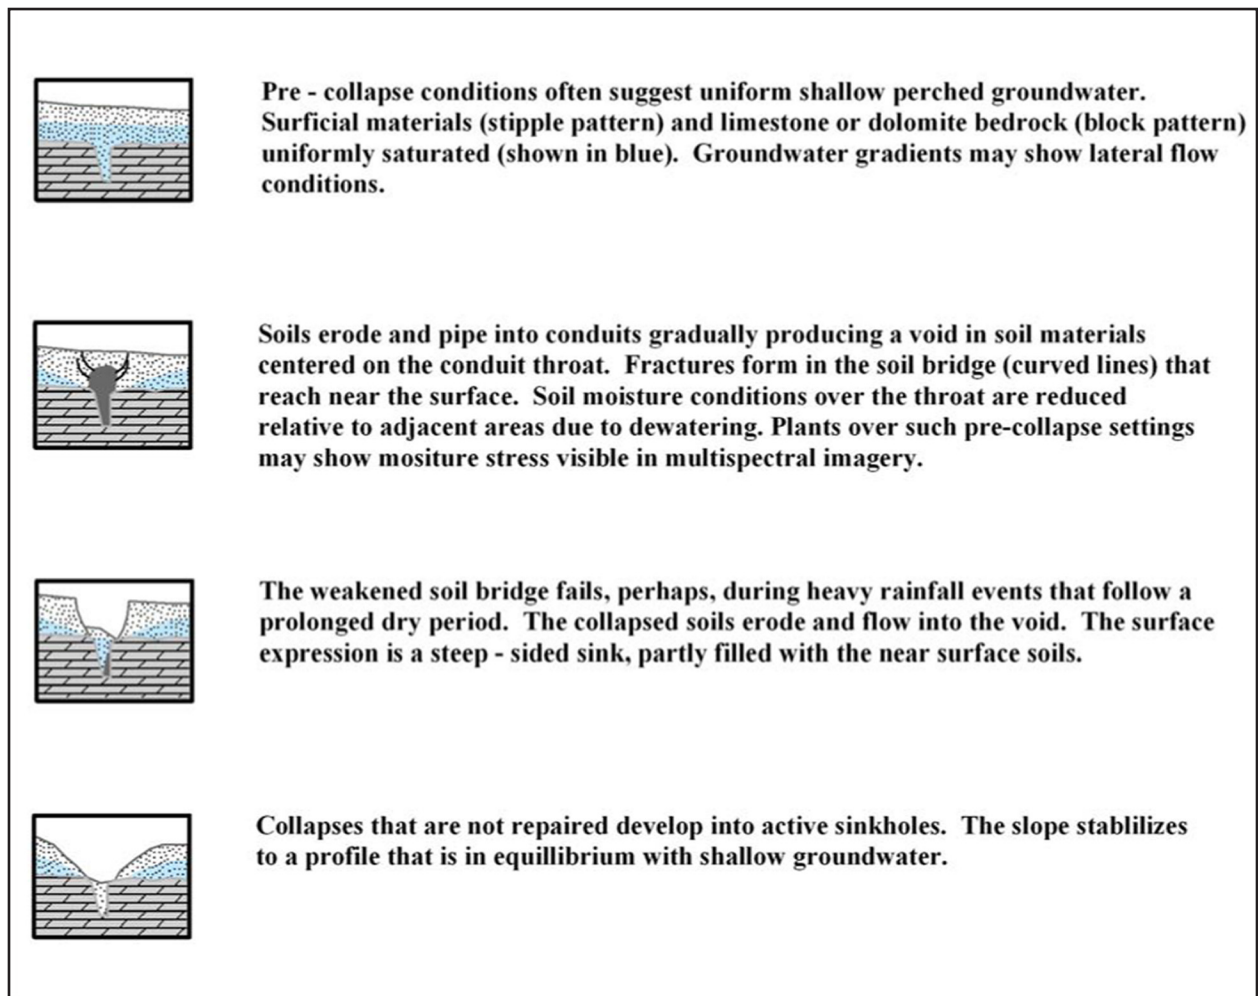
Figure 2

Geologic model of soil-cover karst collapses resulting in typical sinkhole shapes if they are not repaired. Collapses near sinkholes are not uncommon in losing stream valleys that have thick, residual, bedrock soils over weathered, carbonate bedrock, and steep, vertical groundwater gradients. DGLS geologists use these field characteristics to assess collapse potential in carbonate bedrock areas. Vegetation over pre-collapse areas may show differential moisture conditions visible in infrared wavelengths. Satellite imagery, as resolution improves, may provide additional tools to predict locations prone to soil-cover collapse.

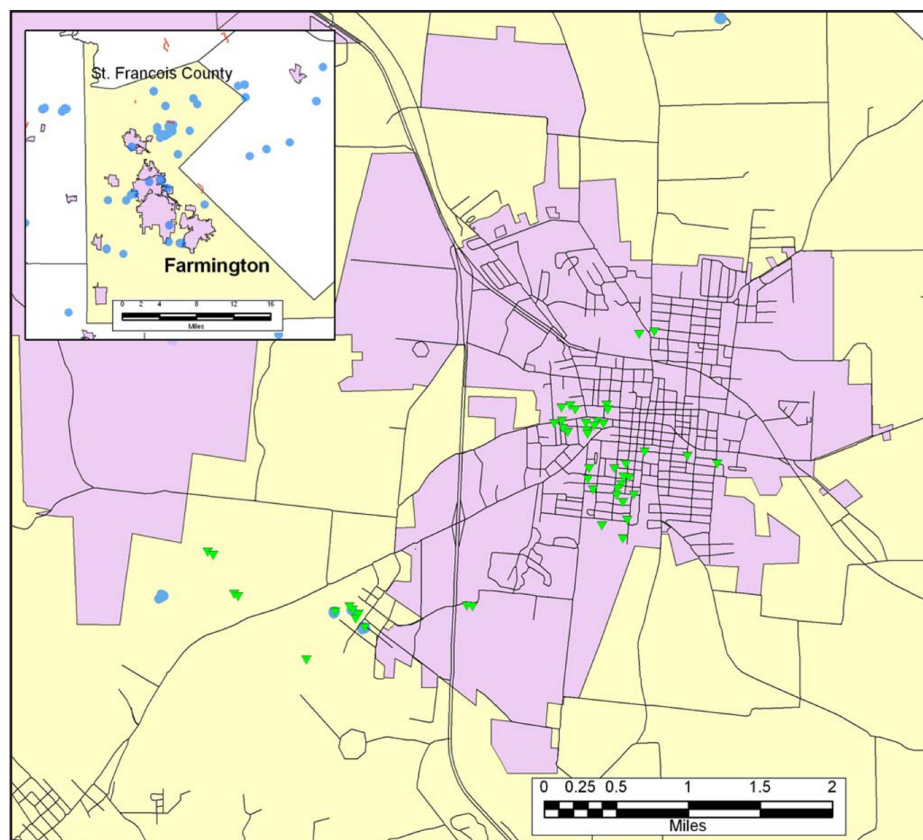
Figure 4 *Forty-eight soil-cover karst collapses were reported in Farmington, Missouri. The bedrock in the shallow subsurface consists of fine to medium-crystalline dolomite of the later, upper Cambrian Bonneterre Formation. Little karst development had been recorded in either the Bonneterre Formation or in continued*

the Farmington area, but fractures and open joints were observed in outcrops and in the collapses themselves. Small dolines were observed near the city. Groundwater draining into bedrock joints erodes and pipes the soils, creating cavities. As the draining progresses, shallow water table conditions reflect soil dewatering near the joints. Most reported collapses were in urban areas, many occurring in residential yards, others forming near or under streets. One formed at a street intersection along a joint in dolomite, over 25 m (80 ft.) deep and nearly 19 m (60 ft.) in diameter, severing utilities and swallowing pavement and sidewalk.

For more than 50 years soil-cover karst collapses have been reported in the city of Farmington, Missouri. Surface expressions of karst features are not common in this area (Figure 4). However, soil-cover collapses have damaged residential building foundations and collapsed sections of city streets resulting in broken municipal water, sewage, and gas lines. Known collapses have a diameter up to 9 m (30 ft.), and are rooted in karst joints as deep

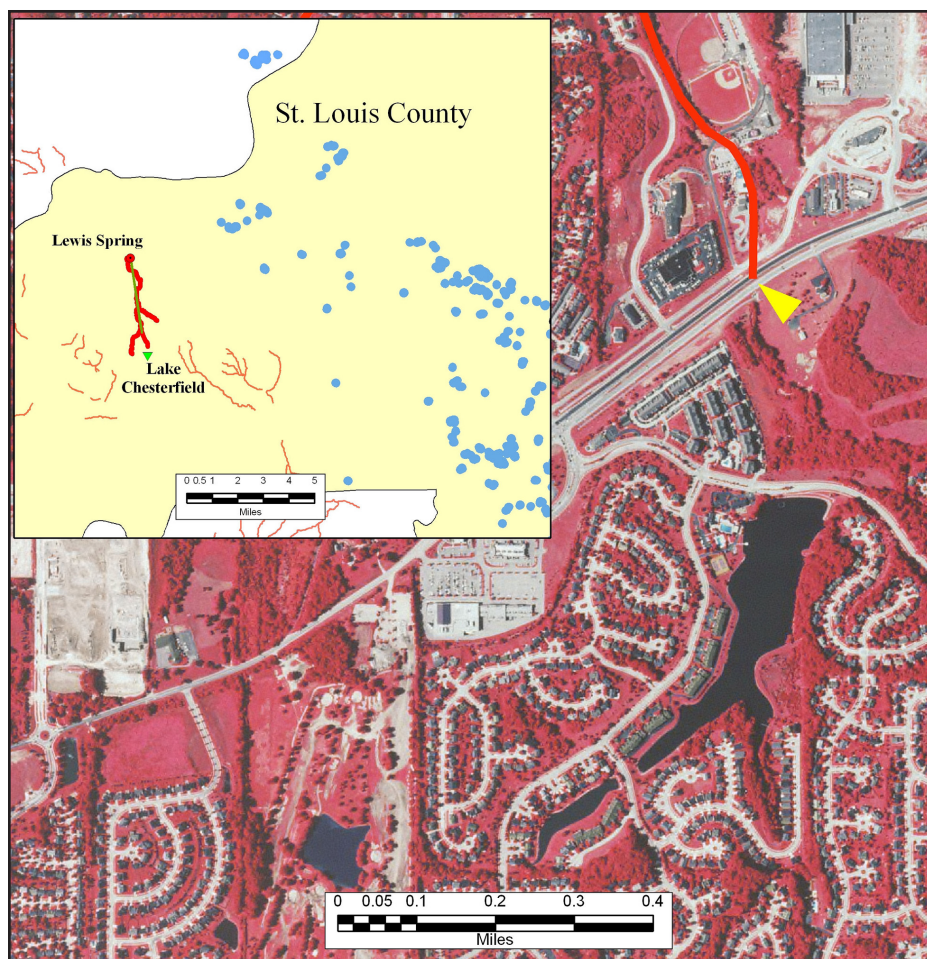
Figure 6A *Infrared aerial photograph showing the location of the Lake Chesterfield Collapse. The nearest mapped sinkholes (inset, dots) are more than 11 km (7 mi.) from Lake Chesterfield, but the lake site is within 400 m (¼ mi.) of a previously mapped losing stream (bold line at upper right, marked by pointer). A water trace from near the site (inset) indicates water lost to the ground near lake site flows to Lewis Spring (dot).*

Built in 1987 to control storm water runoff from a large residential development, Lake Chesterfield was a 9-ha (23-ac.) recreational lake for a community in west St. Louis County (Figures 6A–6C). The lake was formed by construction of an earthen dam across a portion of Caulks Creek. Shallow bedrock at the site consists of the Mississippian-age limestone. Although this unit is highly weathered and contains solution features indicative of karst, the nearest mapped sinkhole is over seven miles from the lake site.

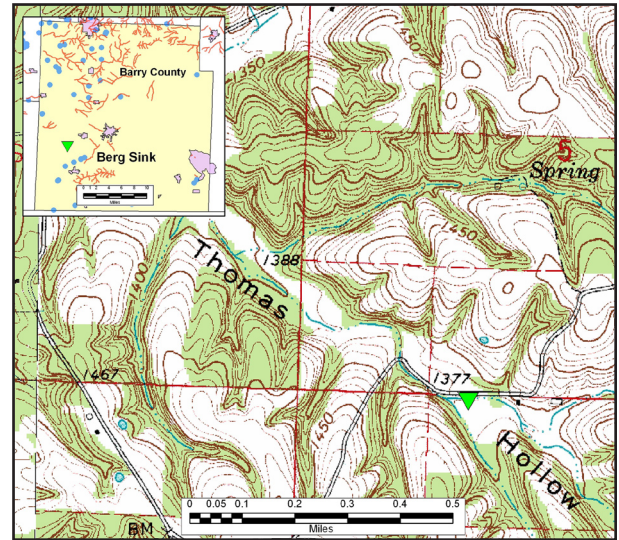
Figure 7

Located in Barry County near Cassville (Figures 7–10), this collapse is also within a losing stream valley, in an area of cherty limestones of the Mississippian-age Elsey and Reeds Spring formation, and has residual soils that are from 9 to >18 m (30 to >60 ft.) thick. The collapse was first observed by the landowners during the third week of February 2005 as a 3-m-diameter (10-ft.), water-filled depression in an open pasture. The owners indicated that the depth of this first opening was about 12 m (40 ft.). By the second week in March of 2005, the collapse had expanded to nearly 76 m (250 ft.) wide by 30 m (100 ft.) long (Figure 8A and 8B), and at one stage appeared to be greater than 46

Berg Sink, Barry County. The bedrock in the shallow subsurface is the variably cherty limestones of the Mississippian Elsey Formation. Streams in the vicinity of the collapse (triangle) had not been classified, but investigations since the collapse showed losing flow above the collapse and within 60 m (200 ft.) downstream. Surficial materials in the valley floor appear to be greater than 9 m (30 ft.) thick based on electrical resistivity. During the first week of March 2005, the collapse flowed to the adjacent losing stream. If the collapse is about 45 m (150 ft.) deep, the conduit would be in the Ozark Aquifer. The nearest sinkholes are approximately 4.3 km (2.7 mi.) from the collapse. Base map: USGS Exeter 7.5' Quadrangle.

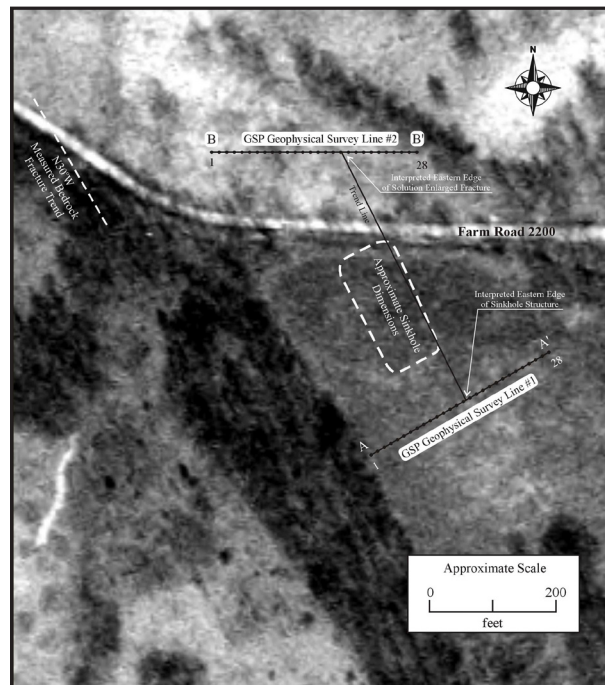
Figure 9 *Site Map of Berg Sink showing the approximate locations of the geophysical survey lines and the surface expression of the sink structure.*
