Restoration Blasting near Limestone Caves at Mt Etna Limestone Mine

By Kim Henley

Principal Blasting Specialist - Quarries and Construction
Orica Explosives
and
Chris White
Company Manager
Pacific Lime Pty Ltd

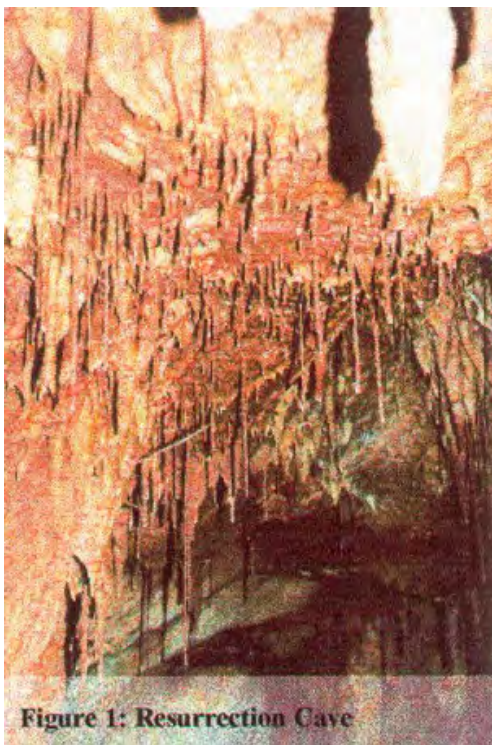
Figure 1: Resurrection Cave

Blasting associated with the mining operations at Mt. Etna during the late 1960's inadvertently created an opening into a previously unknown cave at the site. This opening is the only entrance to the cave, which became known as Quarryman's or Resurrection Cave.

Resurrection Cave contains some of the most impressive formations in the area, including stalactites, shawls, straws, and helictites. Straws and helictites are among the most fragile of limestone cave formations, and take many hundreds of years to grow.

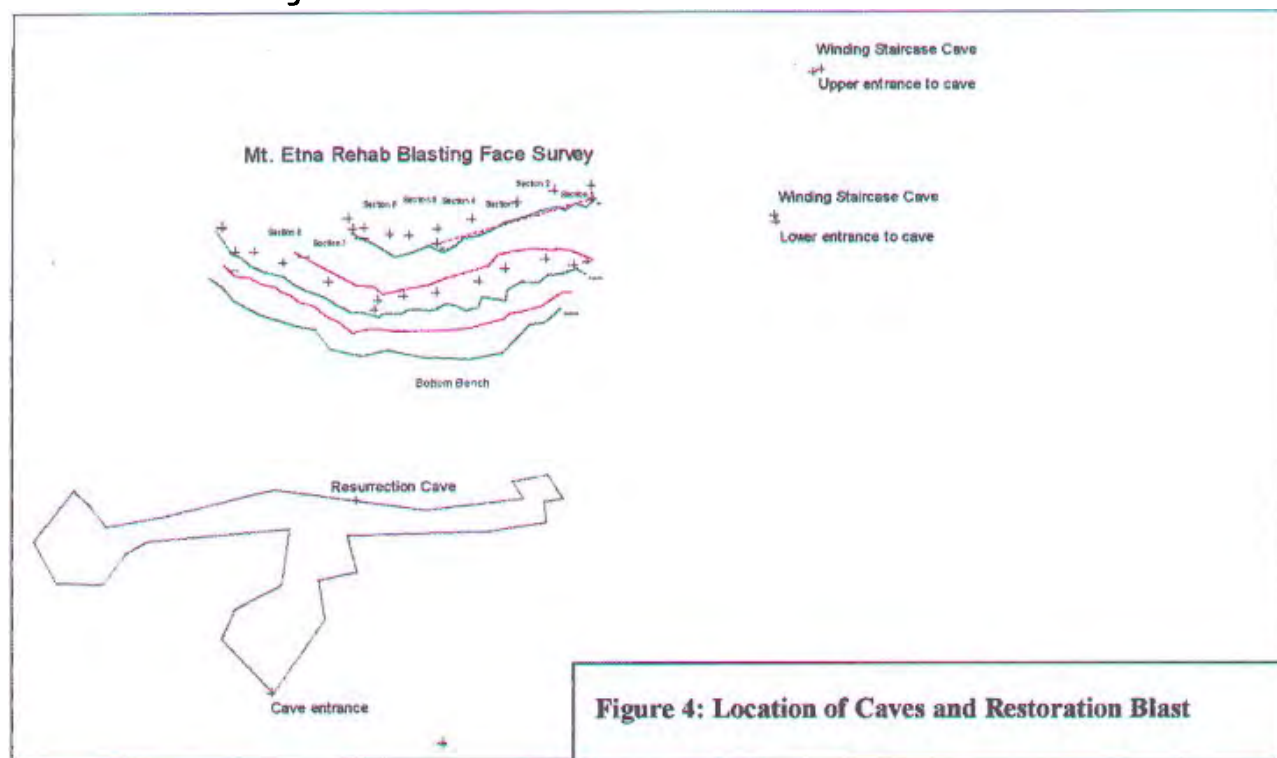
Figure 4: Location of Caves and Restoration Blast

There are three caves near the restoration blast:

- Bat Cleft Cave - about 100m from the nearest end of the blasting area.
- Winding Staircase Cave - about 60 m from the blasting area.
- Resurrection Cave (also called Quarryman's Cave) - about 50 m from the blasting area.

Resurrection Cave is the only cave with significant limestone formations. Both Bat Cleft Cave and Winding Staircase Cave are solute cavities, and have no formations. The greatest possibility of damage was to Resurrection Cave where fragile formations were most likely to be damaged by vibrations from blasting.

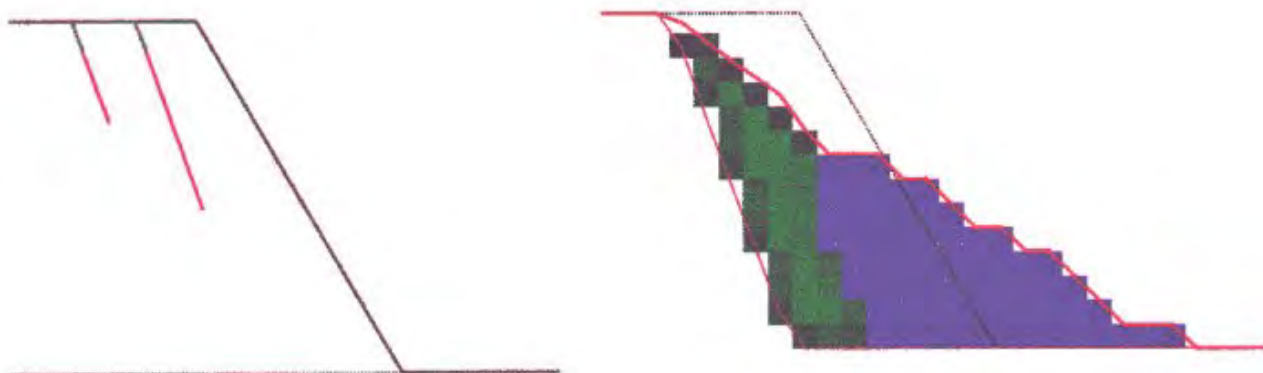
Figure 5: Blast Simulation of Typical Section

The overall slope of the mountain was used to guide the design by placing on the plan lines at 40 degrees inclination. Blast hole depths were calculated to produce a blast that breaks up the tall faces into shorter sections with blast rubble at the base to allow vegetation establishment.

The Orica Explosives blast simulation program Sabrex, backed up the author's extensive knowledge and experience in blasting to design a blast that proved very successful. The simulated sections from Sabrex are shown in Figure 5.

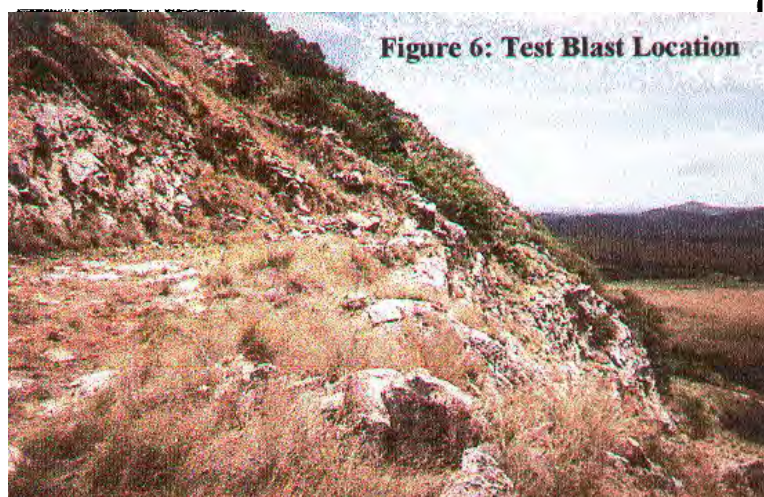
Figure 6: Test Blast Location

Drilling of the test blast was made difficult by the numerous cracks and voids encountered. This frequently caused loss of return air and indicated that charging of the blast needed extreme caution to avoid overcharging causing flyrock and airblast.

Charging of the test blast was extremely difficult. Voids and cracks caused ANFO to be lost from the blast holes and consistent column rise was rarely achieved.

Layflat tube filled with stemming material was used to block the ends of blast holes and also to provide a bridge across voids part way up the holes.

Modifications to the planned blast charging design were made frequently to overcome these problems. Approximately 200 kg of explosive was used to charge the test blast.

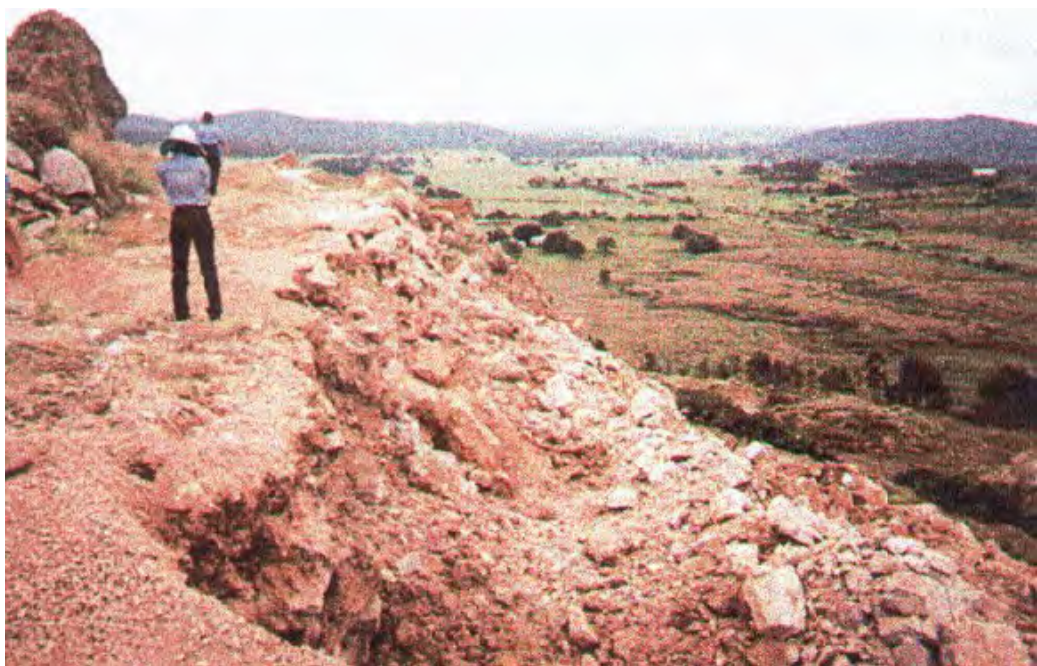
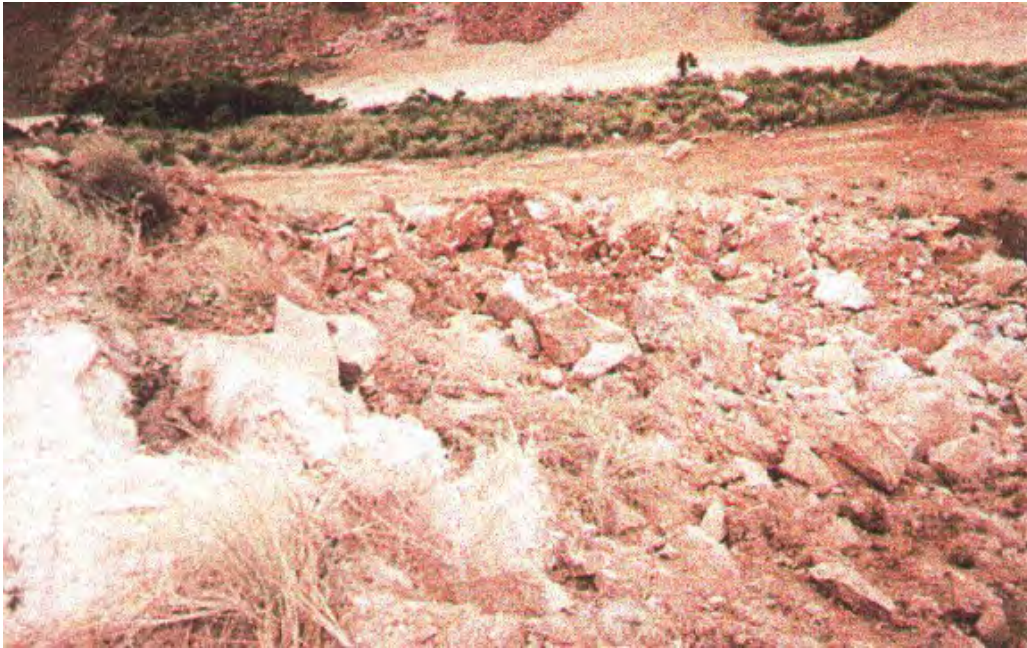
Figure 8: Main Rehabilitation Blast Photos

The top part of the bench lifted and dropped in a similar fashion to the test blast, but rock sizes produced were a more consistent than the test blast because fewer cracks and voids were encountered in the rock.

Everyone interested in the blast outcome also considered this blast successful. A small section of the blast was fragmented but failed to move forwards due to the low powder factor in this area. This section was pushed forward by an excavator that to move the material into final position.
