## Case Studies in Udanax

The case studies presented here relate to the mining problems encountered in a fictitious country called Udanax<sup>1</sup>. These studies are reproduced, with permission, from *Mine Rehabilitation Environment and Health Protection: A Training Manual* (UNEP and WHO, 1998). Trainers and trainees are encouraged to use these case studies as a tool to allow them to think freely in a situation where they are not limited by the practical problems that bedevil real-life situations, such as financial, political and time constraints. Having said this, these case studies are intended to prepare trainees to work in real-life situations. There is plenty of room to expand the case studies, and trainers are encouraged to develop the scenarios further and to prepare additional exercises, especially to bring out issues and topics of particular concern and interest to trainees.

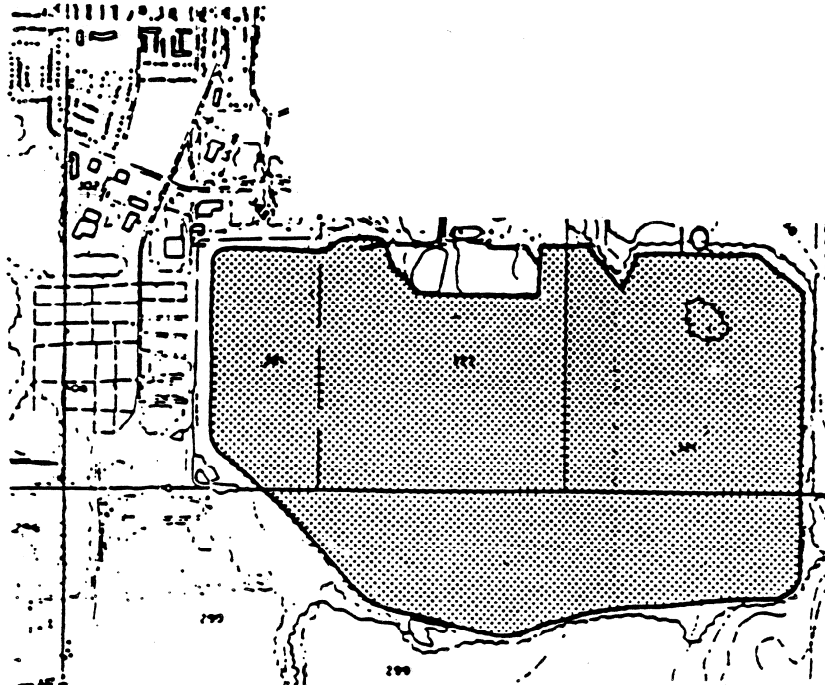
Between 1912 and 1972, 58 million tonnes of tailings were deposited over an area of 192 hectares. The area surrounding the tailings is flat and there was no habitation in the immediate vicinity during the operation of the mine (Figure.2.1).

From preliminary examination it has been determined that the dam was built by the upstream method with spigotted tailings which were not controlled by any design criteria, thus producing a loosely packed mixed grain size material.

**Figure.2.1. Location of Tailings Relative to Housing**

There is water seeping from the toe of the slopes and sand boils near the toe are common. This seepage combined with internal piping and the surface runoff has caused the formation of deep gullies and rotational slips on the slope. The gullies extend to roughly half of the dam elevation and are progressing to the crest. There is a marshy, swampy area at the base of the dam, with numerous tamarack trees, separating the site from the residences.
